DIV7|ROOF Company

Estimate: FOSTER_COLLEGE

The current roofing system is a TPO (Thermoplastic Polyolefin) that is mechanically attached (there are various areas across the mapping area that were found to be improperly installed). **A fully adhered system is highly recommended in comparison to a mechanically attached system to be applied a gravel ballast built-up roof. Fully adhered systems can reduce the number of seams needed, decreasing potential leak points.**

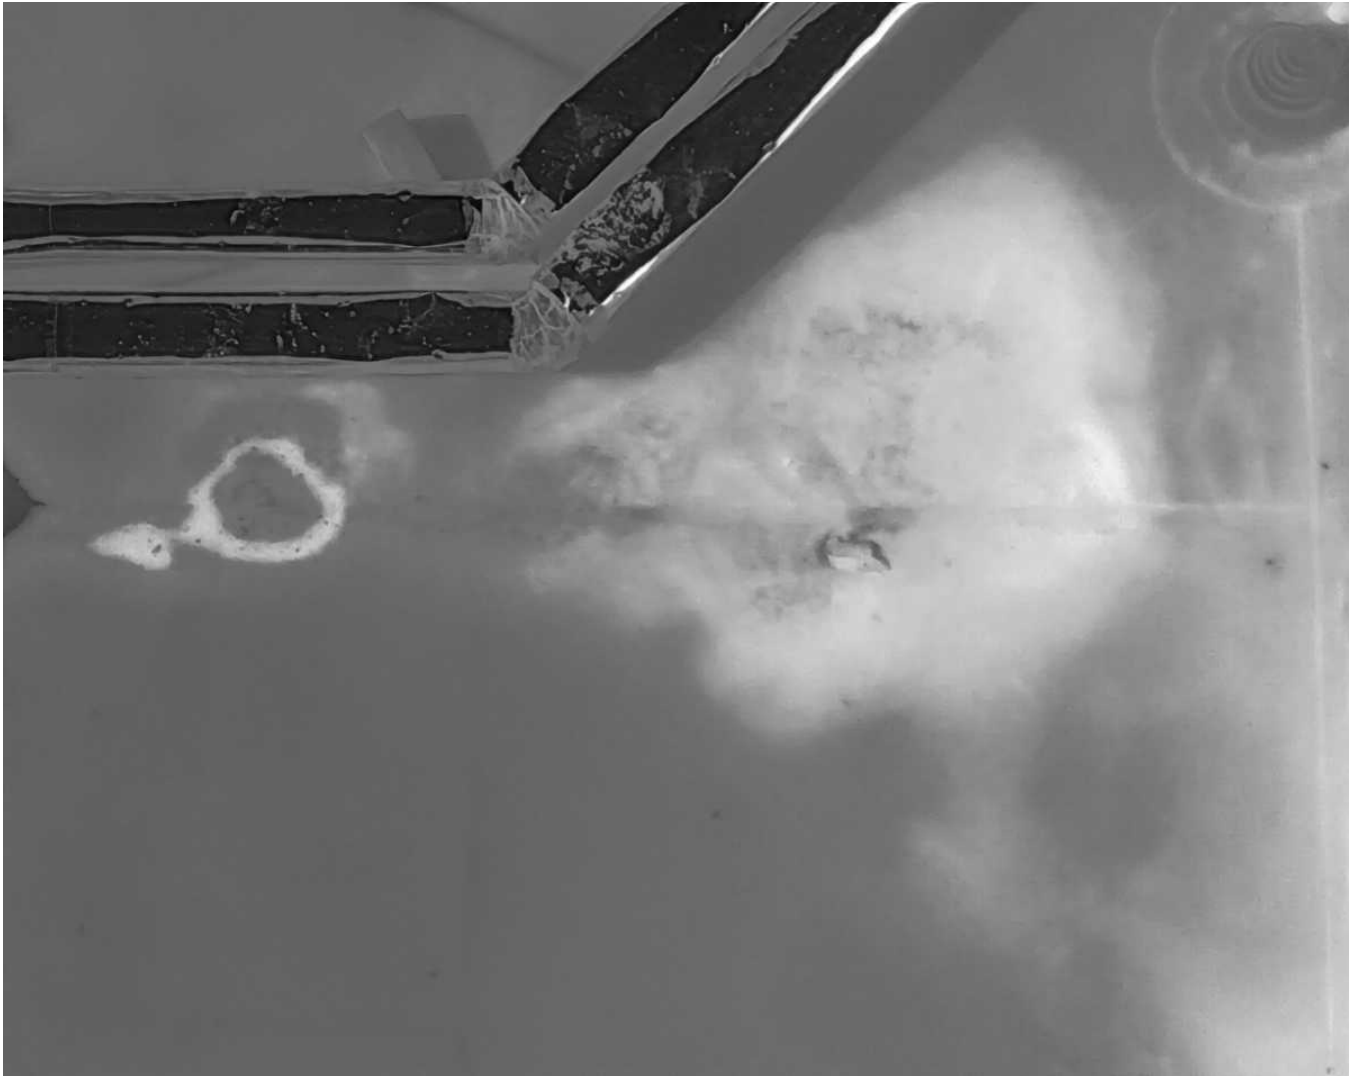
- 10 10-UV Degredation Date Taken: 4/21/2025 Taken By: Angela Night
- While white TPO membranes are designed to reflect UV radiation, ponding water can concentrate the sun's rays, increasing UV damage to the membrane

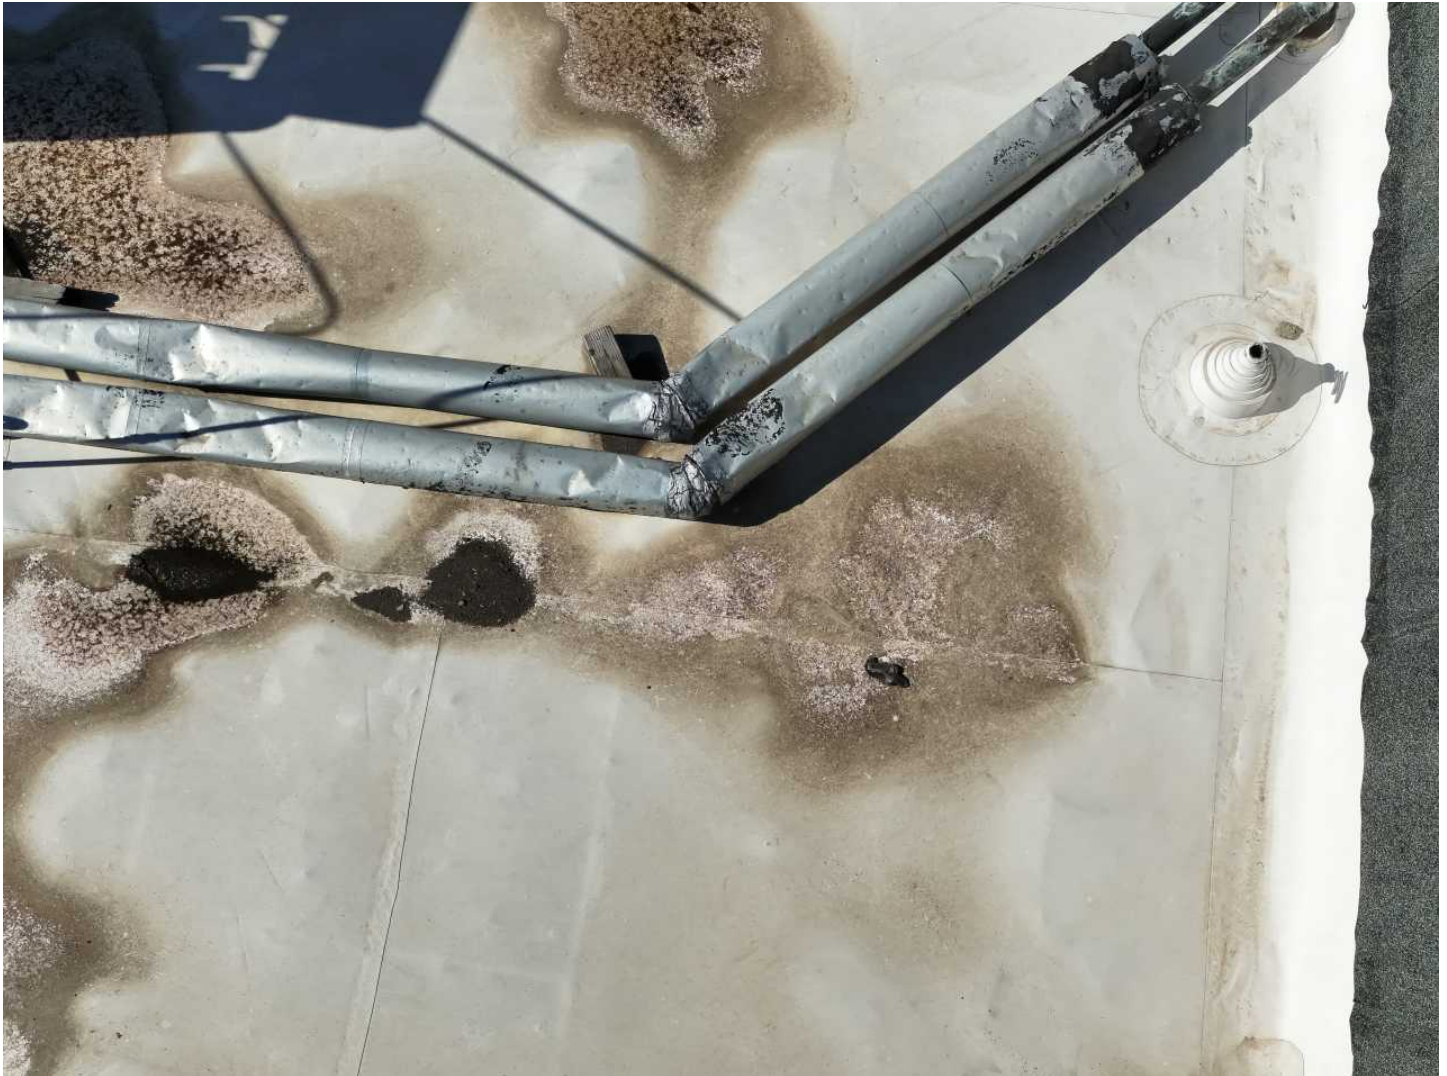
11 11-Boiling Temperatures Date Taken: 4/21/2025 Taken By: Angela Night

Ponding water creates dark areas on the roof surface. These dark areas absorb more sunlight than a white roof, leading to a significant temperature increase.

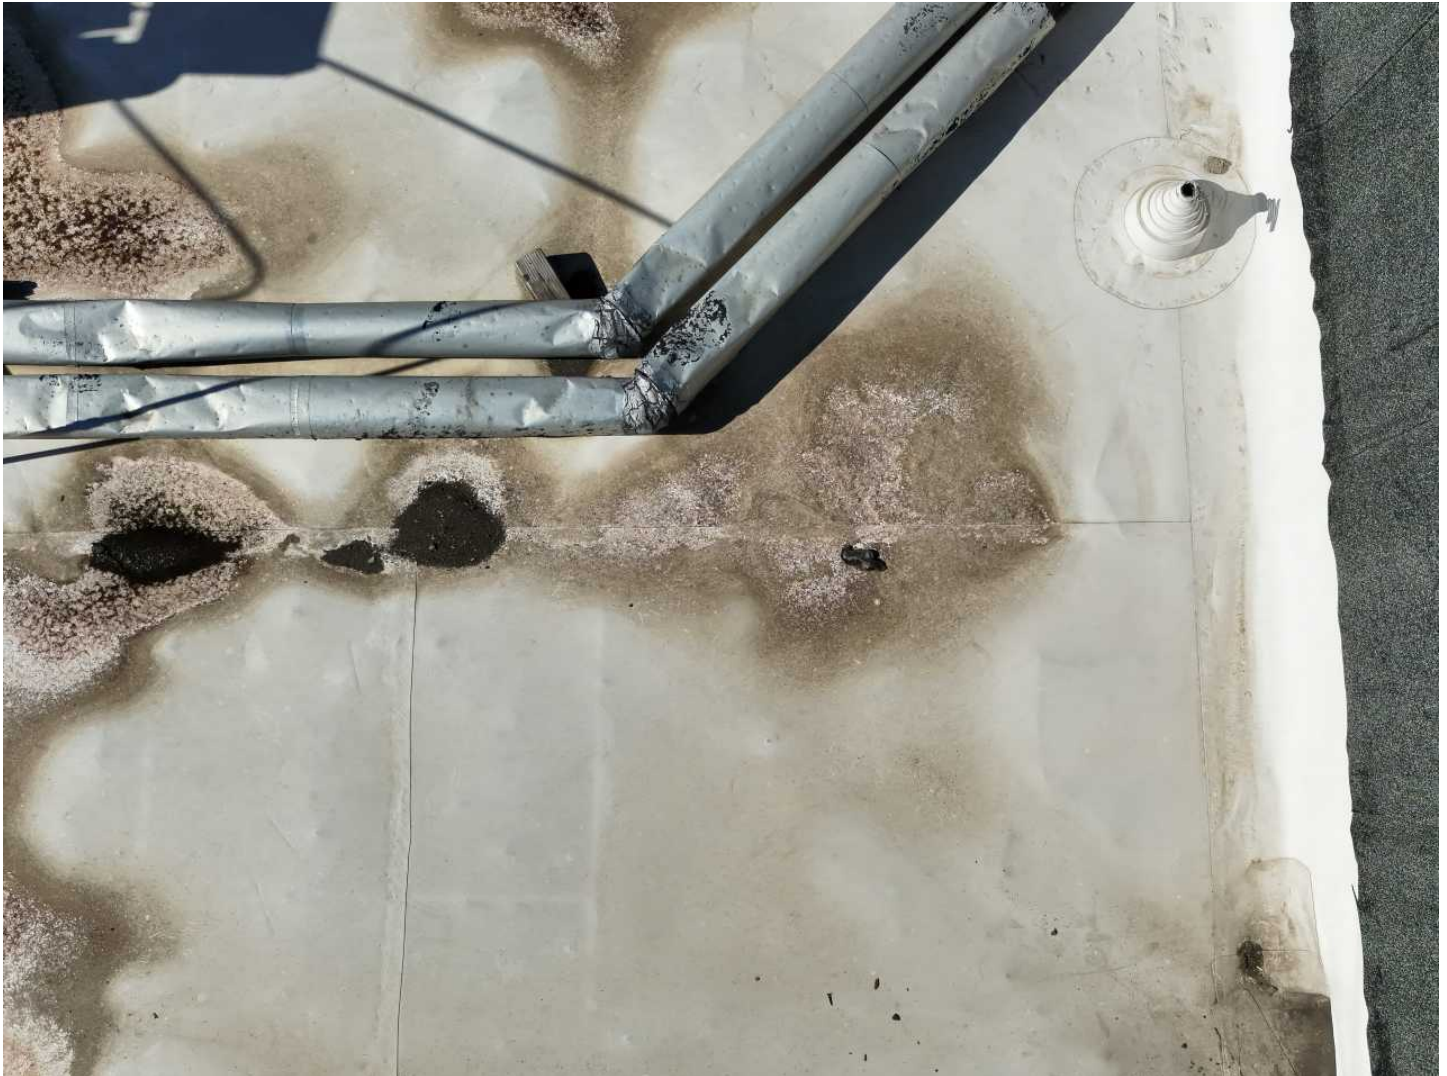
12 12-UV Degredation Date Taken: 4/21/2025 Taken By: Angela Night

While white TPO membranes are designed to reflect UV radiation, ponding water can concentrate the sun's rays, increasing UV damage to the membrane

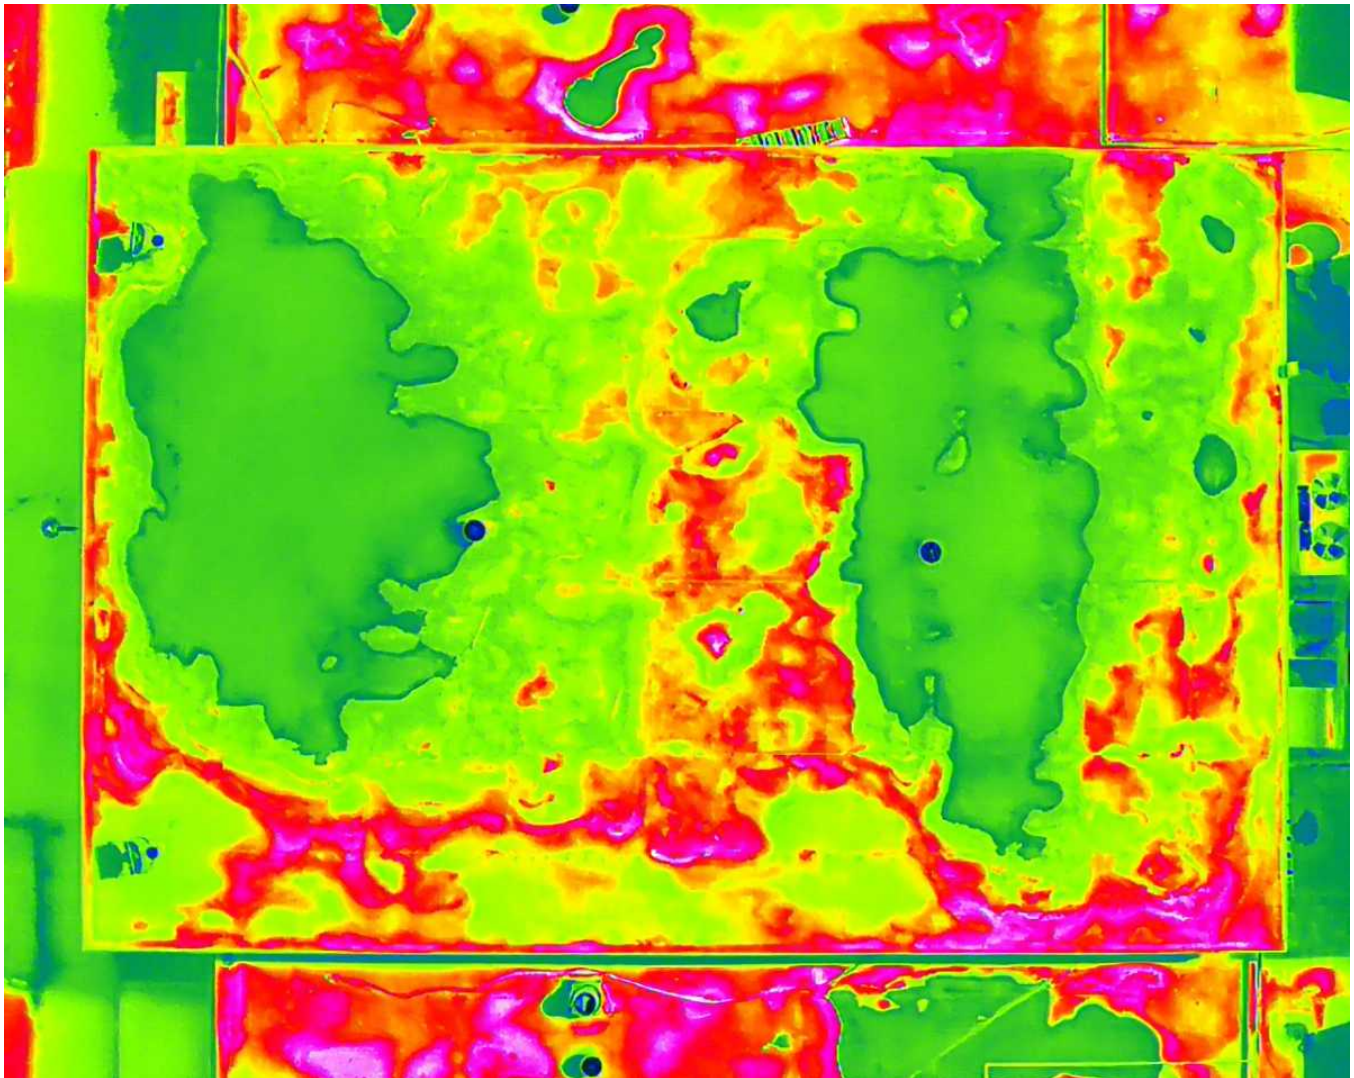
24-UV Degredation

While white TPO membranes are designed to reflect UV radiation, ponding water can concentrate the sun's rays, increasing UV damage to the membrane

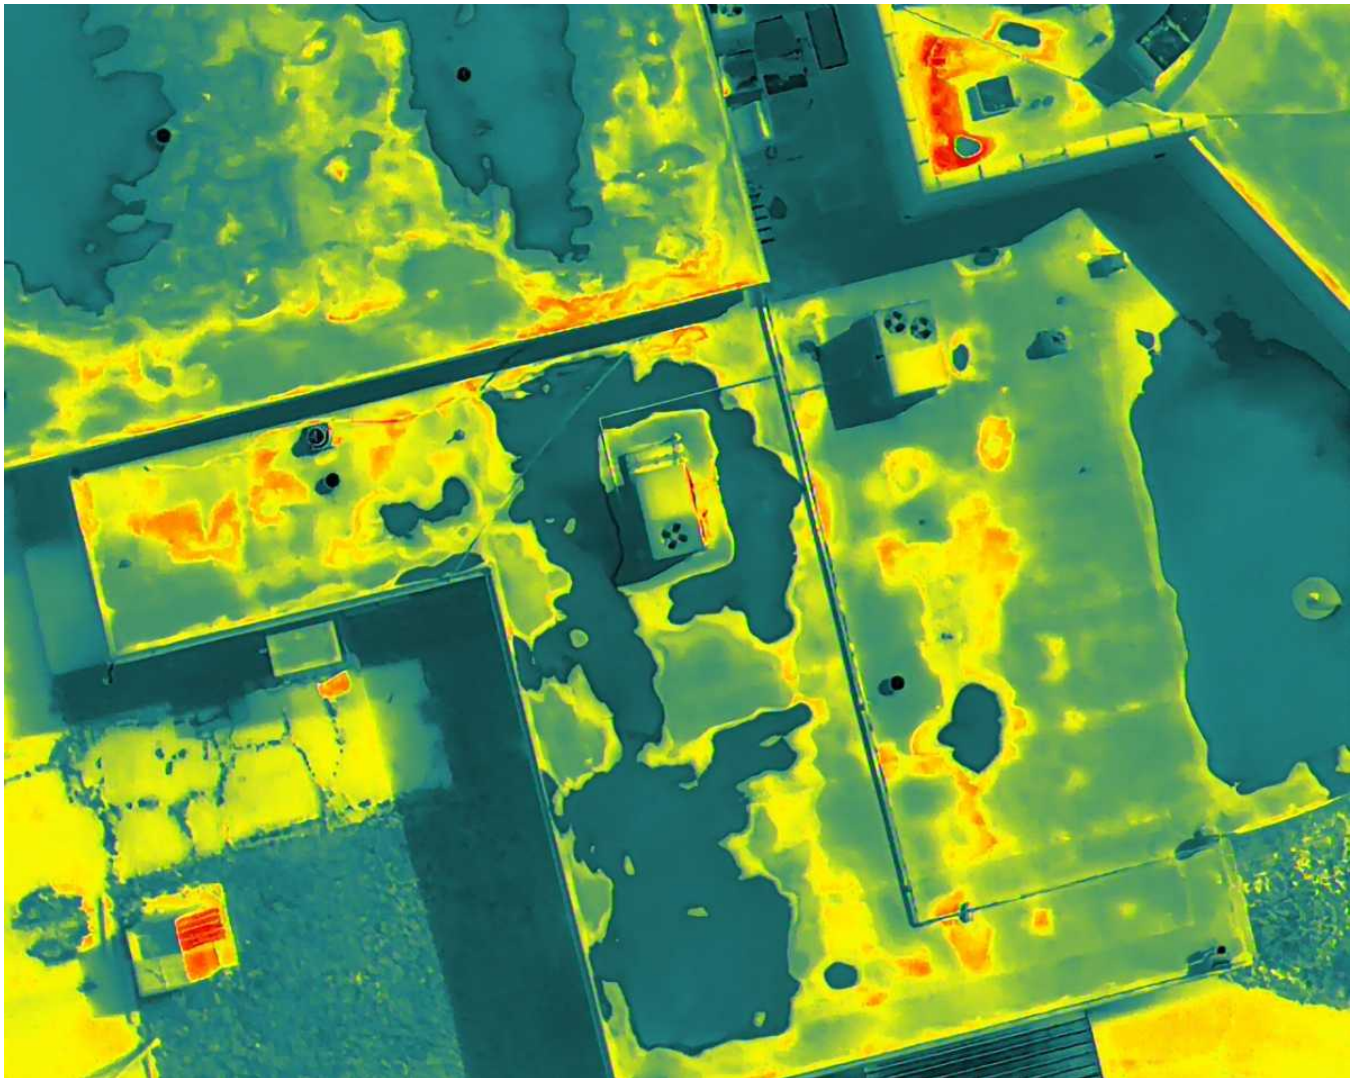
25-UV Degredation

While white TPO membranes are designed to reflect UV radiation, ponding water can concentrate the sun's rays, increasing UV damage to the membrane

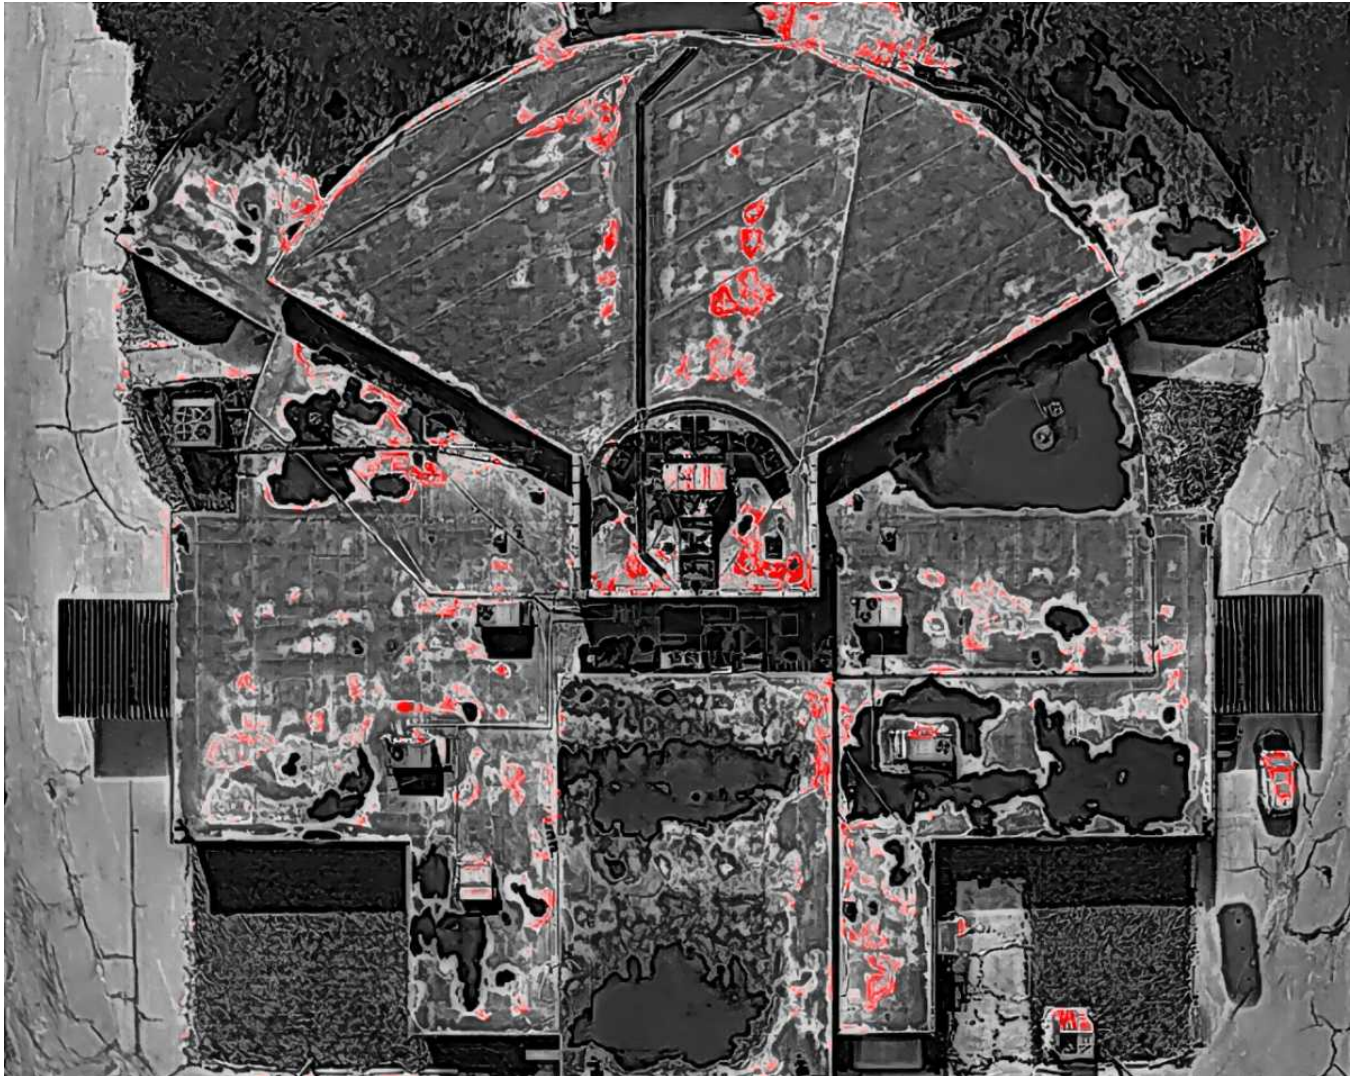
26-UV Degredation

While white TPO membranes are designed to reflect UV radiation, ponding water can concentrate the sun's rays, increasing UV damage to the membrane

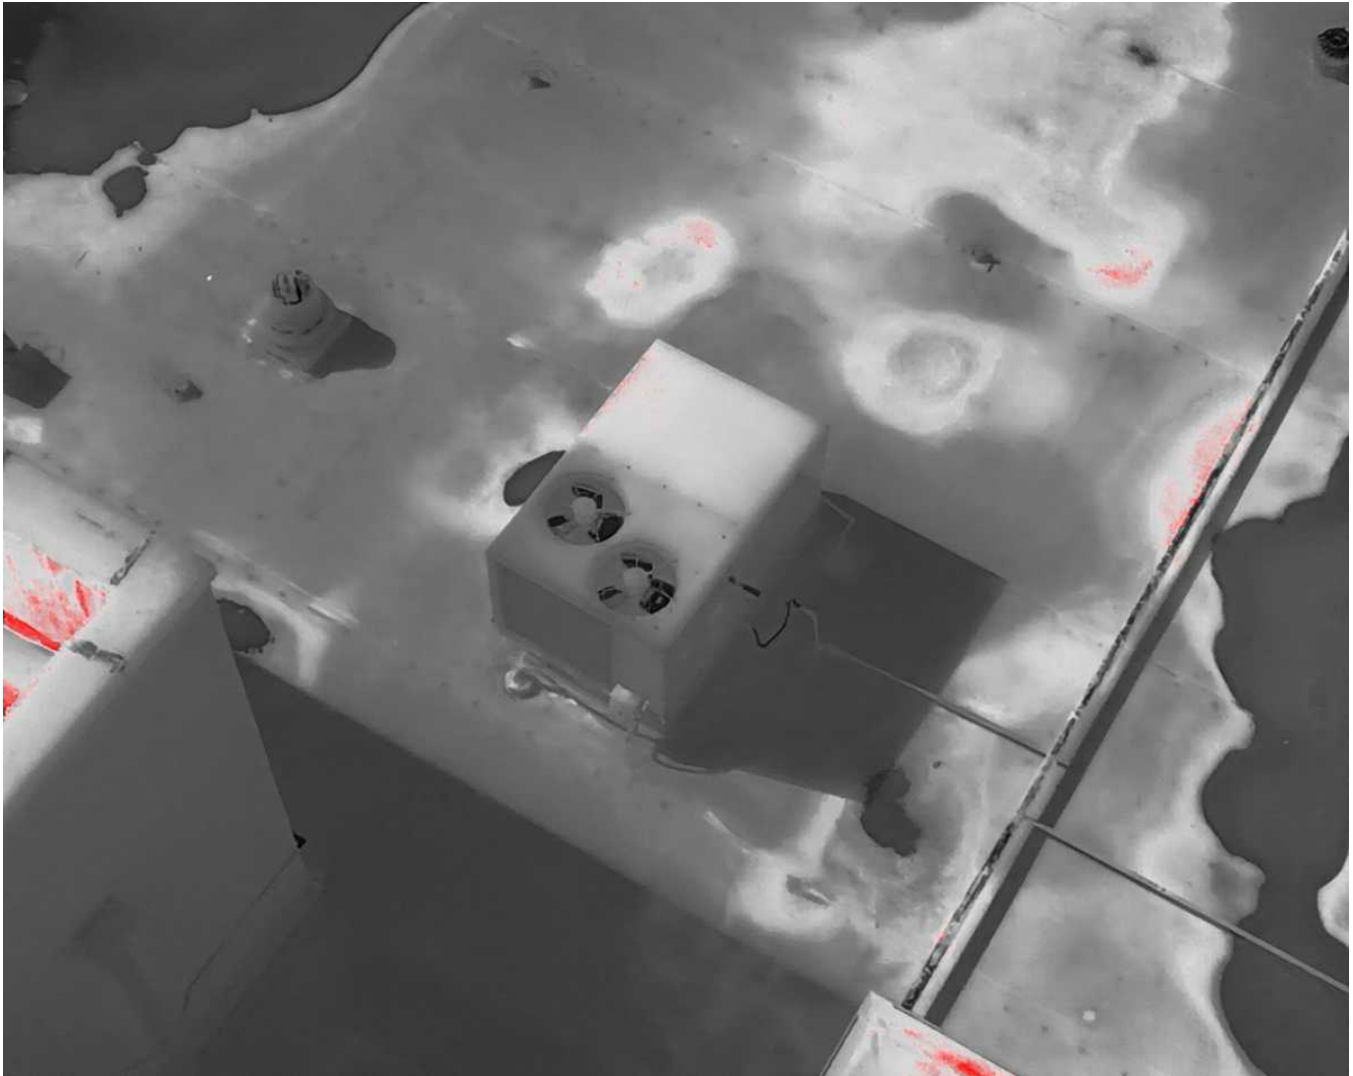
27 27-UV Degredation Date Taken: 4/21/2025 Taken By: Angela Night

While white TPO membranes are designed to reflect UV radiation, ponding water can concentrate the sun's rays, increasing UV damage to the membrane

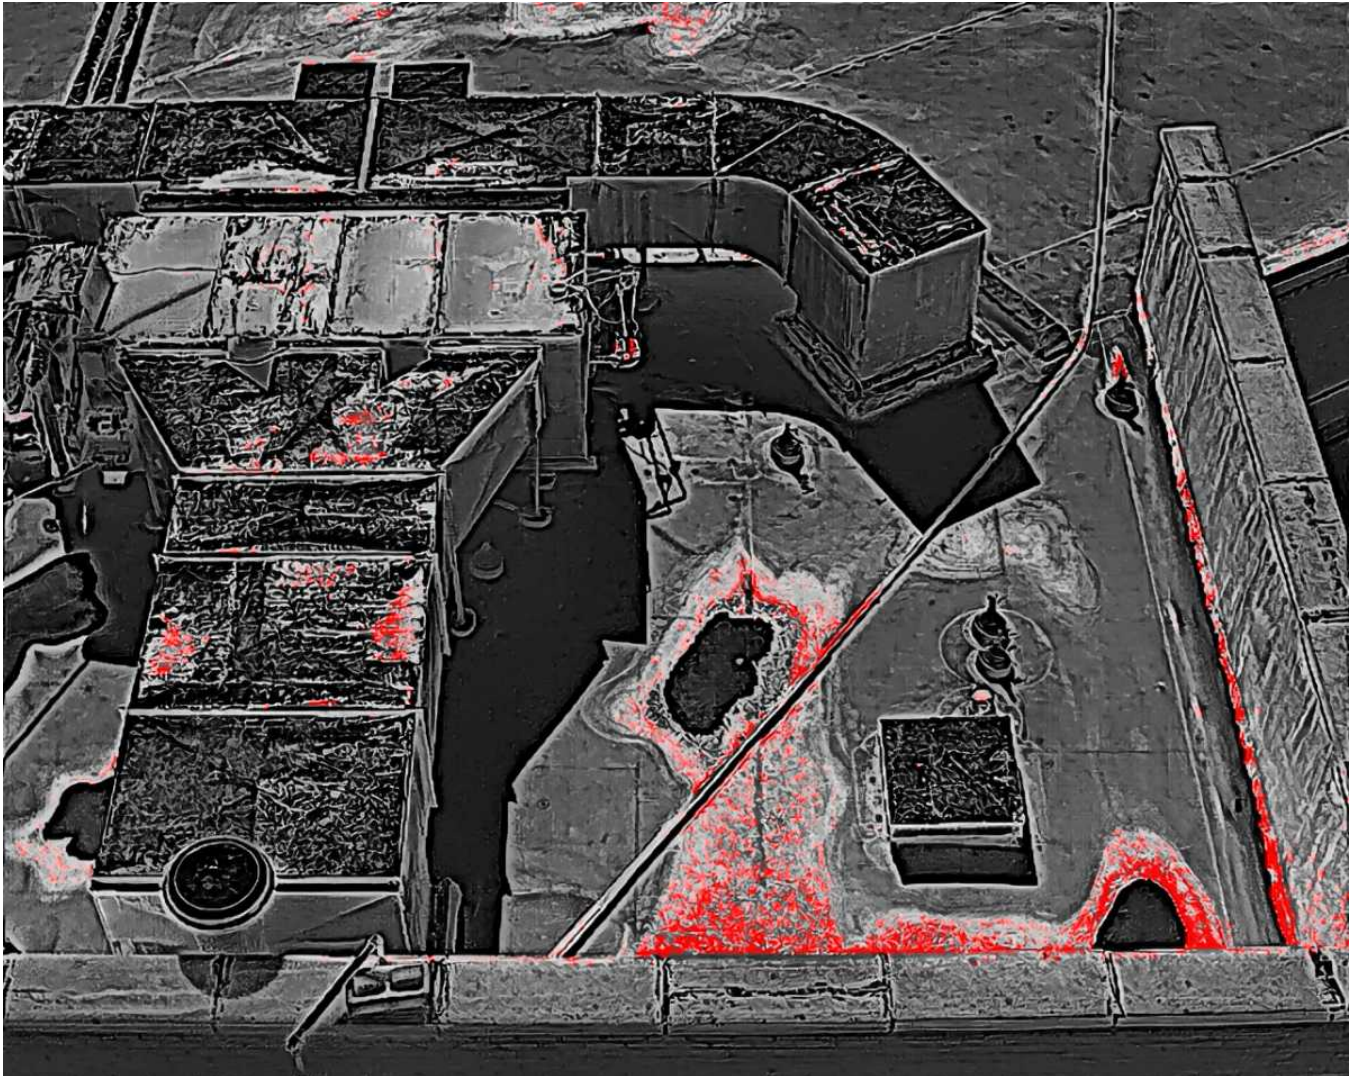
29 29-UV Degredation Date Taken: 4/21/2025 Taken By: Angela Night

While white TPO membranes are designed to reflect UV radiation, ponding water can concentrate the sun's rays, increasing UV damage to the membrane

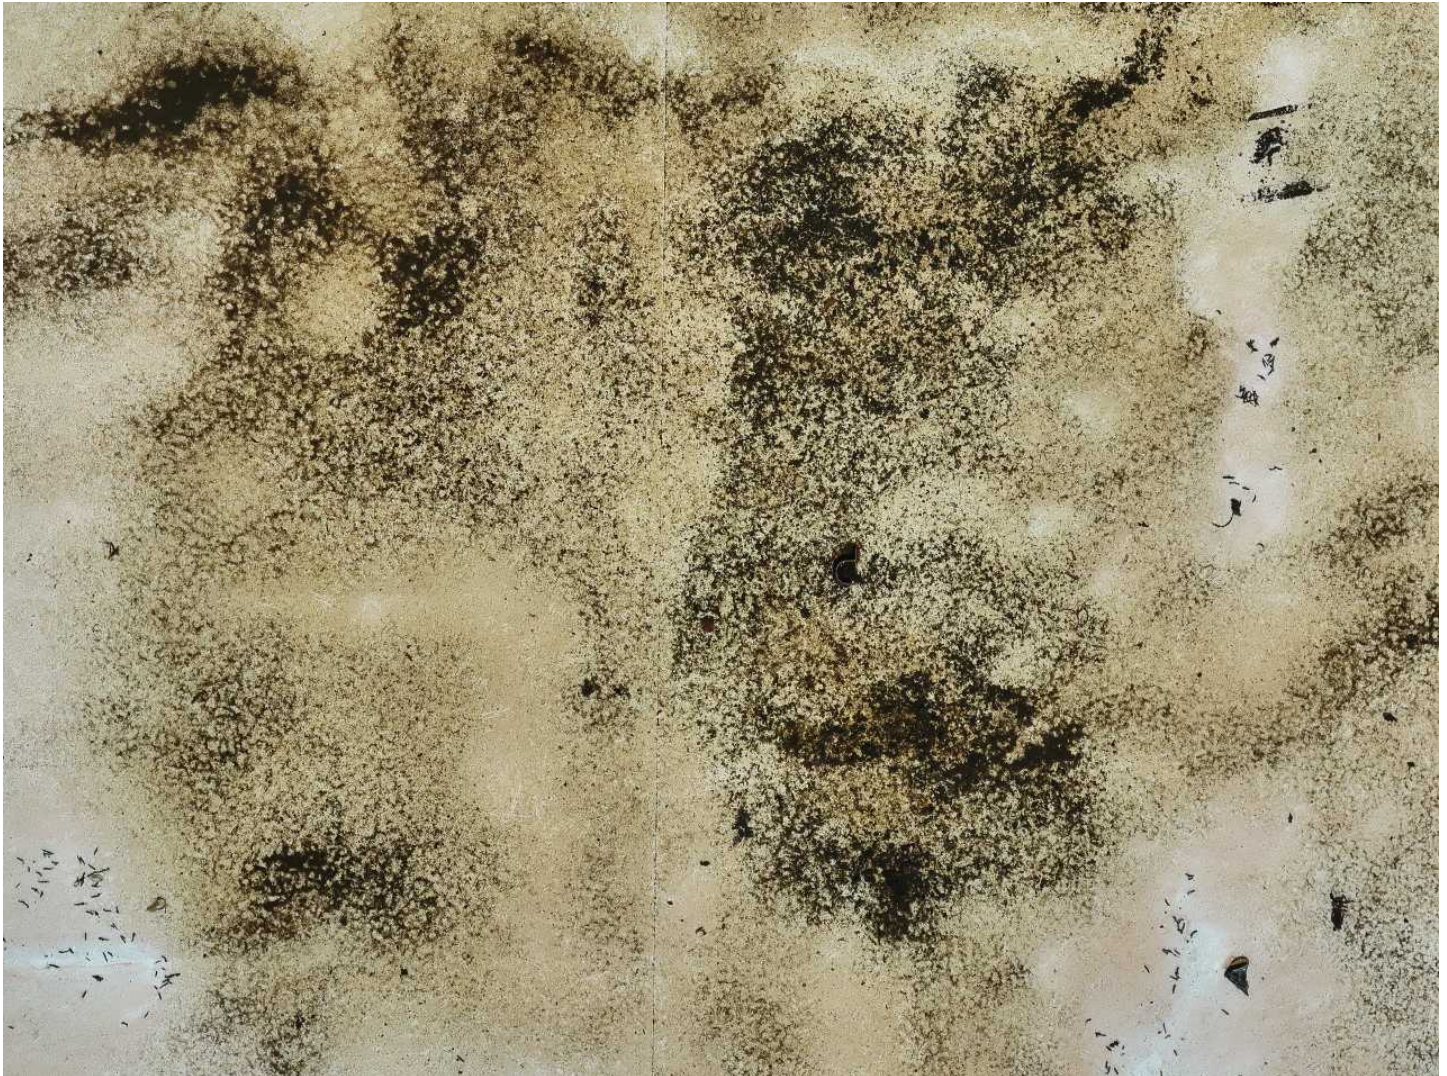
30-UV Degredation

While white TPO membranes are designed to reflect UV radiation, ponding water can concentrate the sun's rays, increasing UV damage to the membrane

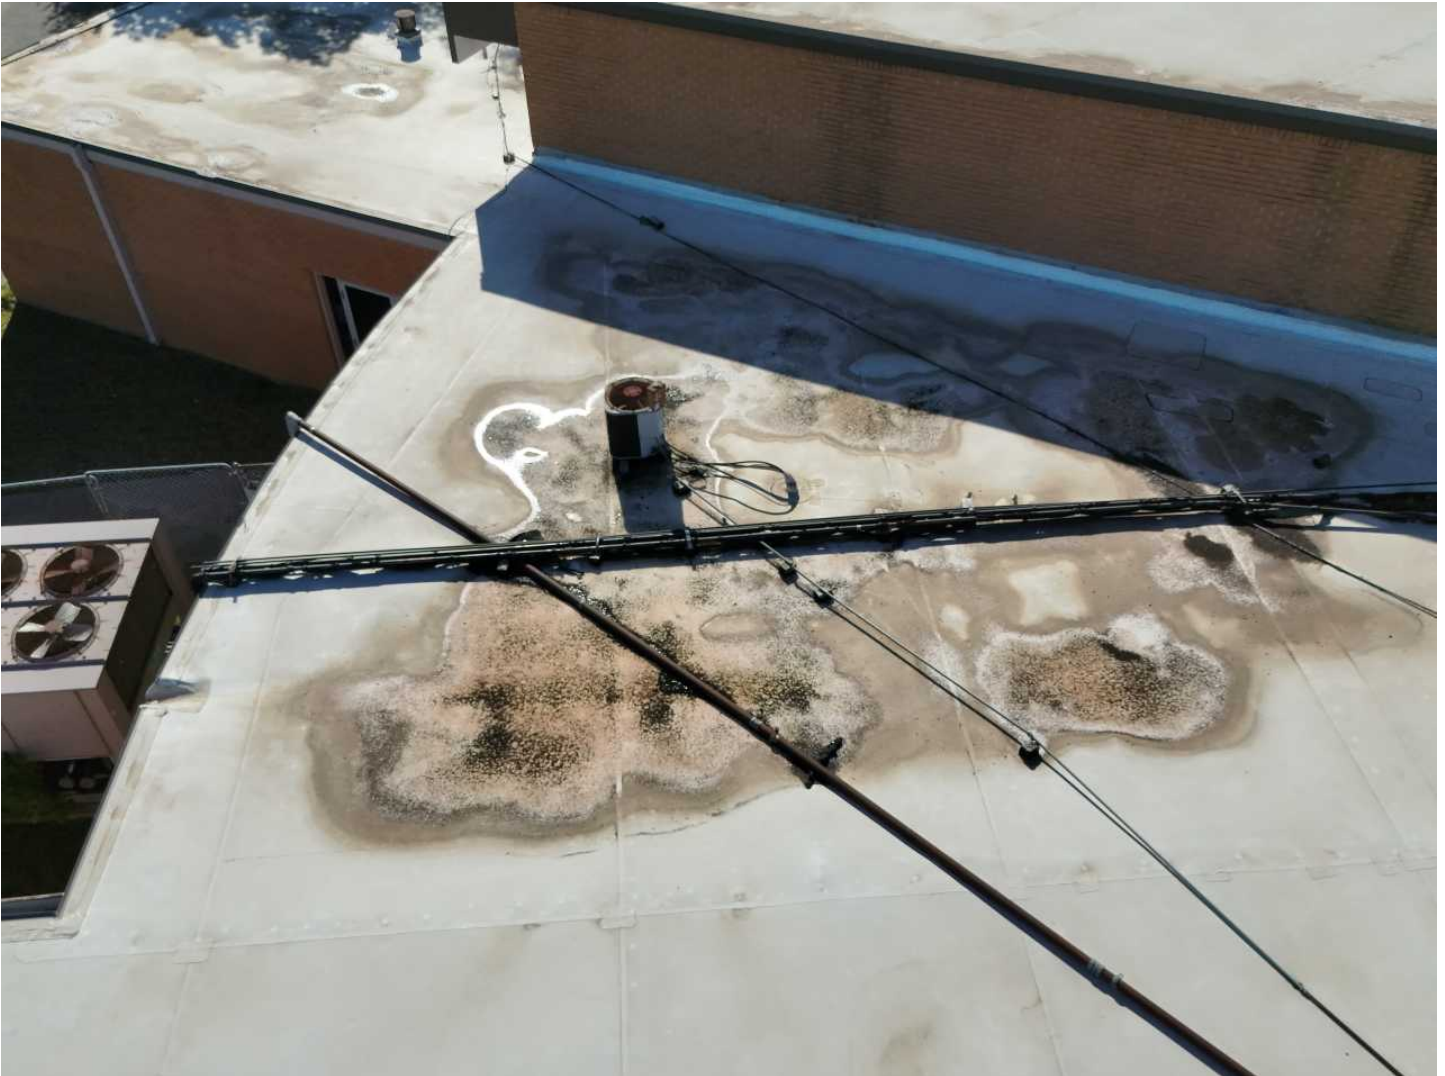
33-UV Degredation

While white TPO membranes are designed to reflect UV radiation, ponding water can concentrate the sun's rays, increasing UV damage to the membrane

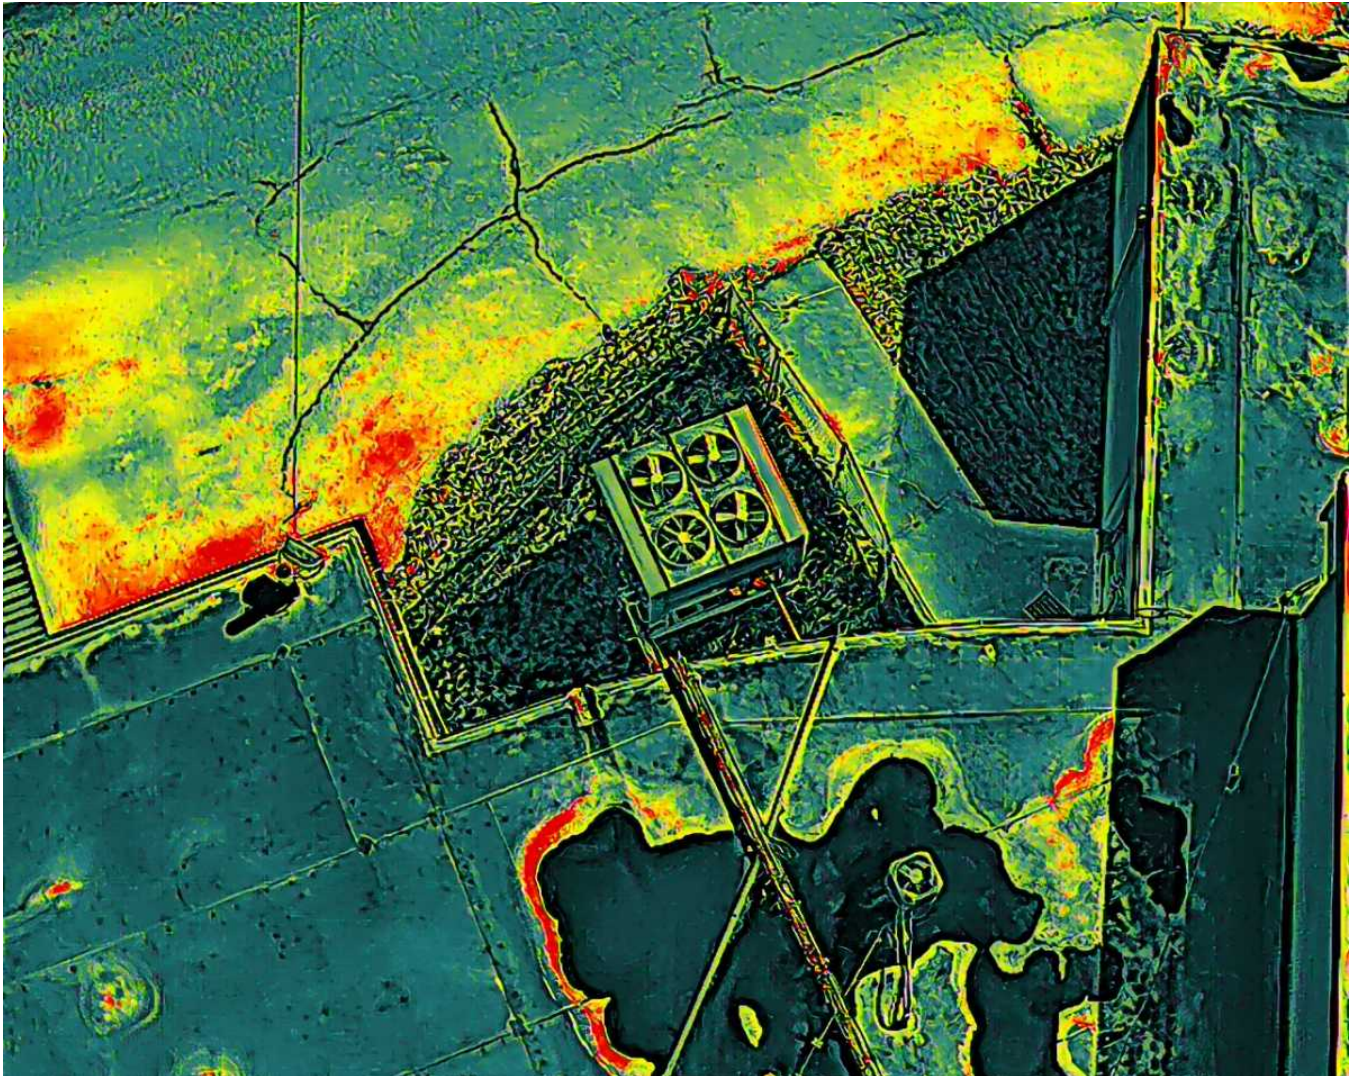
While white TPO membranes are designed to reflect UV radiation, ponding water can concentrate the sun's rays, increasing UV damage to the membrane

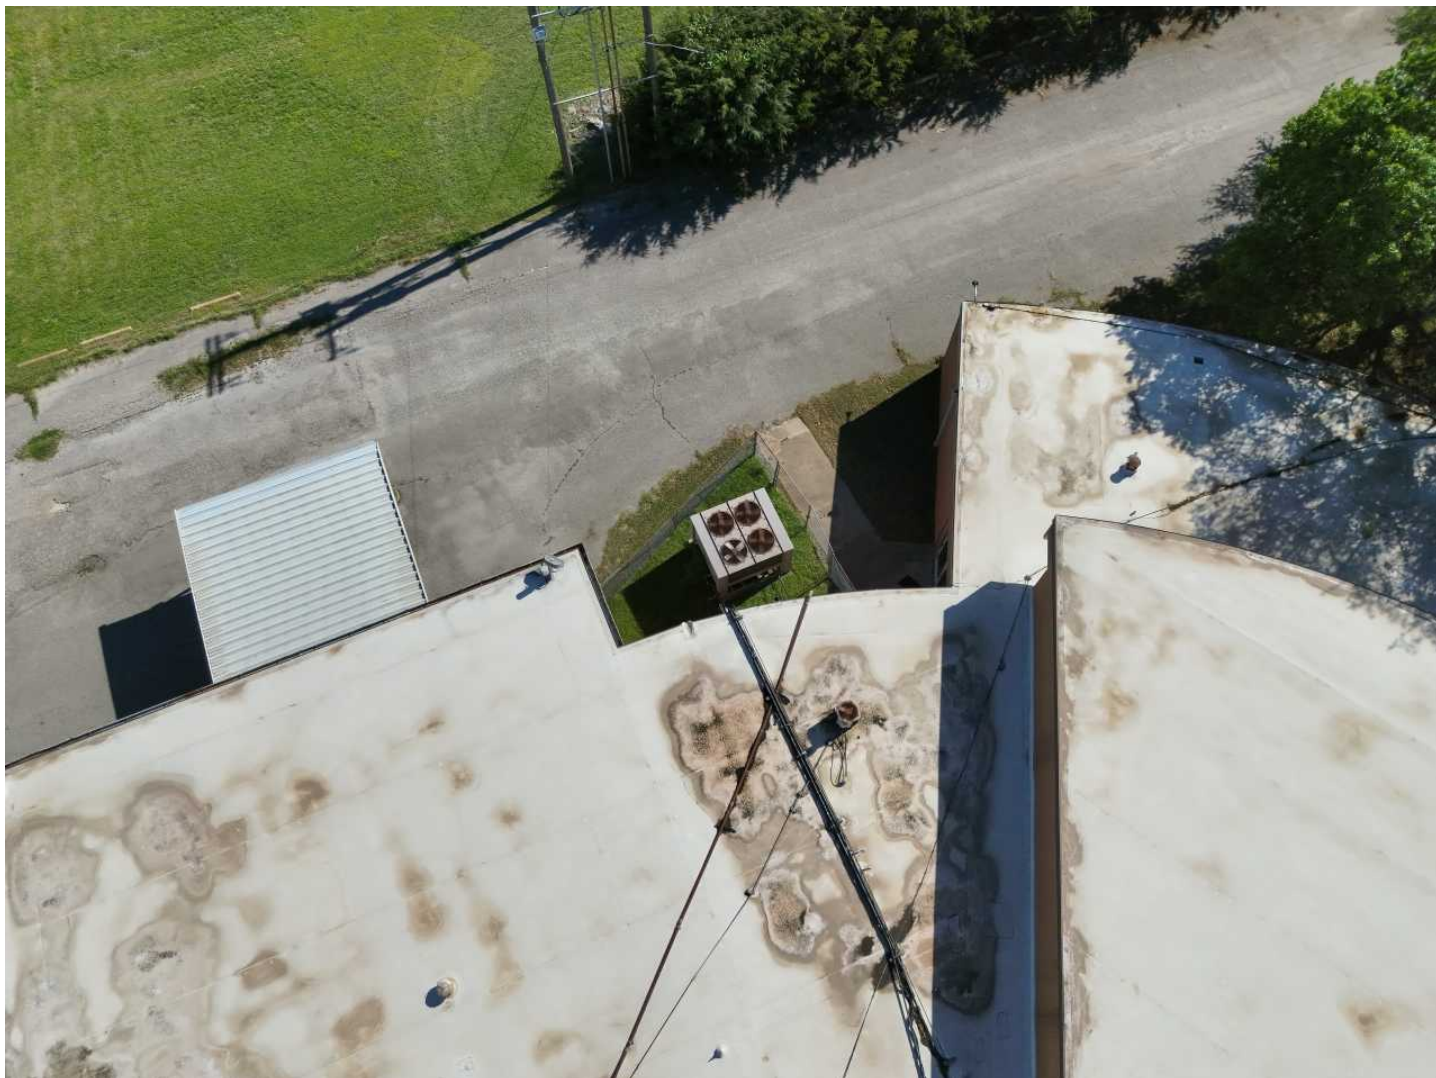
38-UV Degredation

While white TPO membranes are designed to reflect UV radiation, ponding water can concentrate the sun's rays, increasing UV damage to the membrane

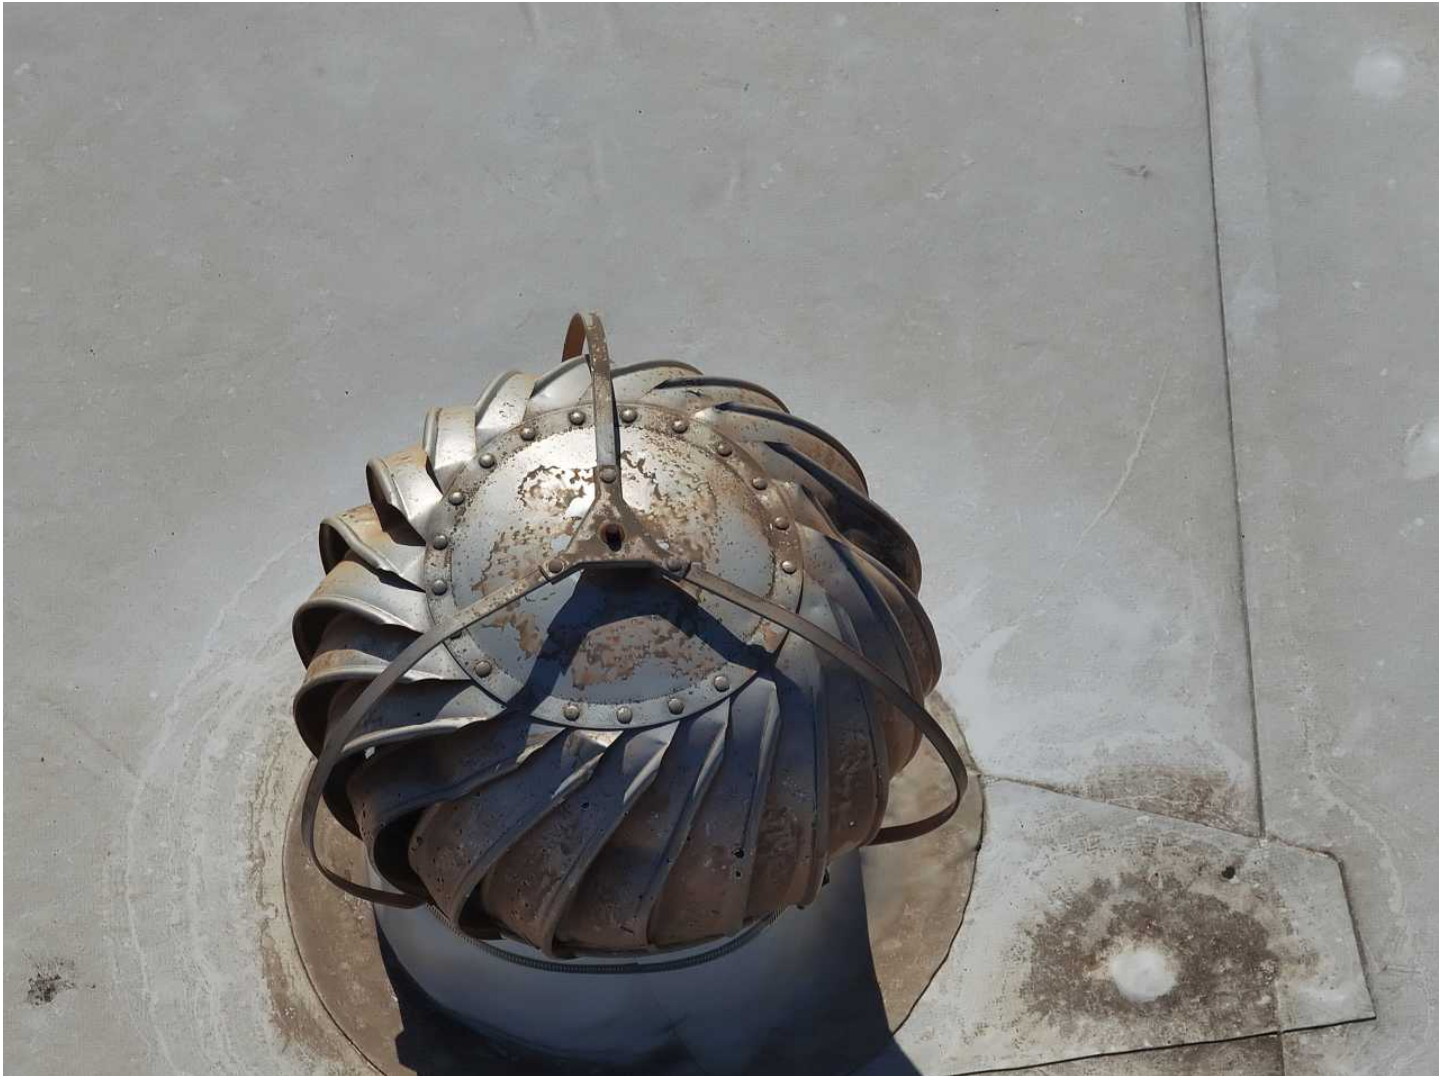
65 65-Fixture Impedement Date Taken: 4/21/2025 Taken By: Angela Night
Damaged roofing components need replaced for proper and integral maintenance.

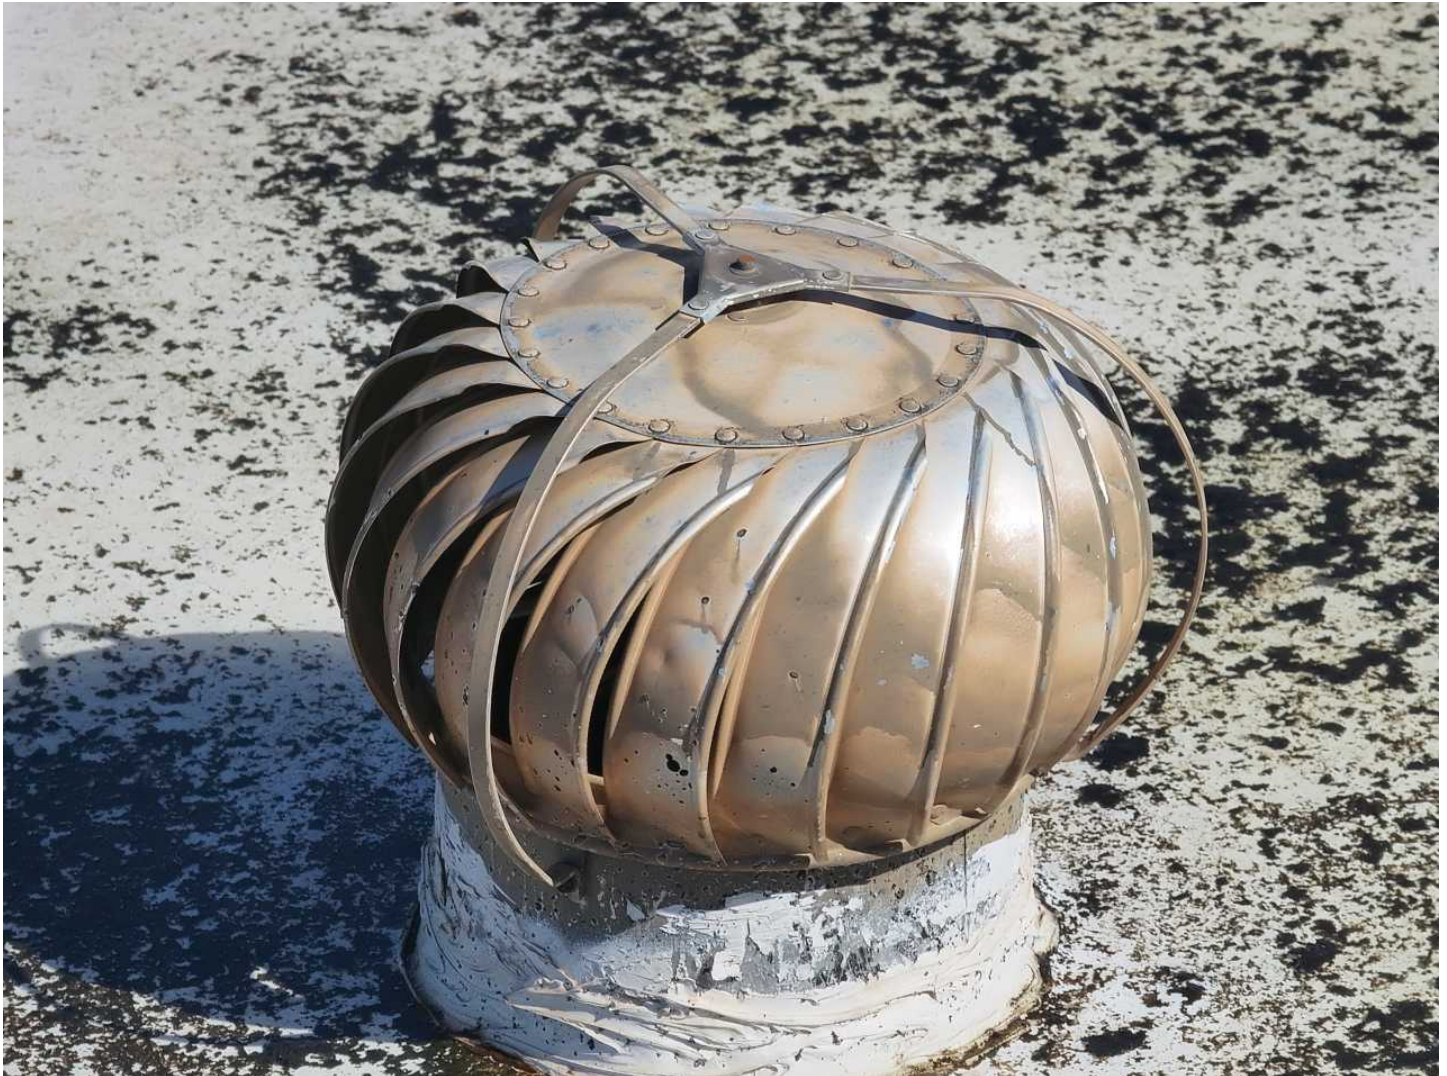
66 66-Fixture Impedement Date Taken: 4/21/2025 Taken By: Angela Night
Damaged roofing components need replaced for proper and integral maintenance.
