DIV7|ROOF Company

Estimate: FOSTER_COLLEGE

The current roofing system is a TPO (Thermoplastic Polyolefin) that is mechanically attached (there are various areas across the mapping area that were found to be improperly installed). **A fully adhered system is highly recommended in comparison to a mechanically attached system to be applied a gravel ballast built-up roof. Fully adhered systems can reduce the number of seams needed, decreasing potential leak points.**

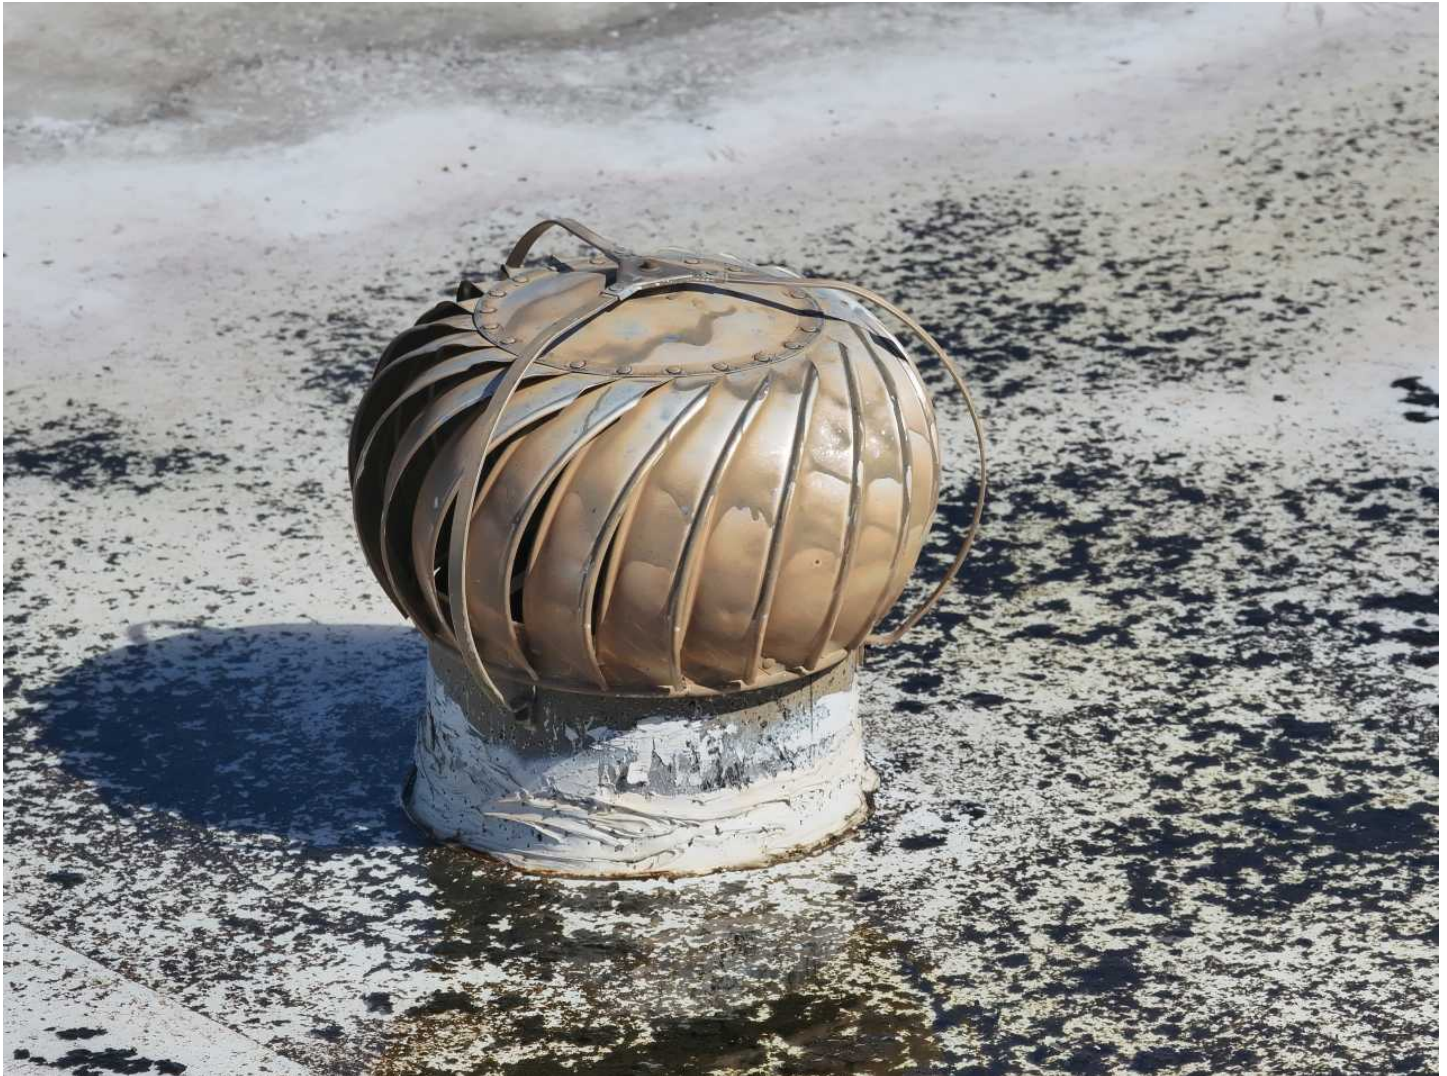
67 67-Fixture Impedement Date Taken: 4/21/2025 Taken By: Angela Night
Damaged roofing components need replaced for proper and integral maintenance.

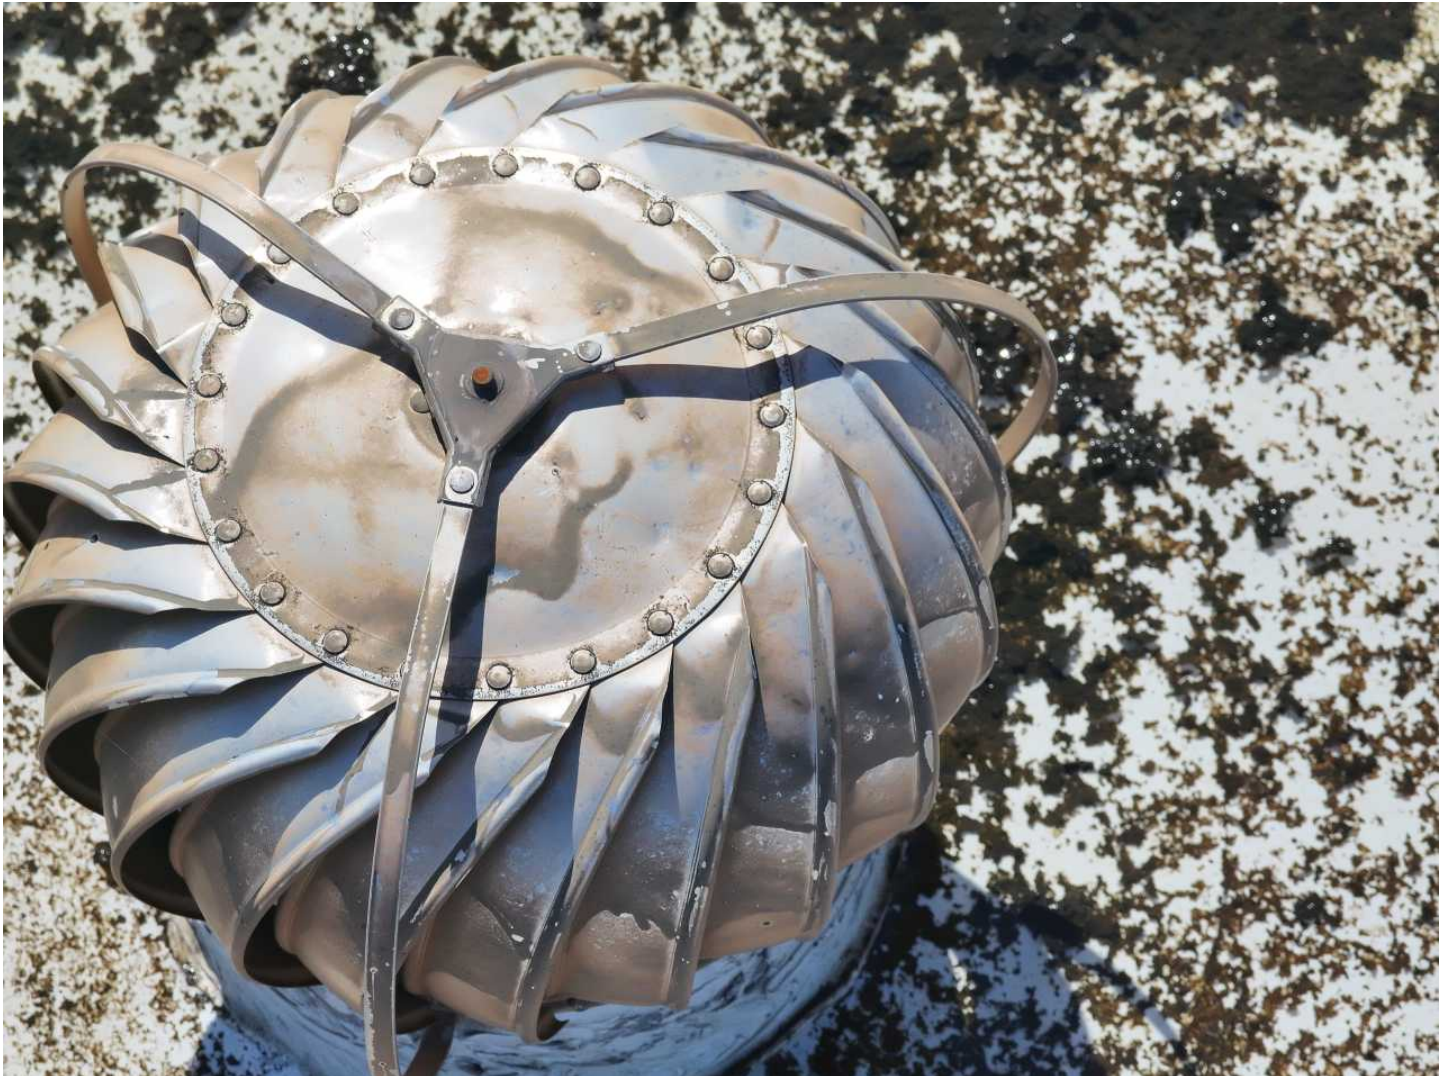
68 68-Fixture Impedement Date Taken: 4/21/2025 Taken By: Angela Night
Damaged roofing components need replaced for proper and integral maintenance.

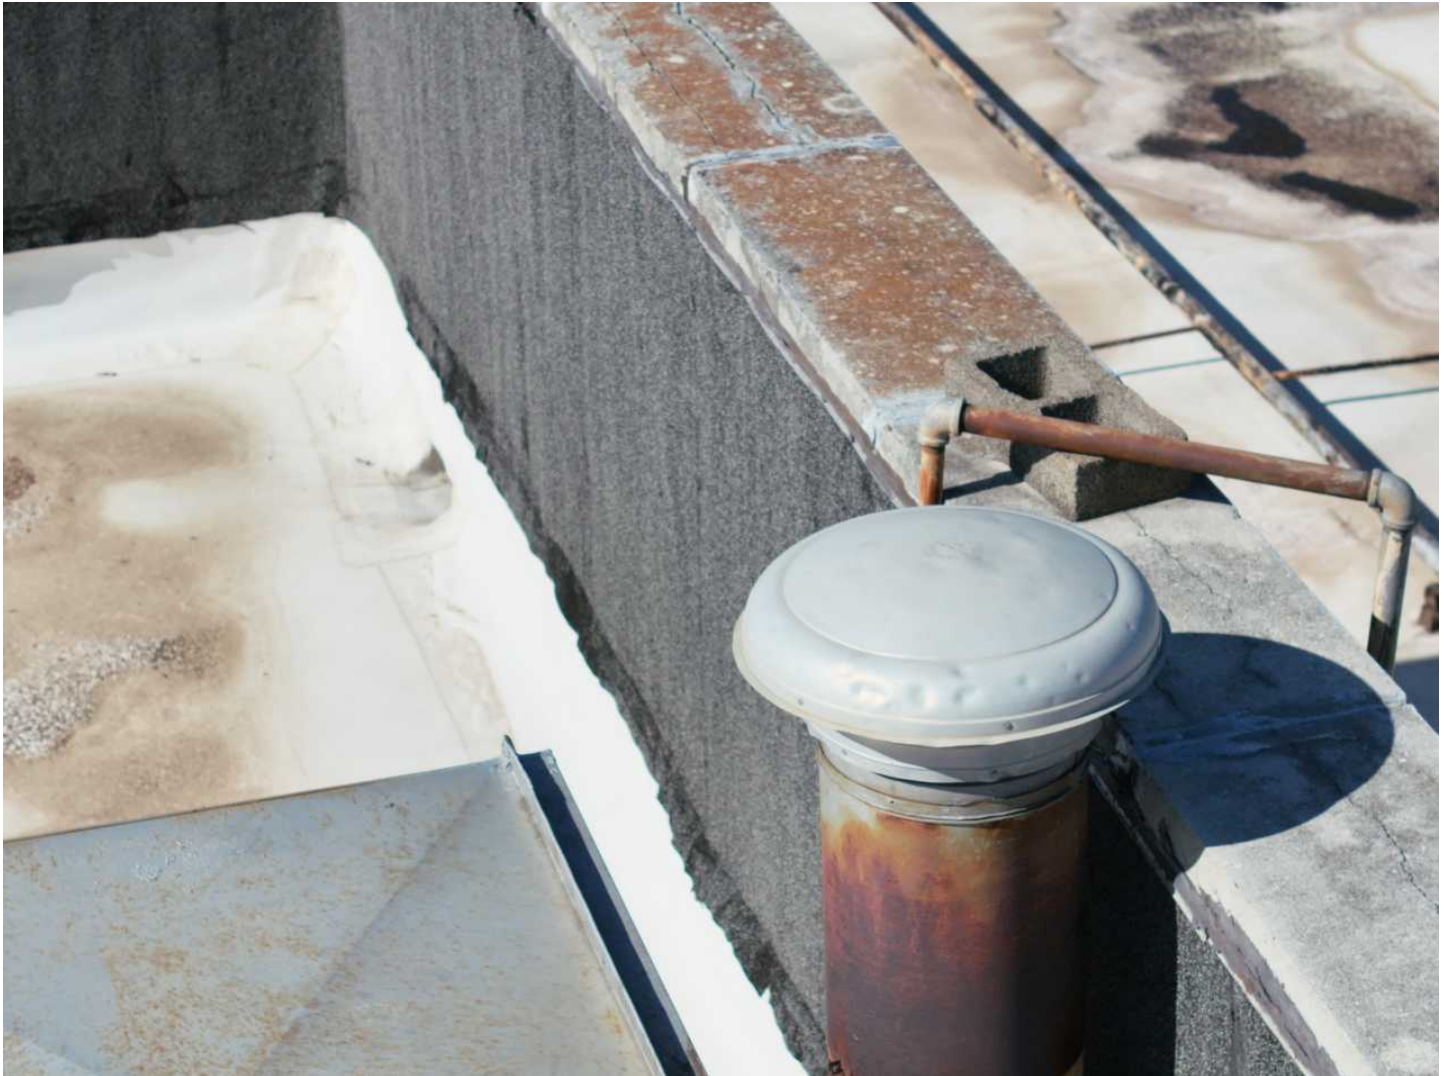
69 69-Fixture Impedement Date Taken: 4/21/2025 Taken By: Angela Night
Damaged roofing components need replaced for proper and integral maintenance.

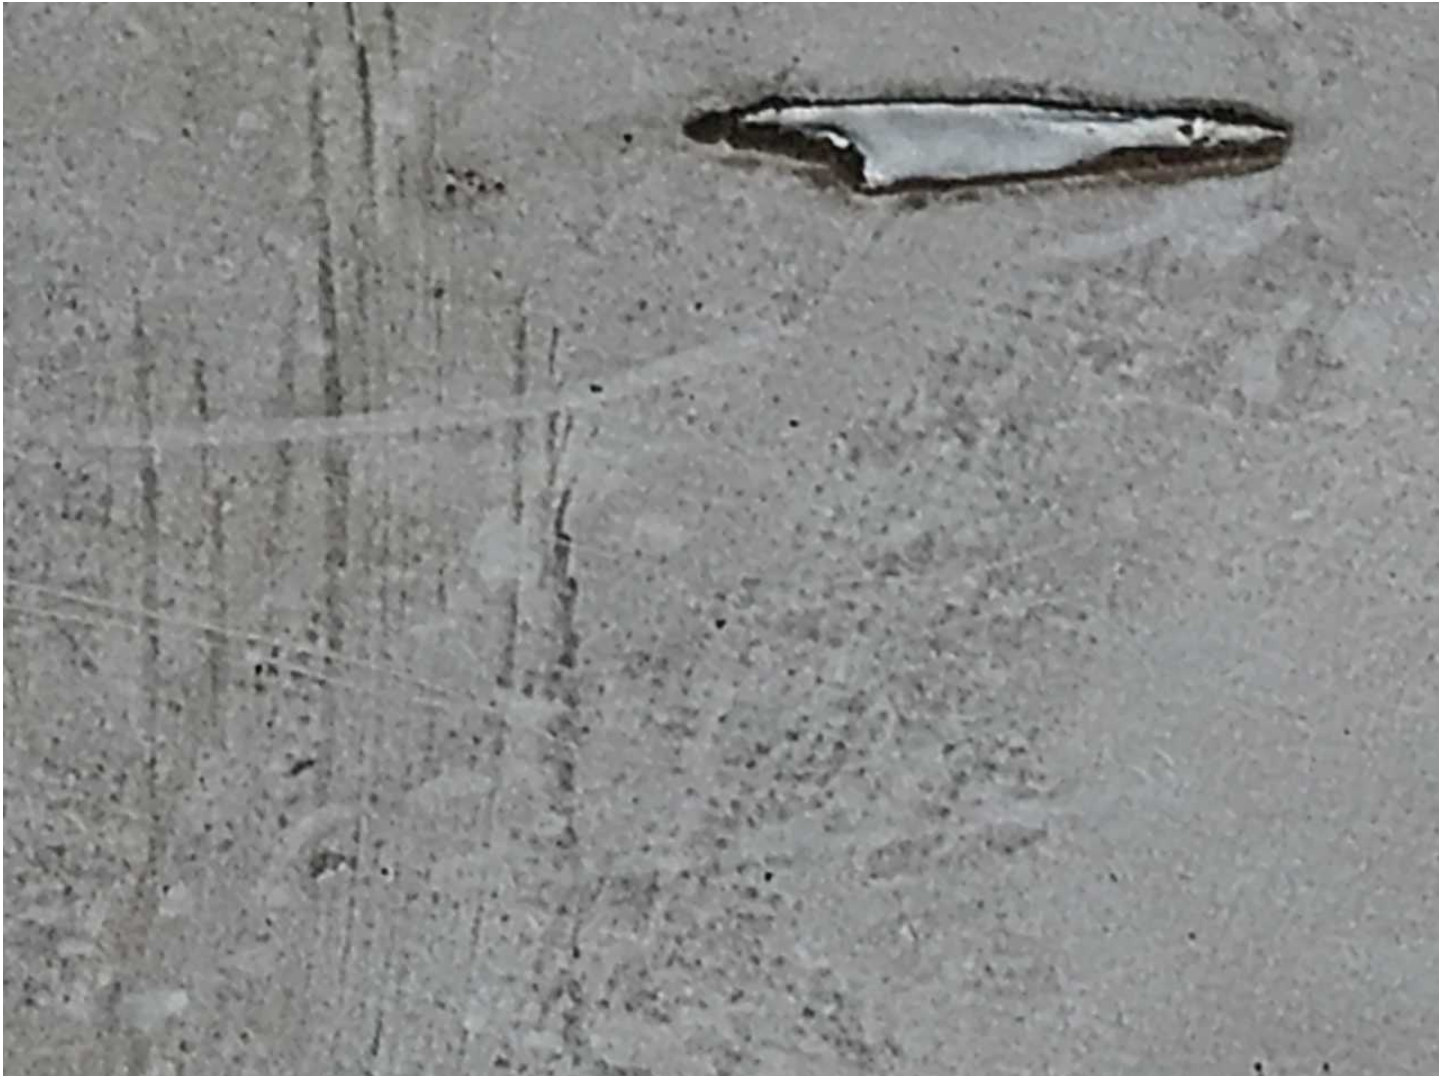
70 70-Fixture Impedement Date Taken: 4/21/2025 Taken By: Angela Night
Damaged roofing components need replaced for proper and integral maintenance.

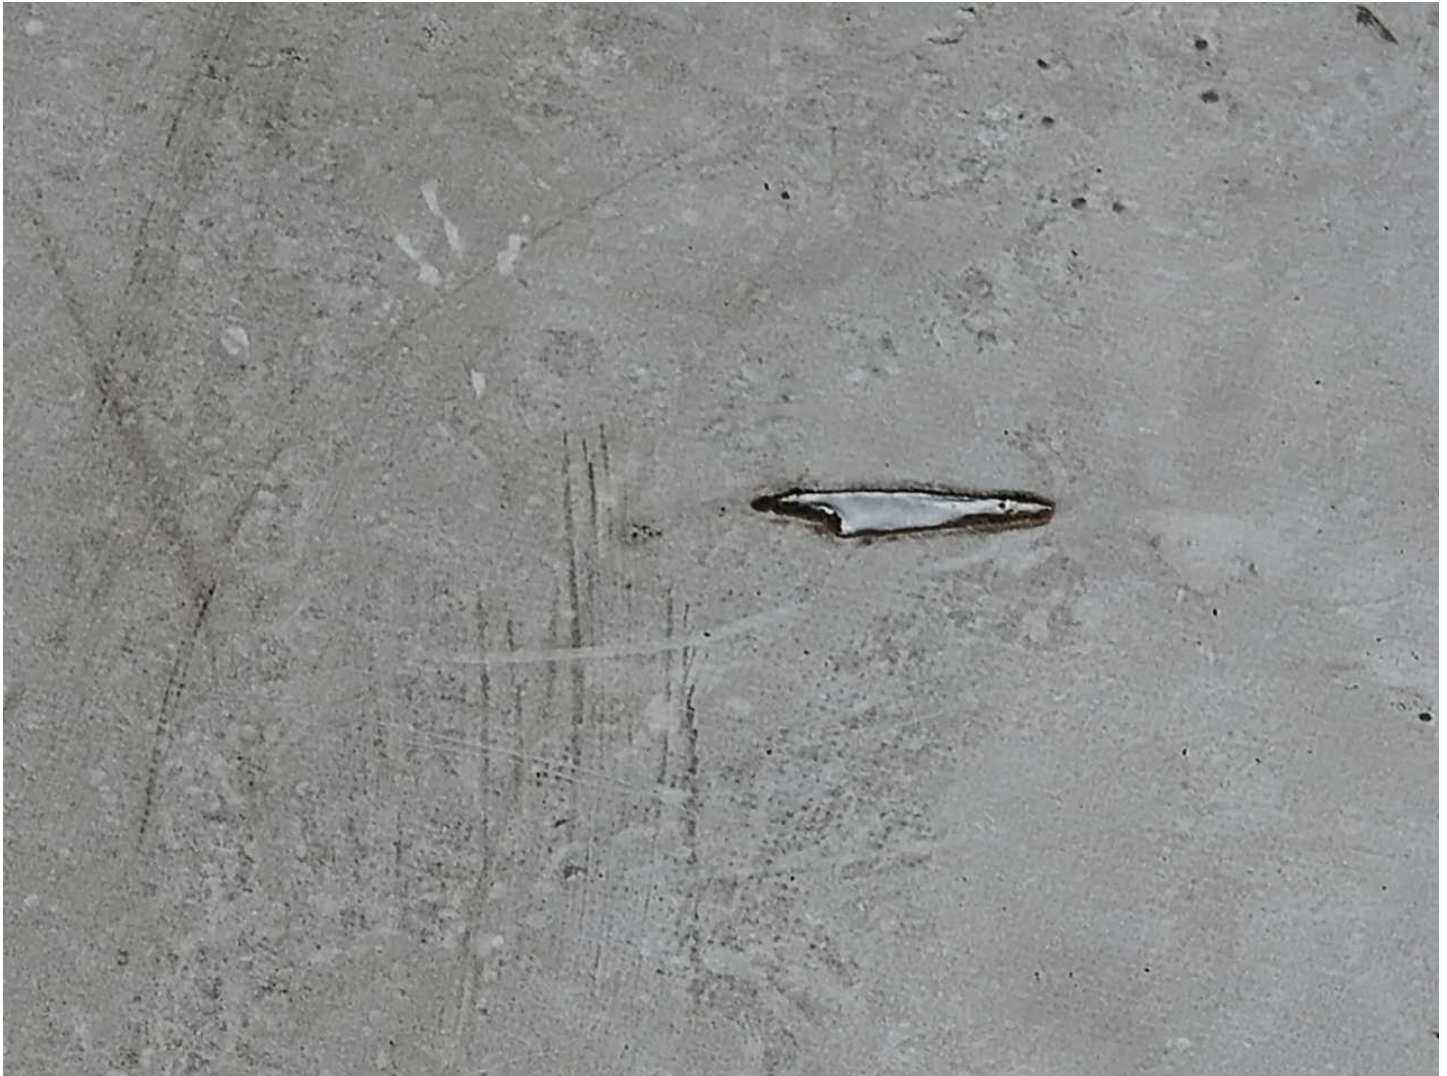
71 71-Mechanical Damage Date Taken: 4/21/2025 Taken By: Angela Night
Splits are present on the roof that potentially were caused by irregular handling by roof repair companies.

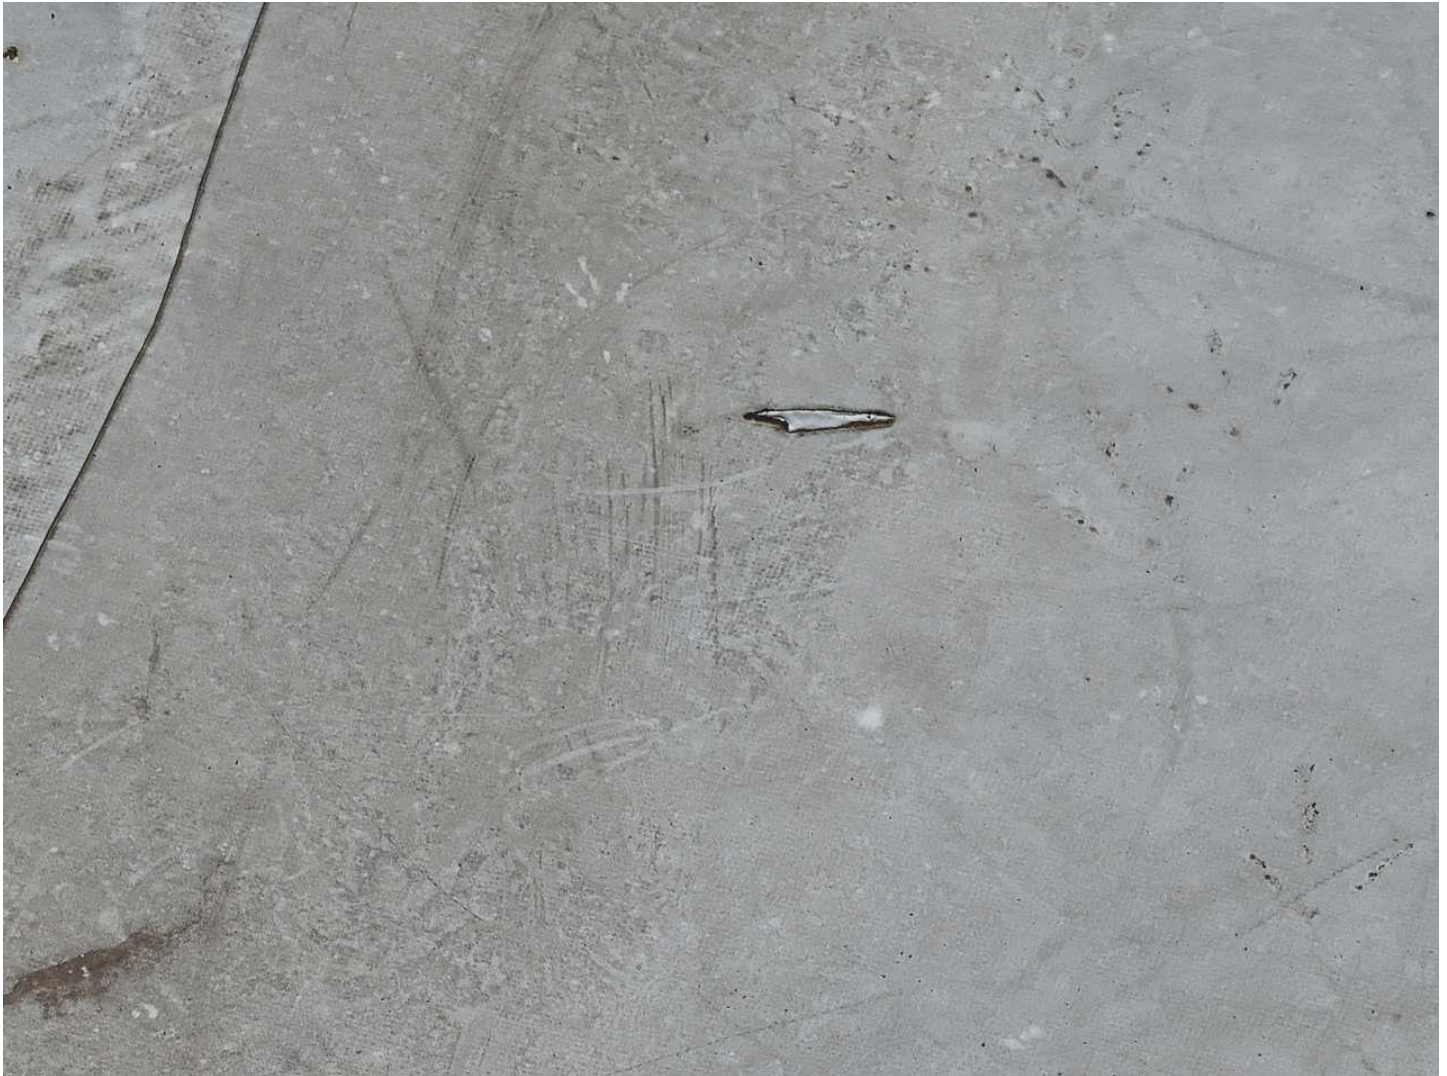
72 72-Mechanical Damage Date Taken: 4/21/2025 Taken By: Angela Night
Splits are present on the roof that potentially were caused by irregular handling by roof repair companies.

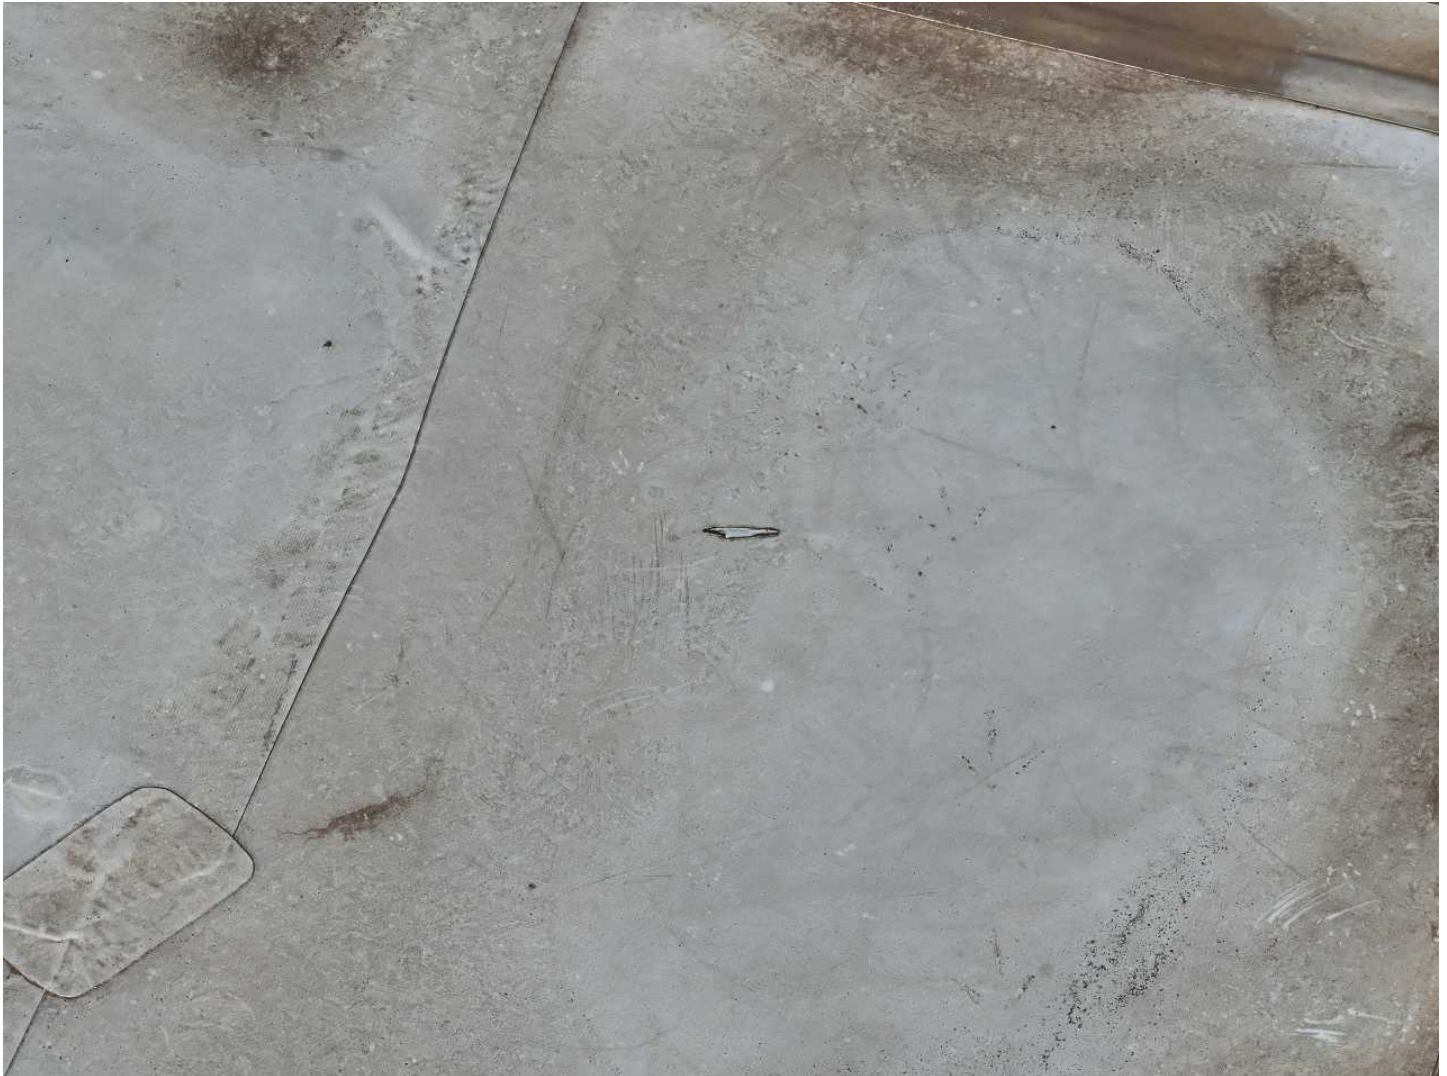
73 73-Mechanical Damage Date Taken: 4/21/2025 Taken By: Angela Night
Splits are present on the roof that potentially were caused by irregular handling by roof repair companies.

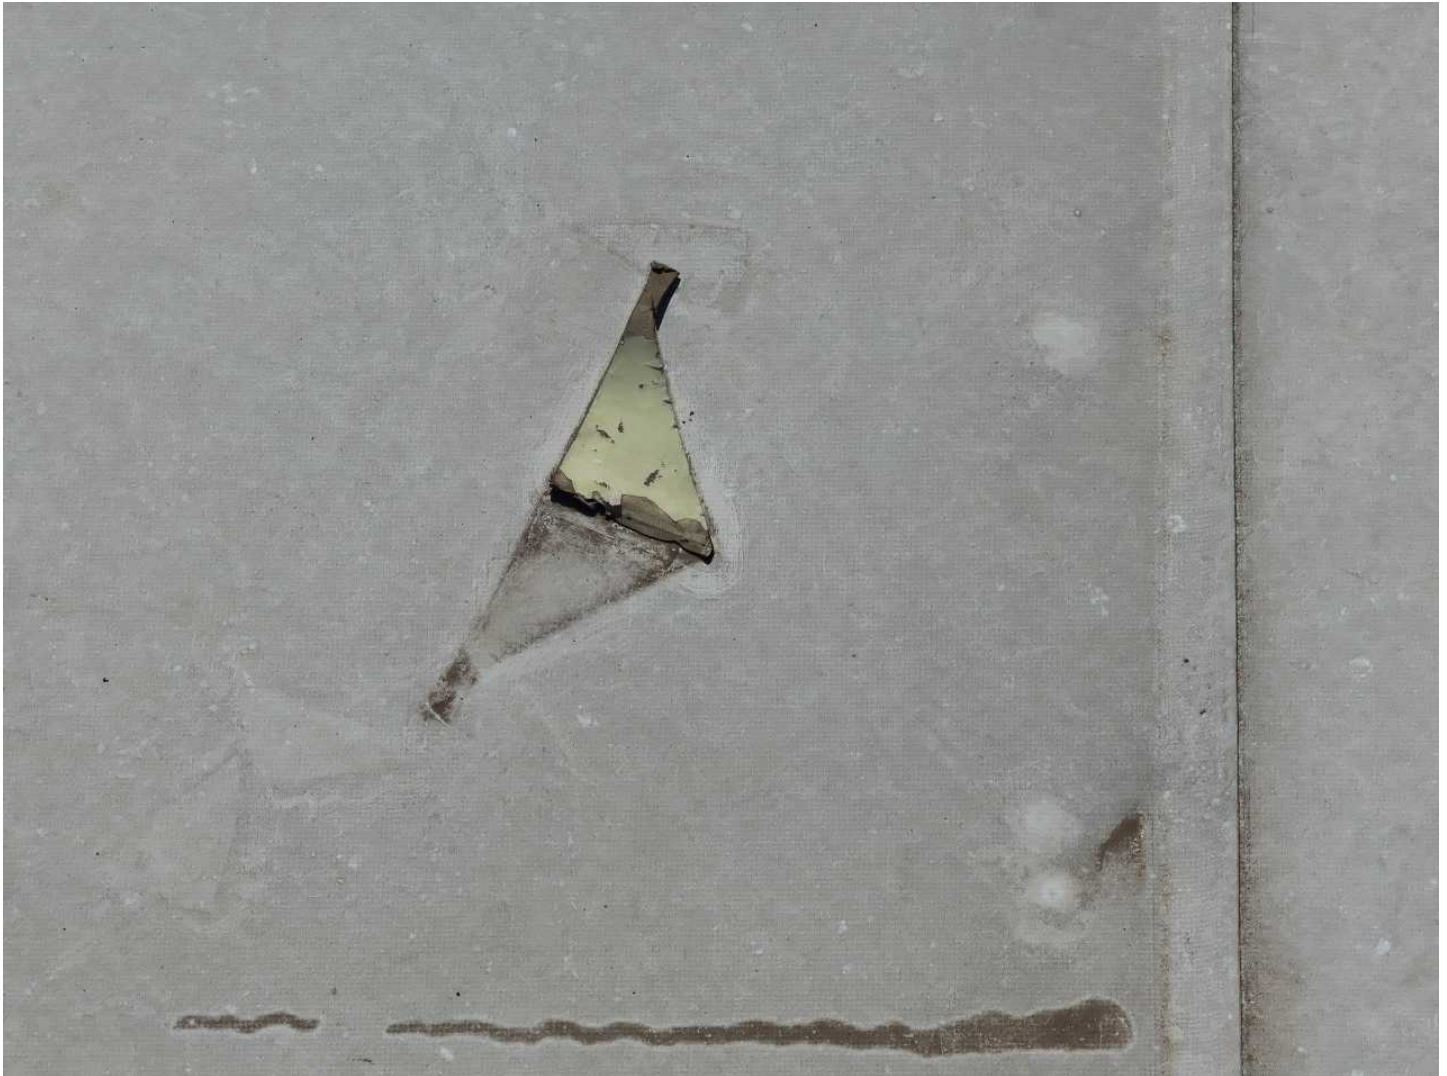
75 75-Mechanical Damage Date Taken: 4/21/2025 Taken By: Angela Night
Splits are present on the roof that potentially were caused by irregular handling by roof repair companies.

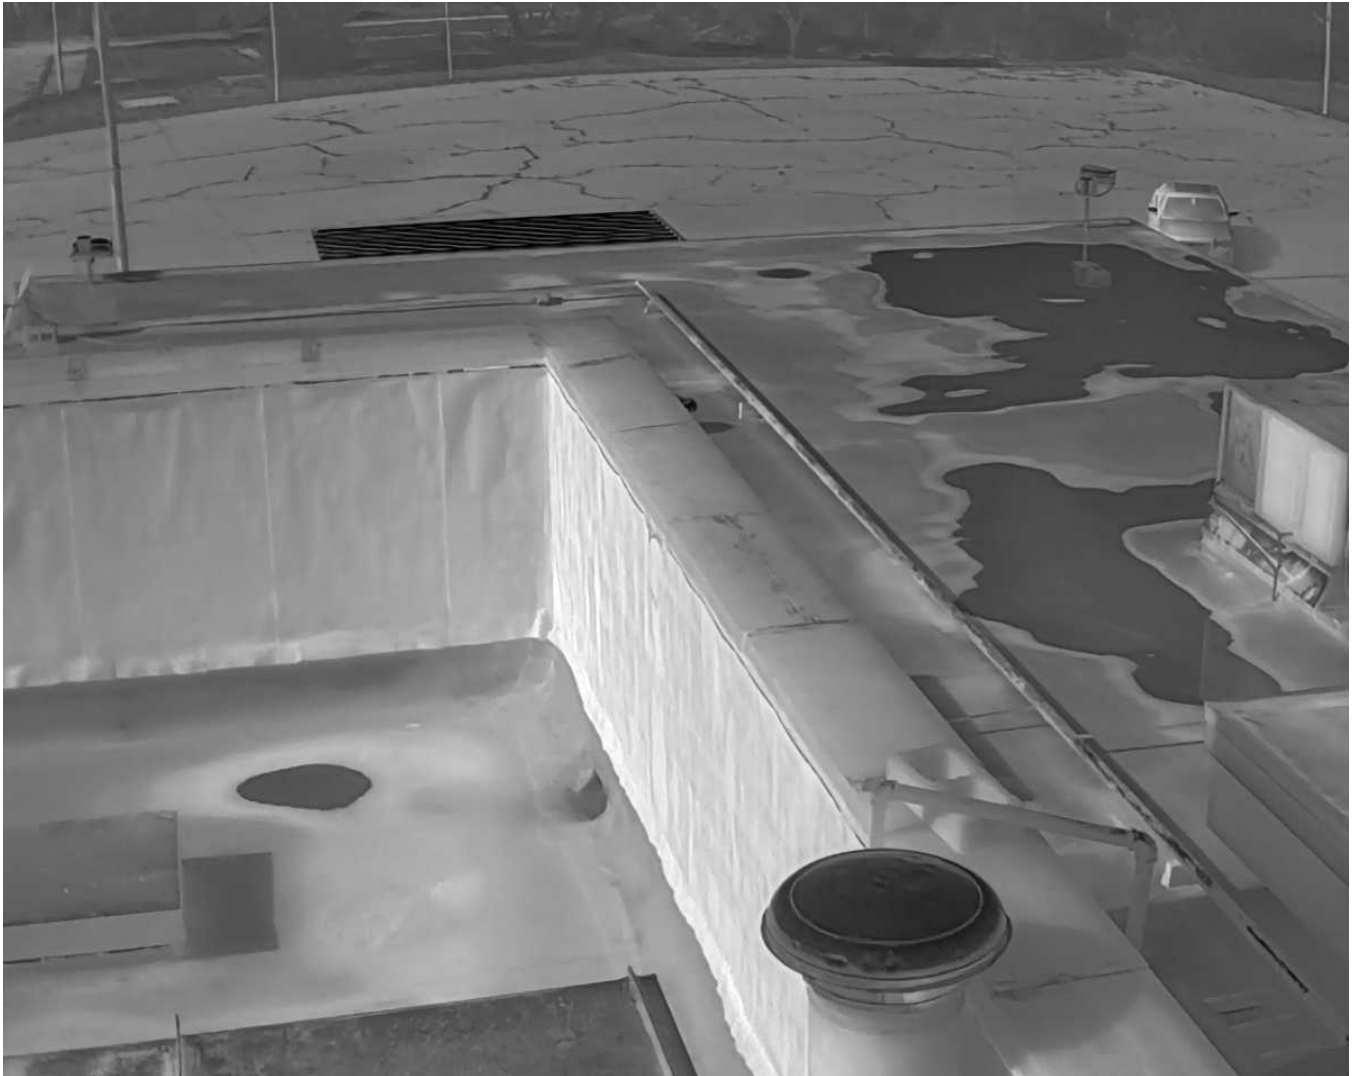
76 76-Mechanical Damage Date Taken: 4/21/2025 Taken By: Angela Night
Splits are present on the roof that potentially were caused by irregular handling by roof repair companies.

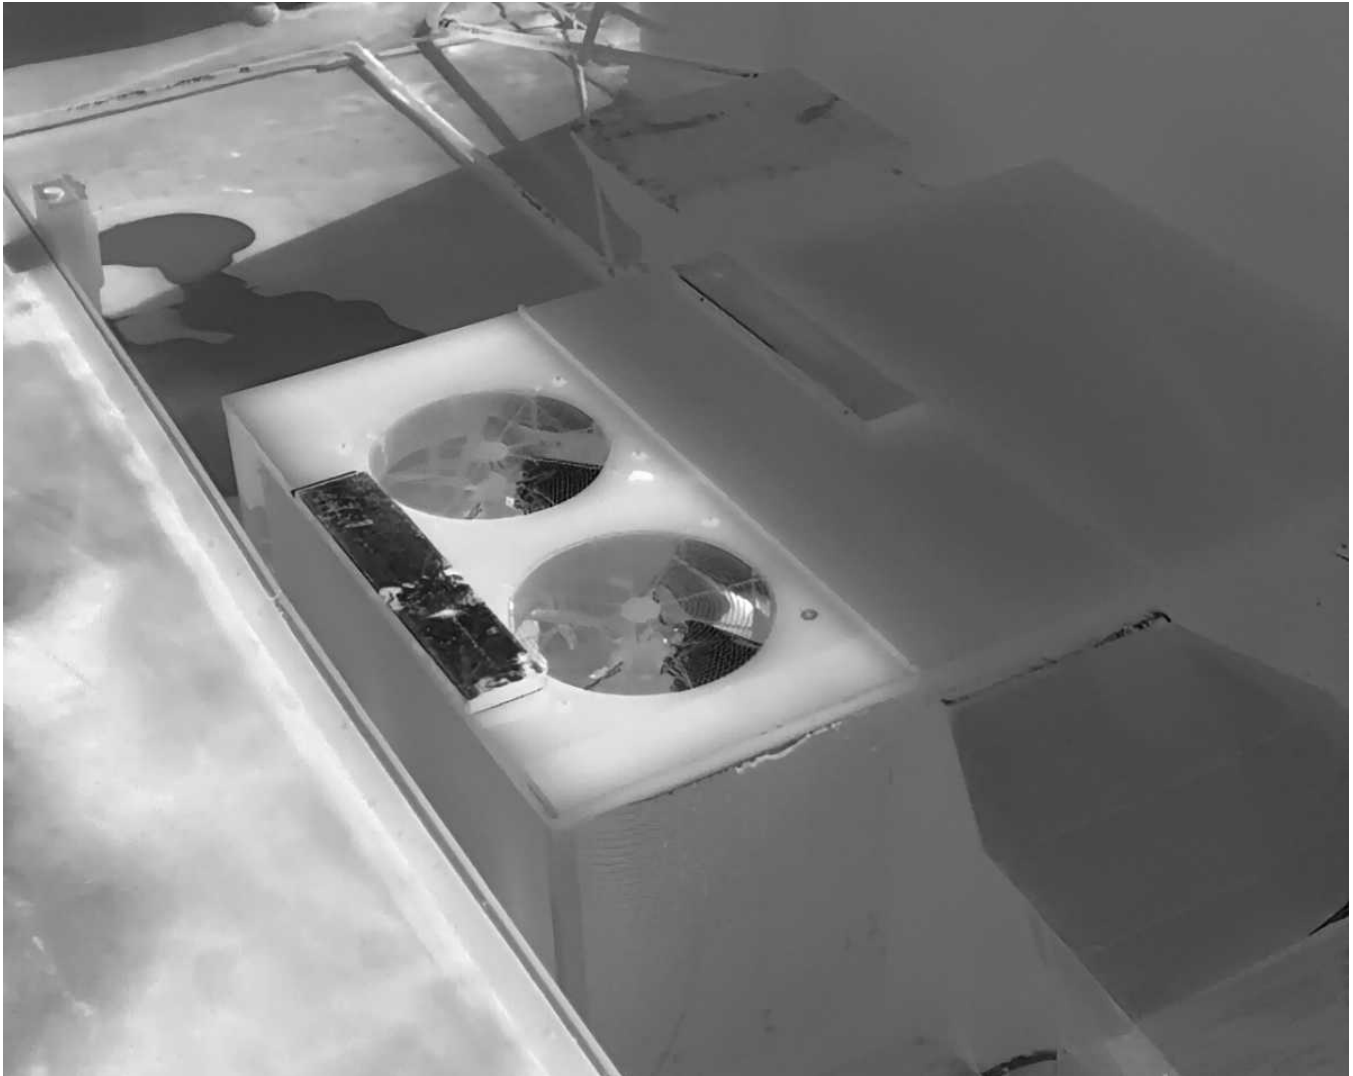
77 77-Loose Seams Date Taken: 4/21/2025 Taken By: Angela Night
Edges around the roof membrane are separating from their seams due to poor installation and gap movement.

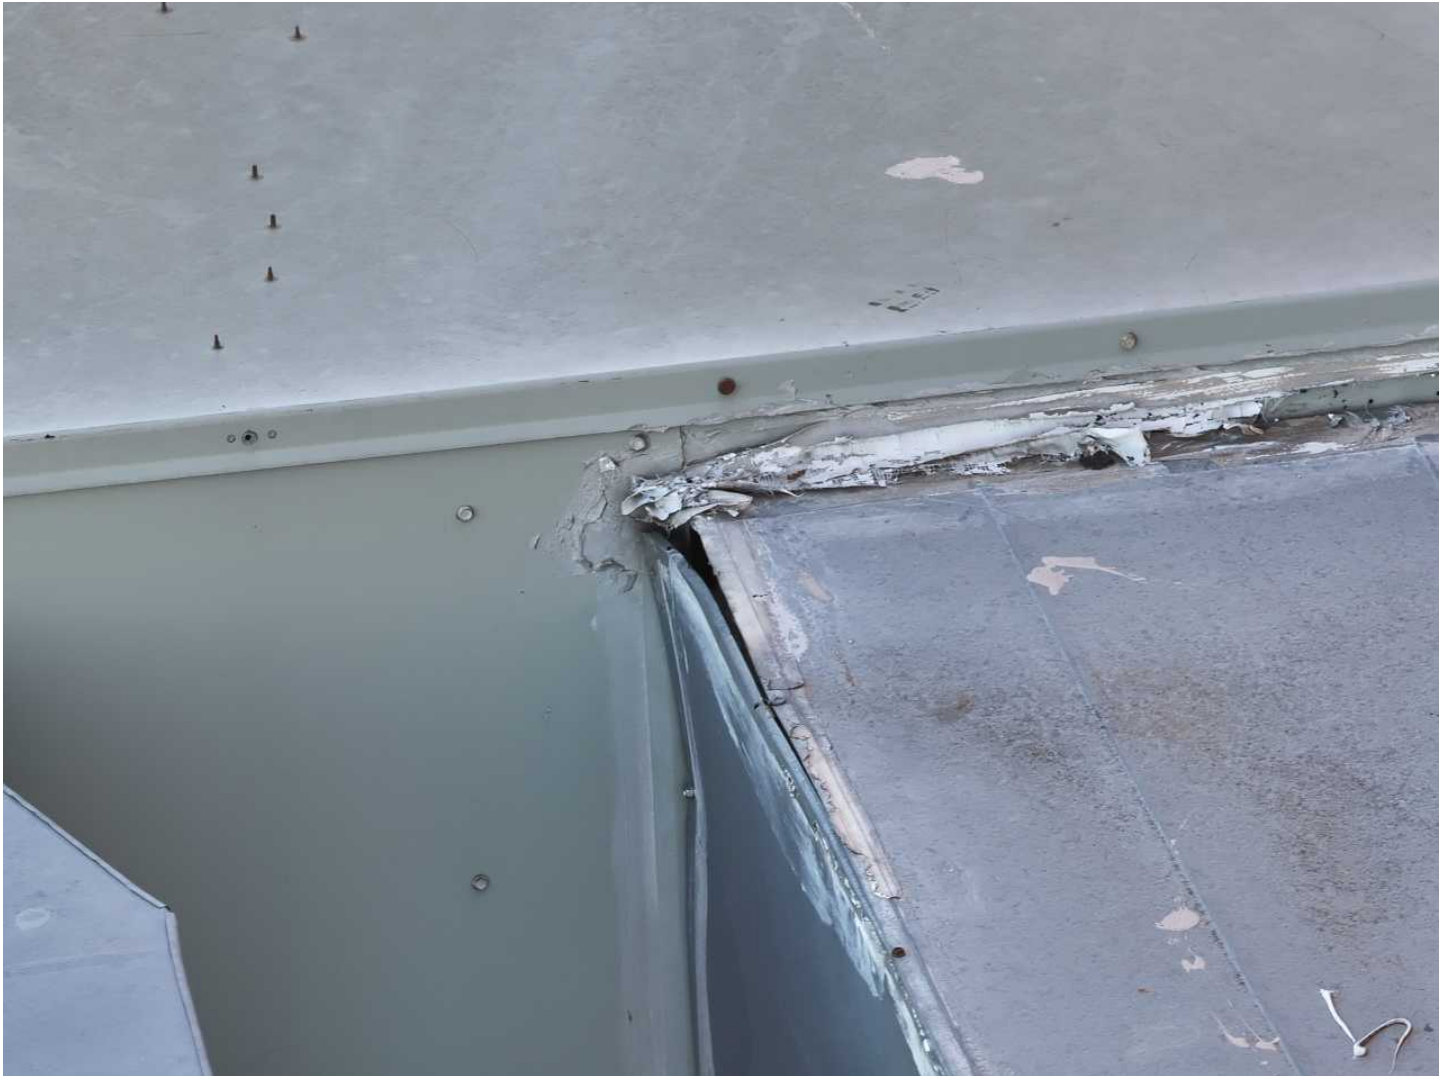
78-HVAC

Exposed areas around mechanical systems were found atop the roof.

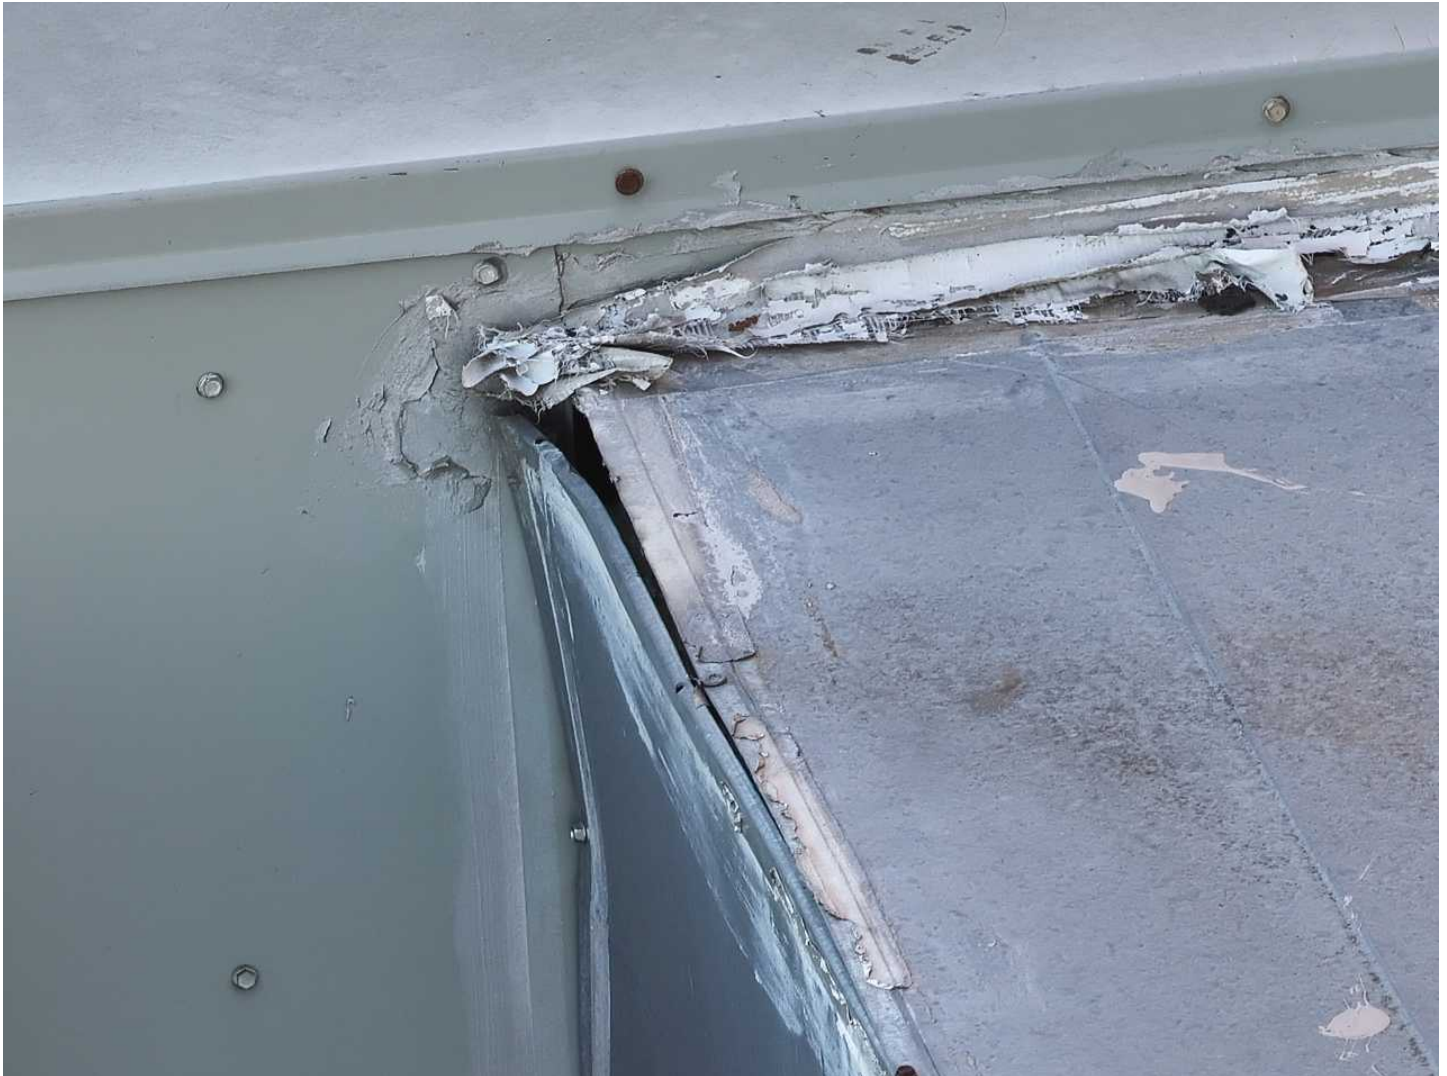
79 110-HVAC (Rectangular Duct) Date Taken: 4/21/2025 Taken By: Angela Night
Exposed areas around the mechanical ducts were found atop the roof.

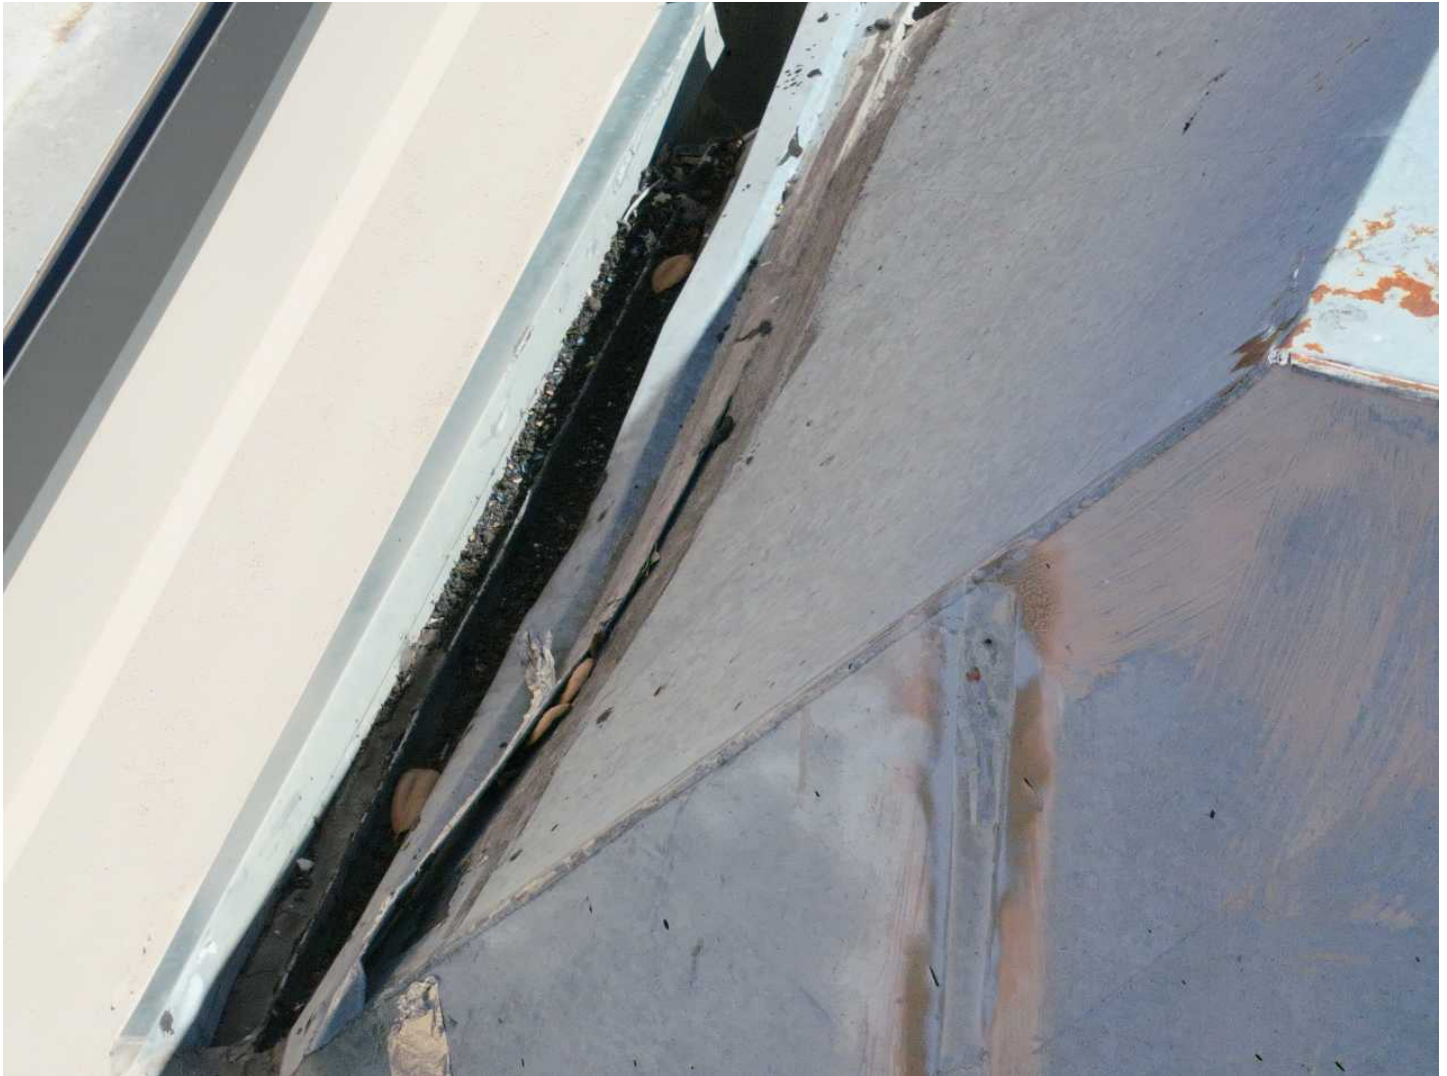
80 109-HVAC (Rectangular Duct) Date Taken: 4/21/2025 Taken By: Angela Night
Exposed areas around the mechanical ducts were found atop the roof.

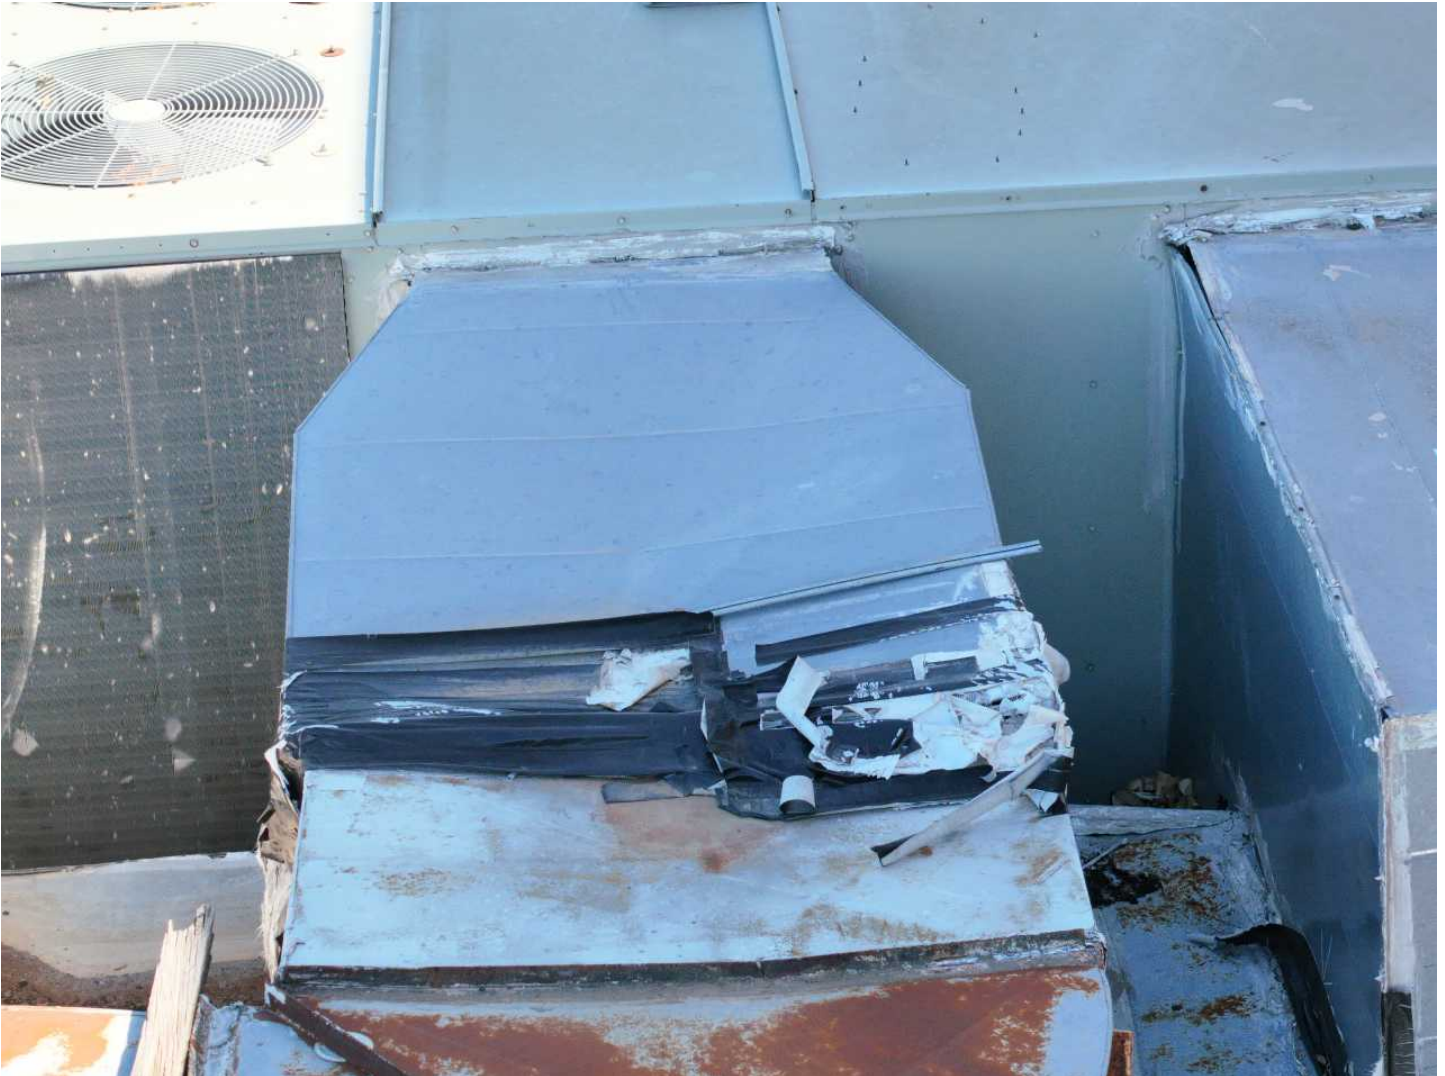
81 108-HVAC (Rectangular Duct) Date Taken: 4/21/2025 Taken By: Angela Night
Exposed areas around the mechanical ducts were found atop the roof.
