DIV7|ROOF Company

Estimate: FOSTER_COLLEGE

The current roofing system is a TPO (Thermoplastic Polyolefin) that is mechanically attached (there are various areas across the mapping area that were found to be improperly installed). **A fully adhered system is highly recommended in comparison to a mechanically attached system to be applied a gravel ballast built-up roof. Fully adhered systems can reduce the number of seams needed, decreasing potential leak points.**

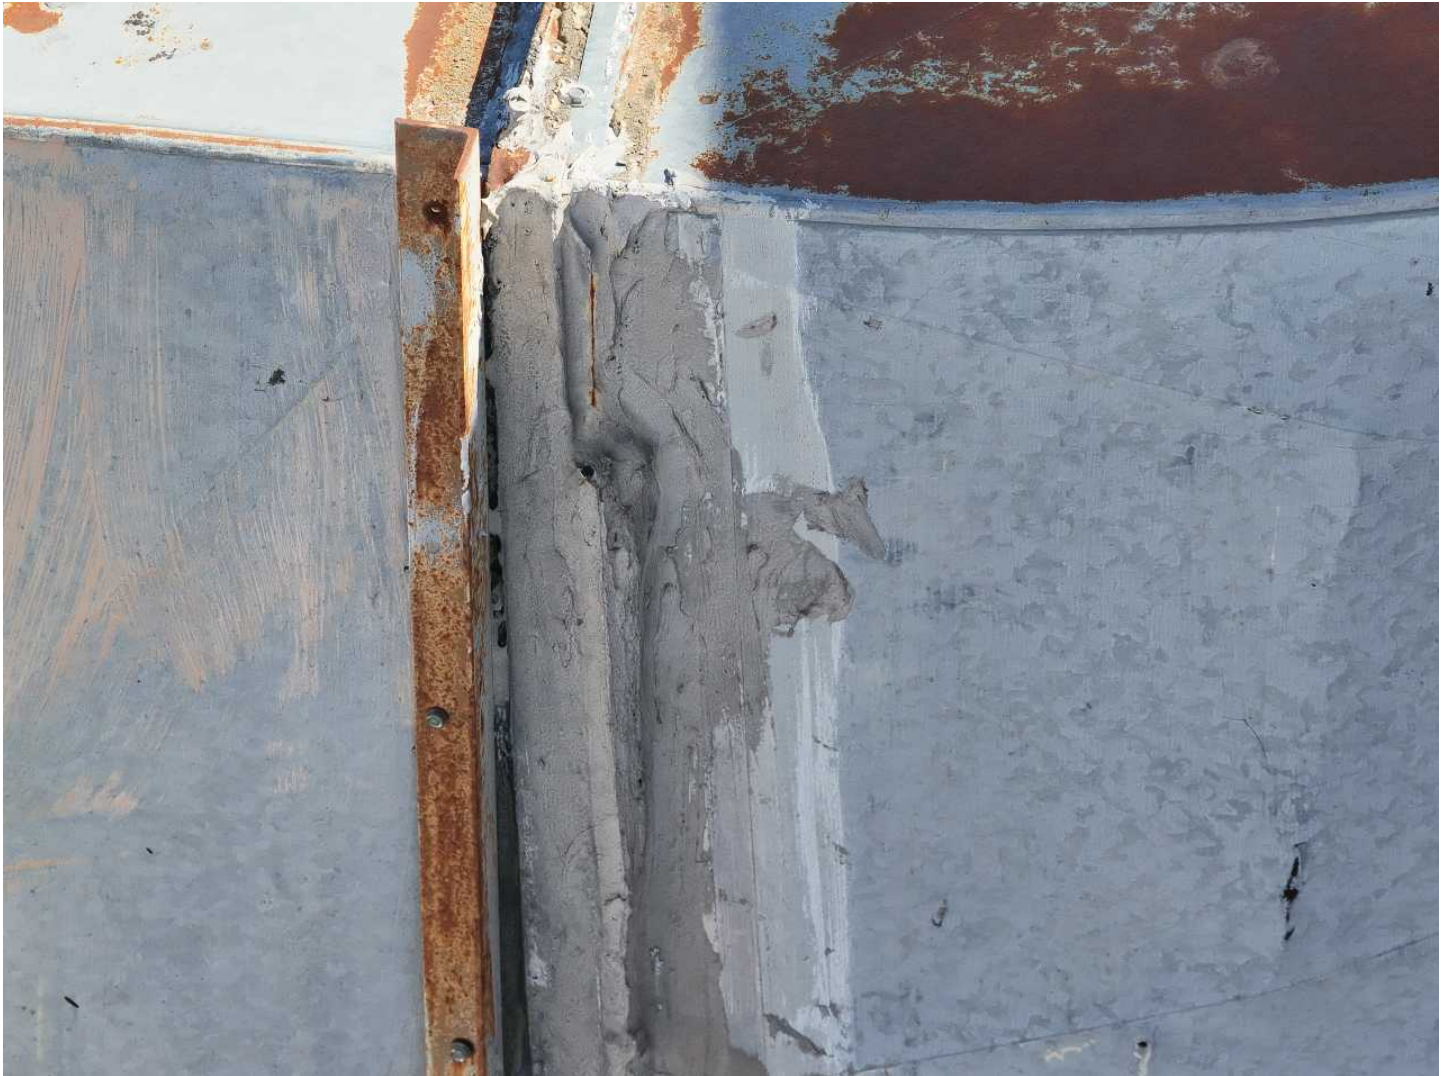
82 107-HVAC (Rectangular Duct) Date Taken: 4/21/2025 Taken By: Angela Night
Exposed areas around the mechanical ducts were found atop the roof.

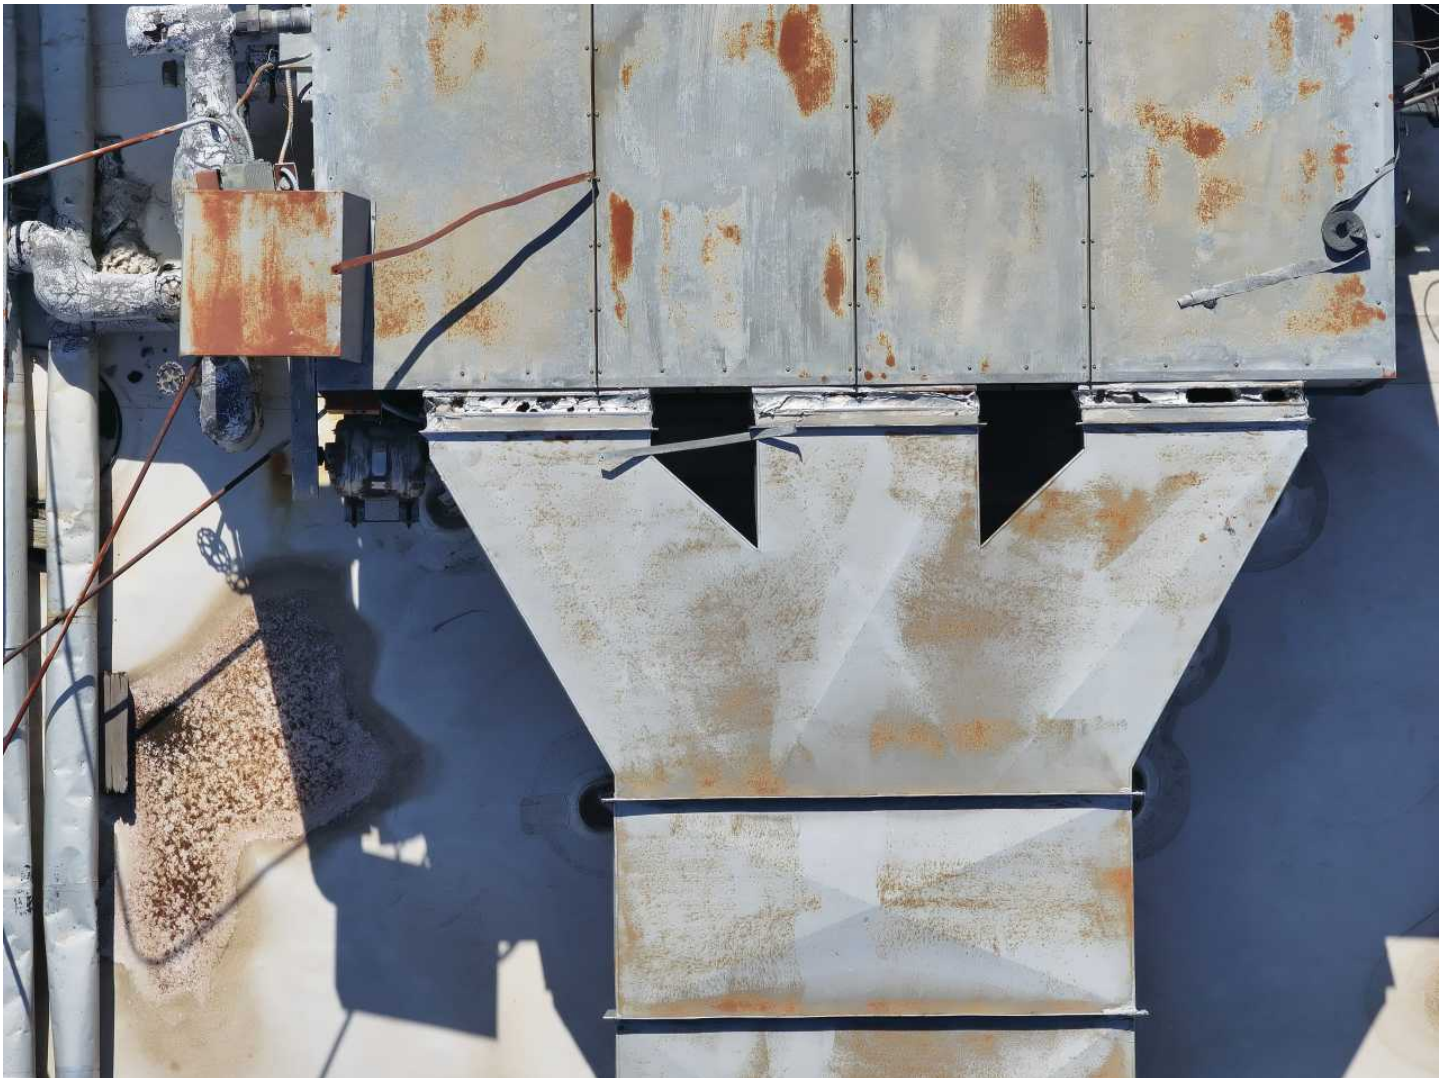
83 106-HVAC (Rectangular Duct) Date Taken: 4/21/2025
Exposed areas around the mechanical ducts were found atop the roof.

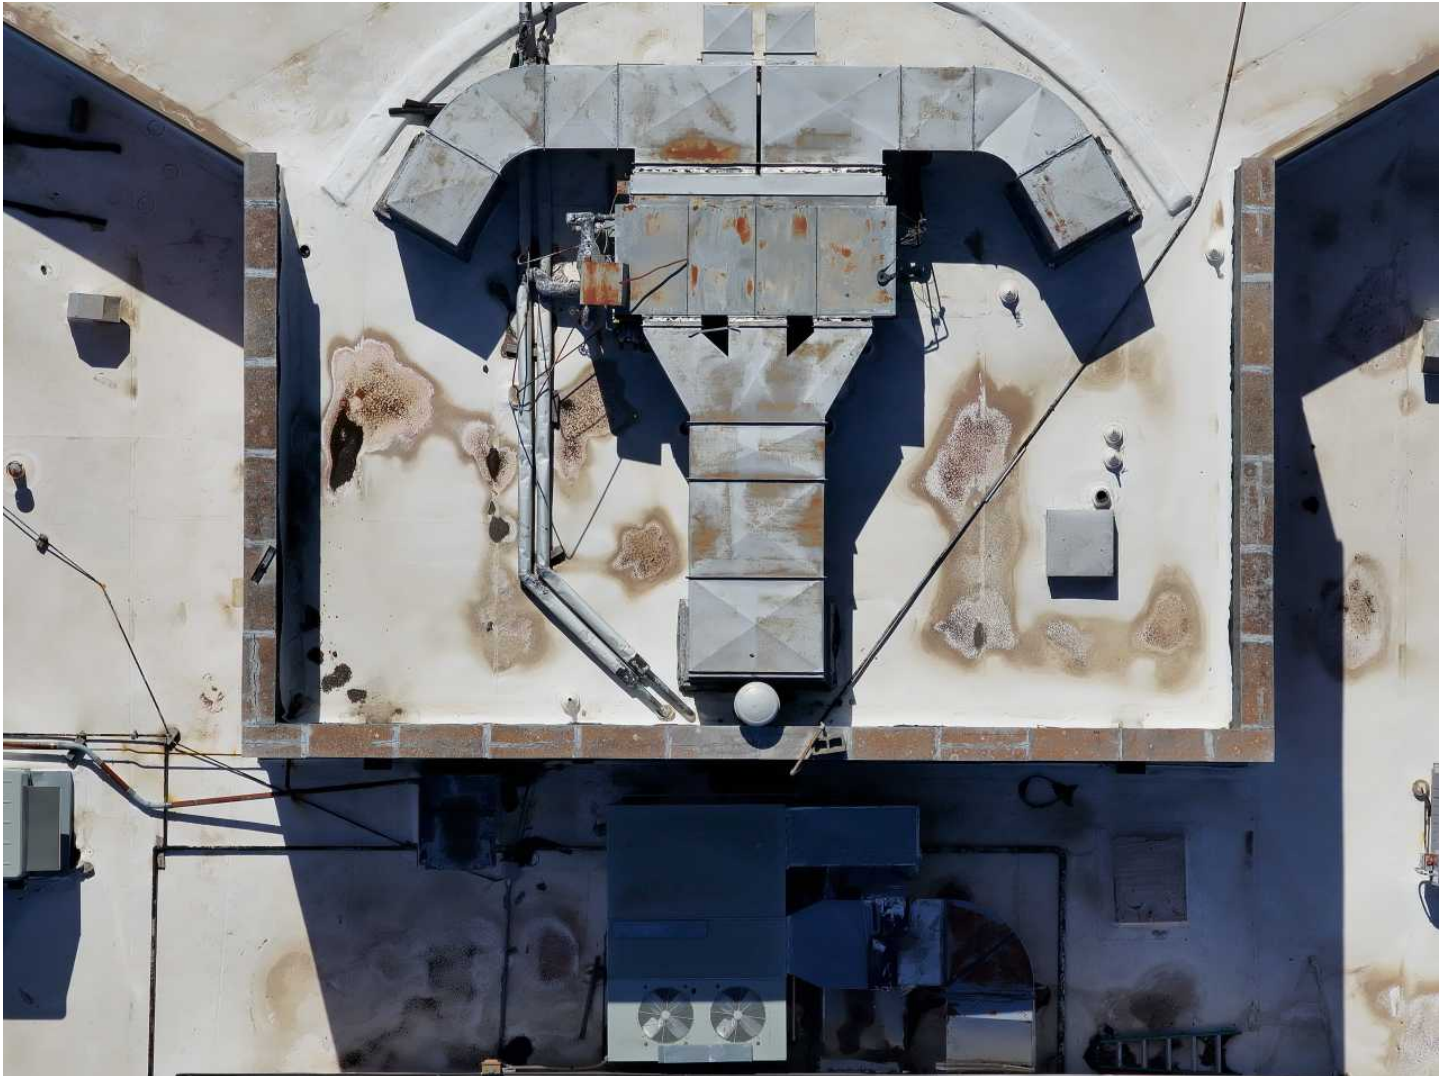
84 83-HVAC (Rectangular Duct) Date Taken: 4/21/2025 Taken By: Angela Night
Exposed areas around the mechanical ducts were found atop the roof.

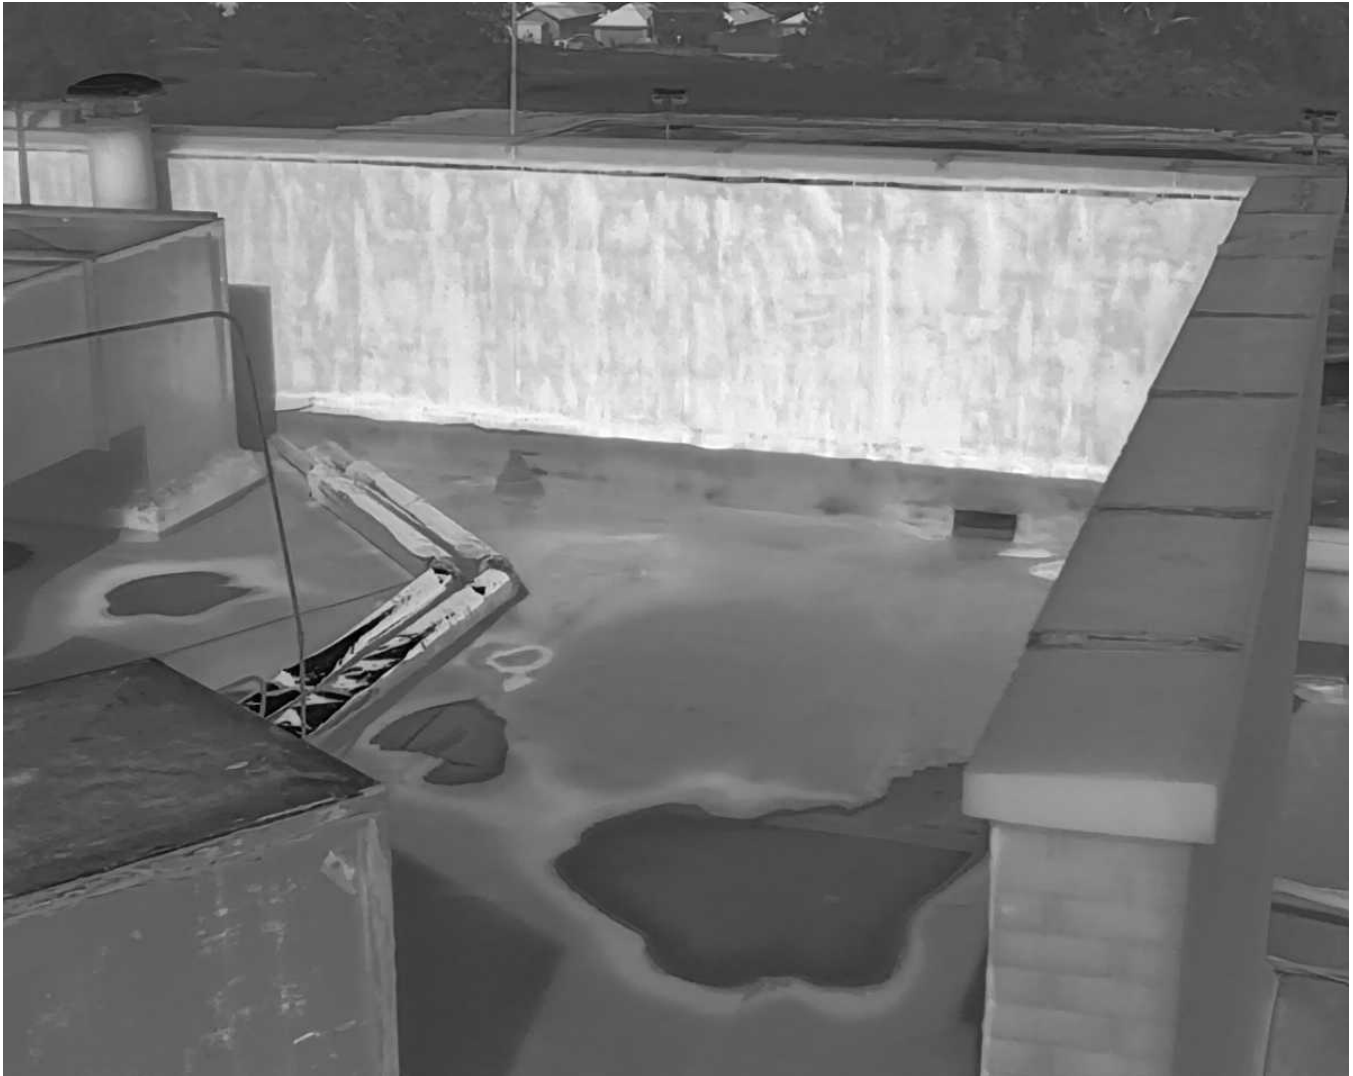
The wall has reached full temps and will begin to loose its structural integrity.

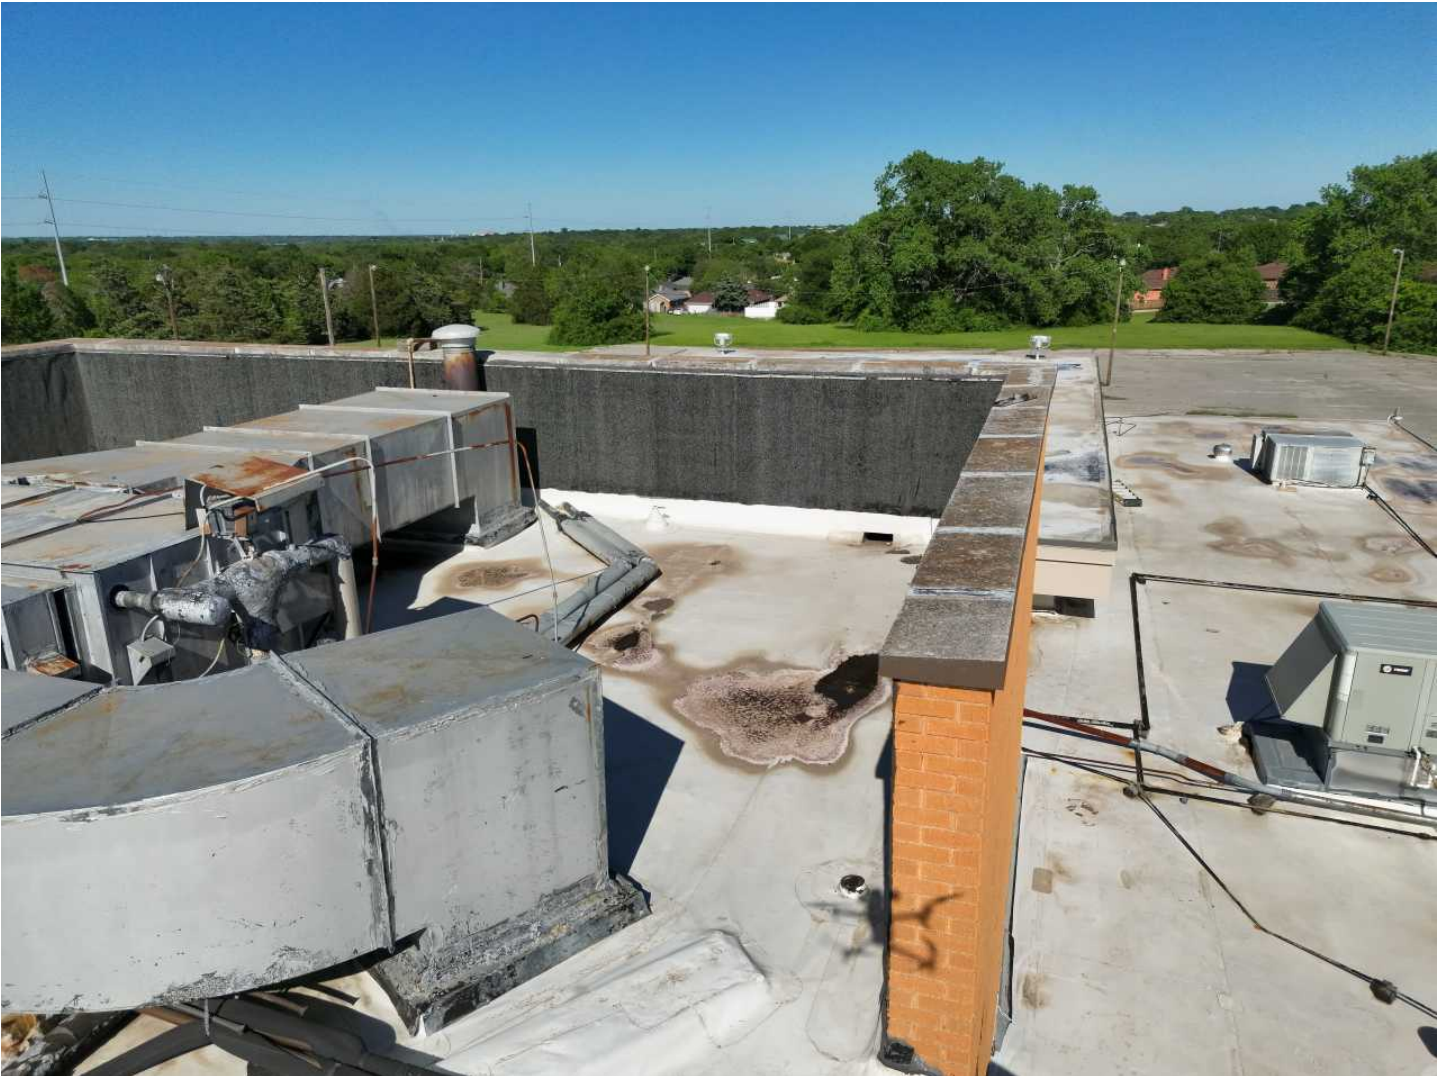
86 80-Loose Seams Date Taken: 4/21/2025 Taken By: Angela Night
Edges around the roof membrane are separating from their seams due to poor installation and gap movement.

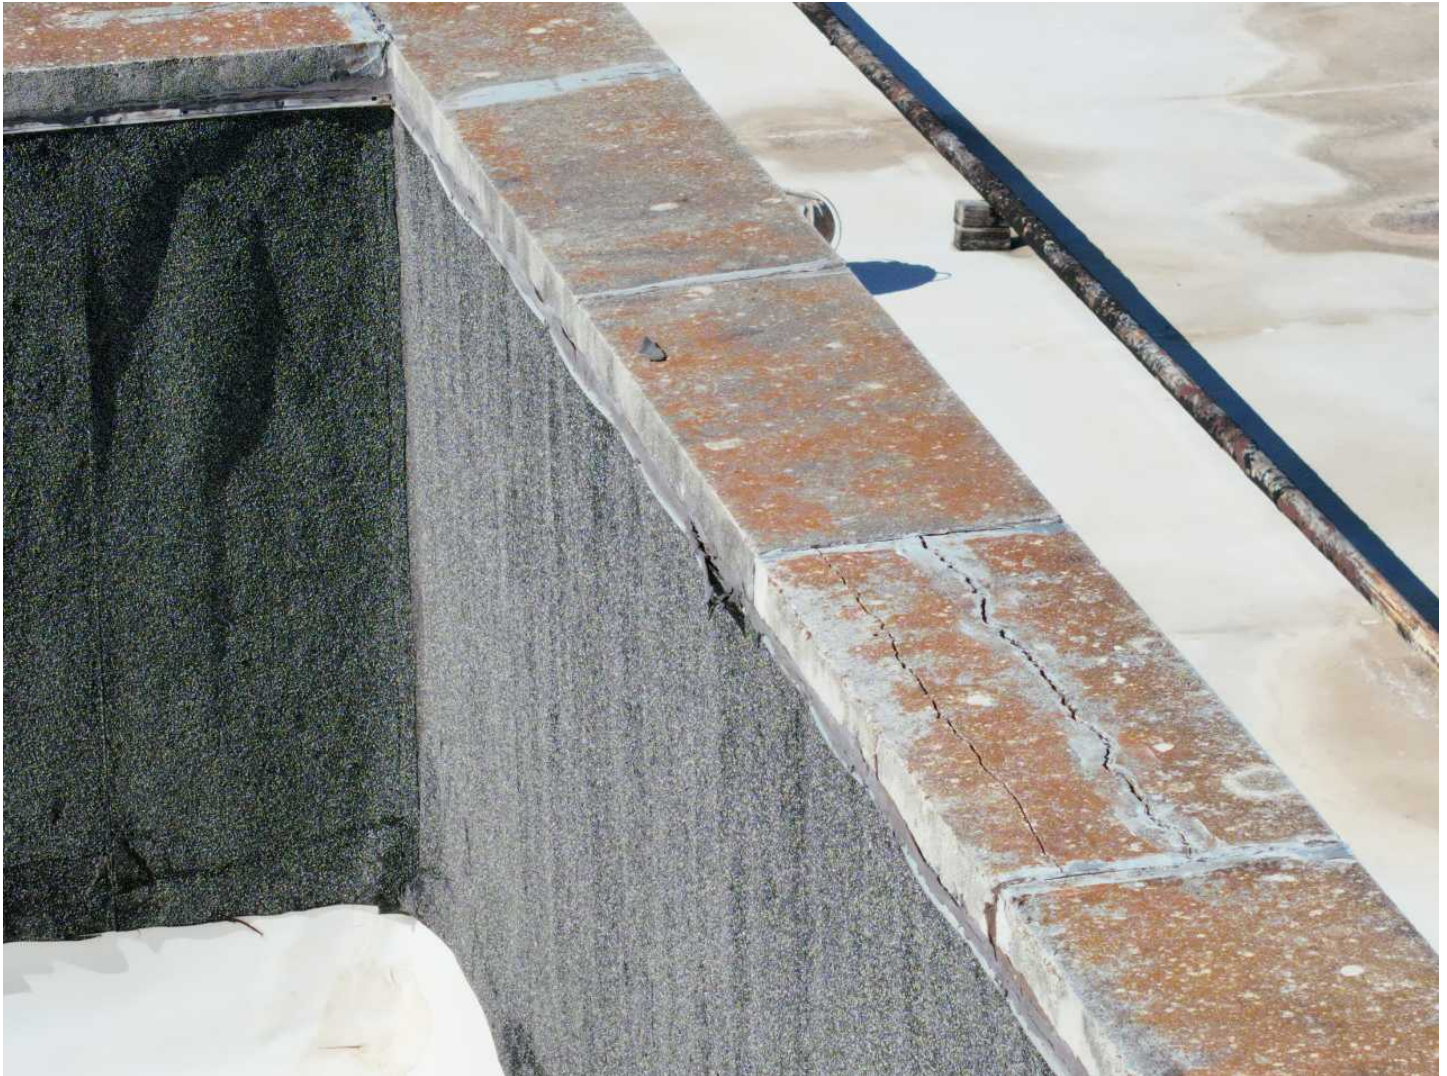
- 91 86-Loose Seams Date Taken: 4/21/2025 Taken By: Angela Night
Edges around the roof membrane are separating from their seams due to poor installation and gap movement.

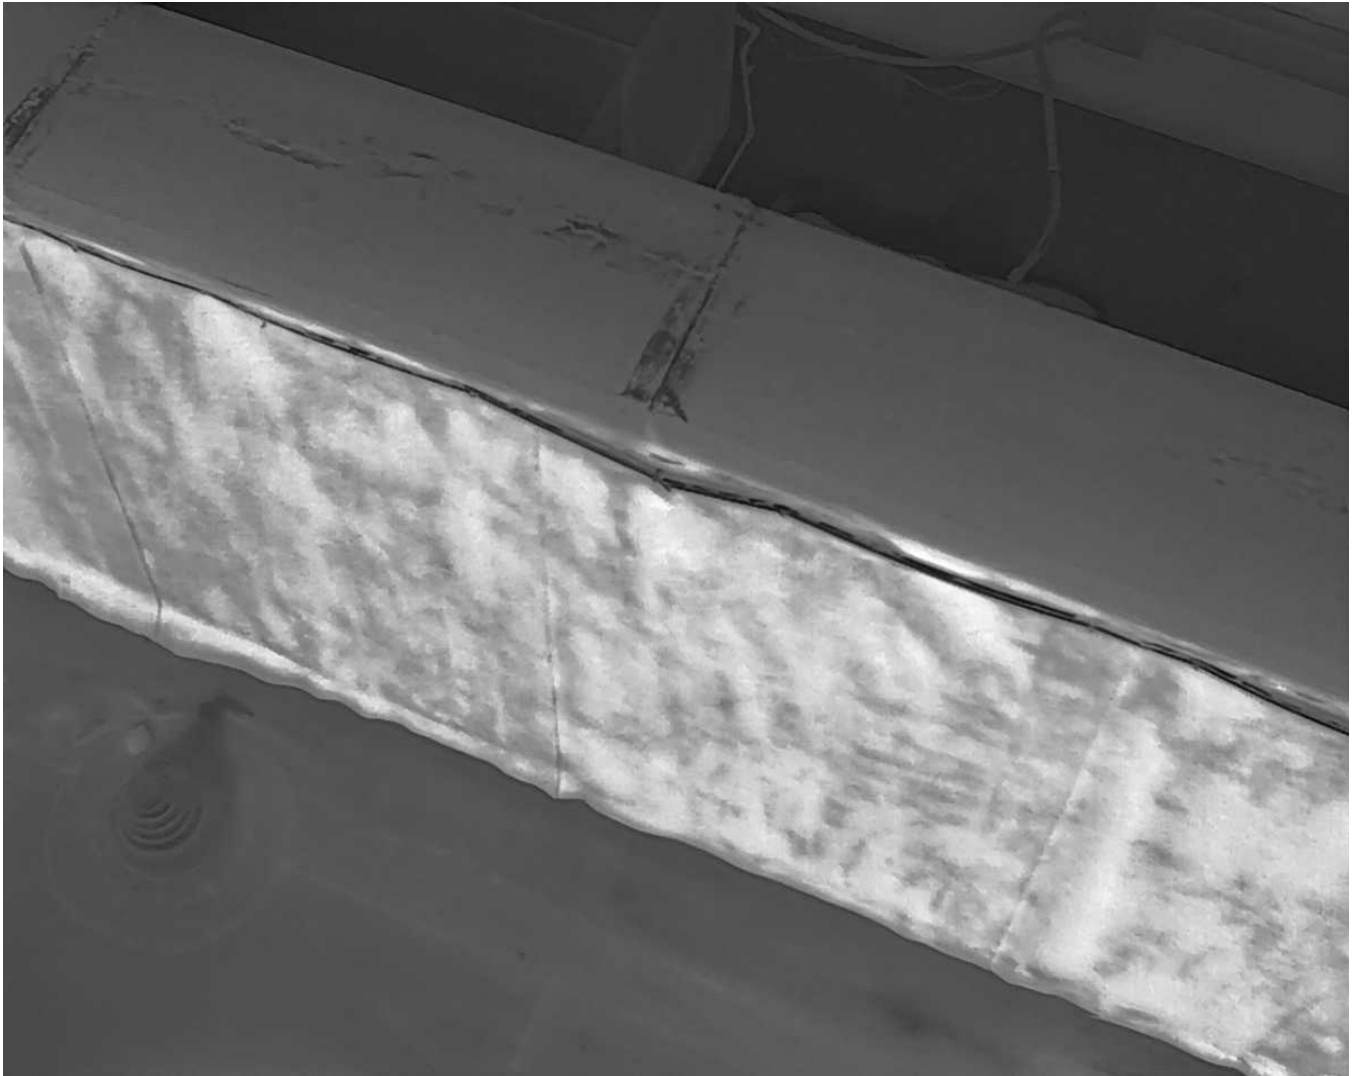
92 87-Loose Seams Date Taken: 4/21/2025 Taken By: Angela Night
Edges around the roof membrane are separating from their seams due to poor installation and gap movement.

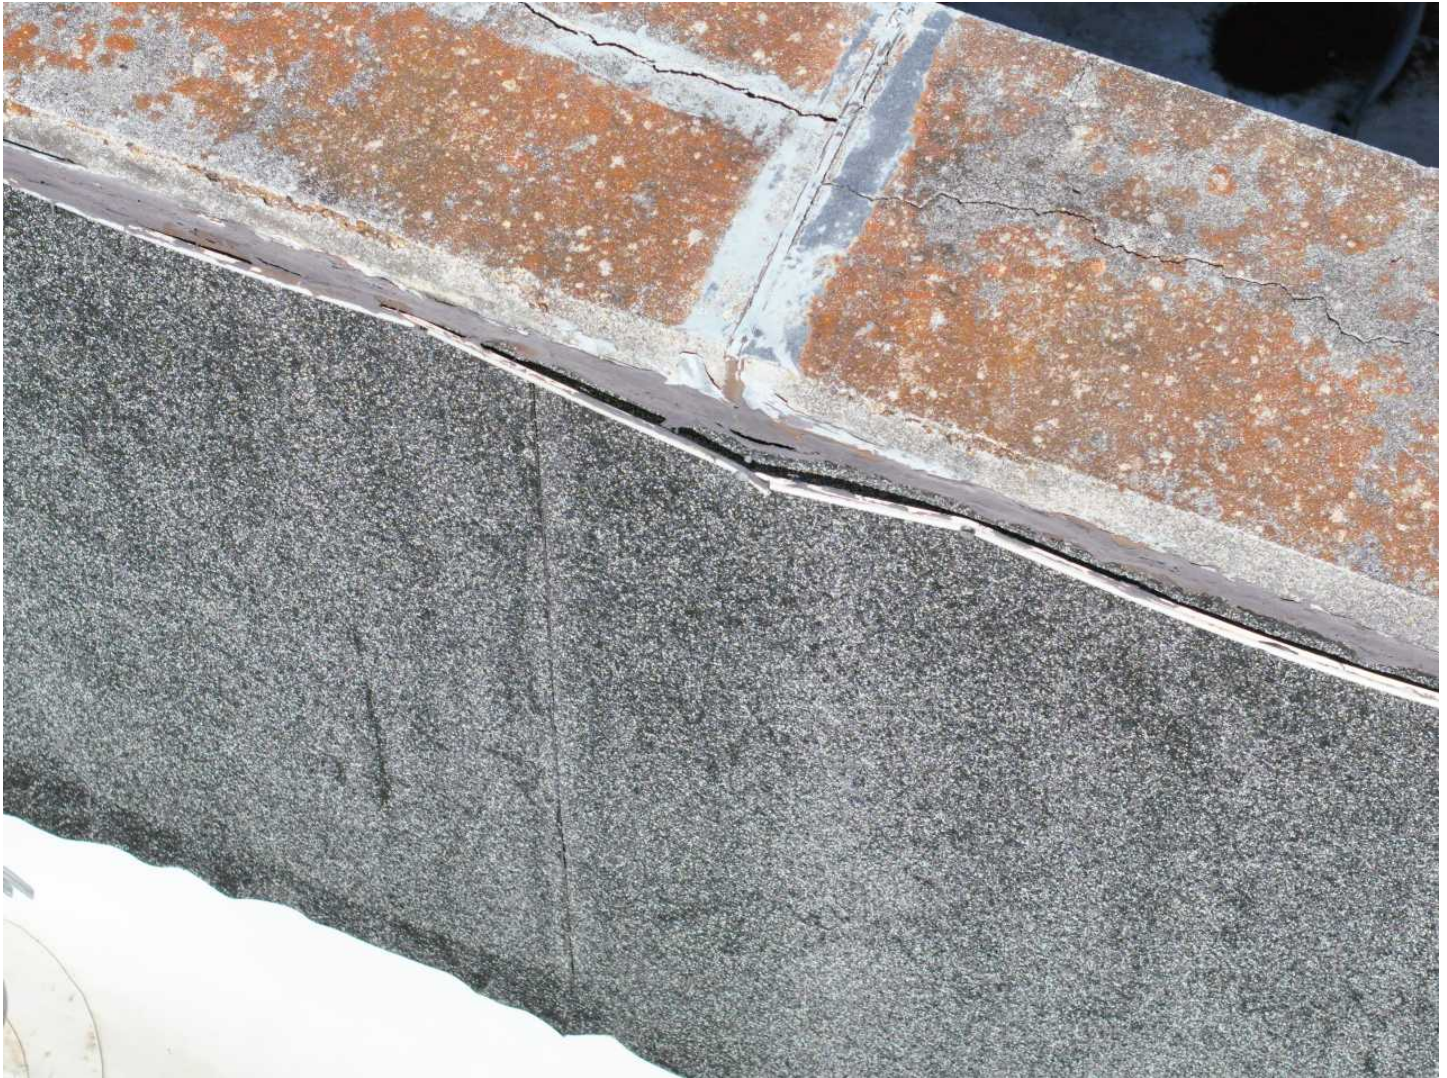
94 89-Loose Seams Date Taken: 4/21/2025 Taken By: Angela Night
Edges around the roof membrane are separating from their seams due to poor installation and gap movement.

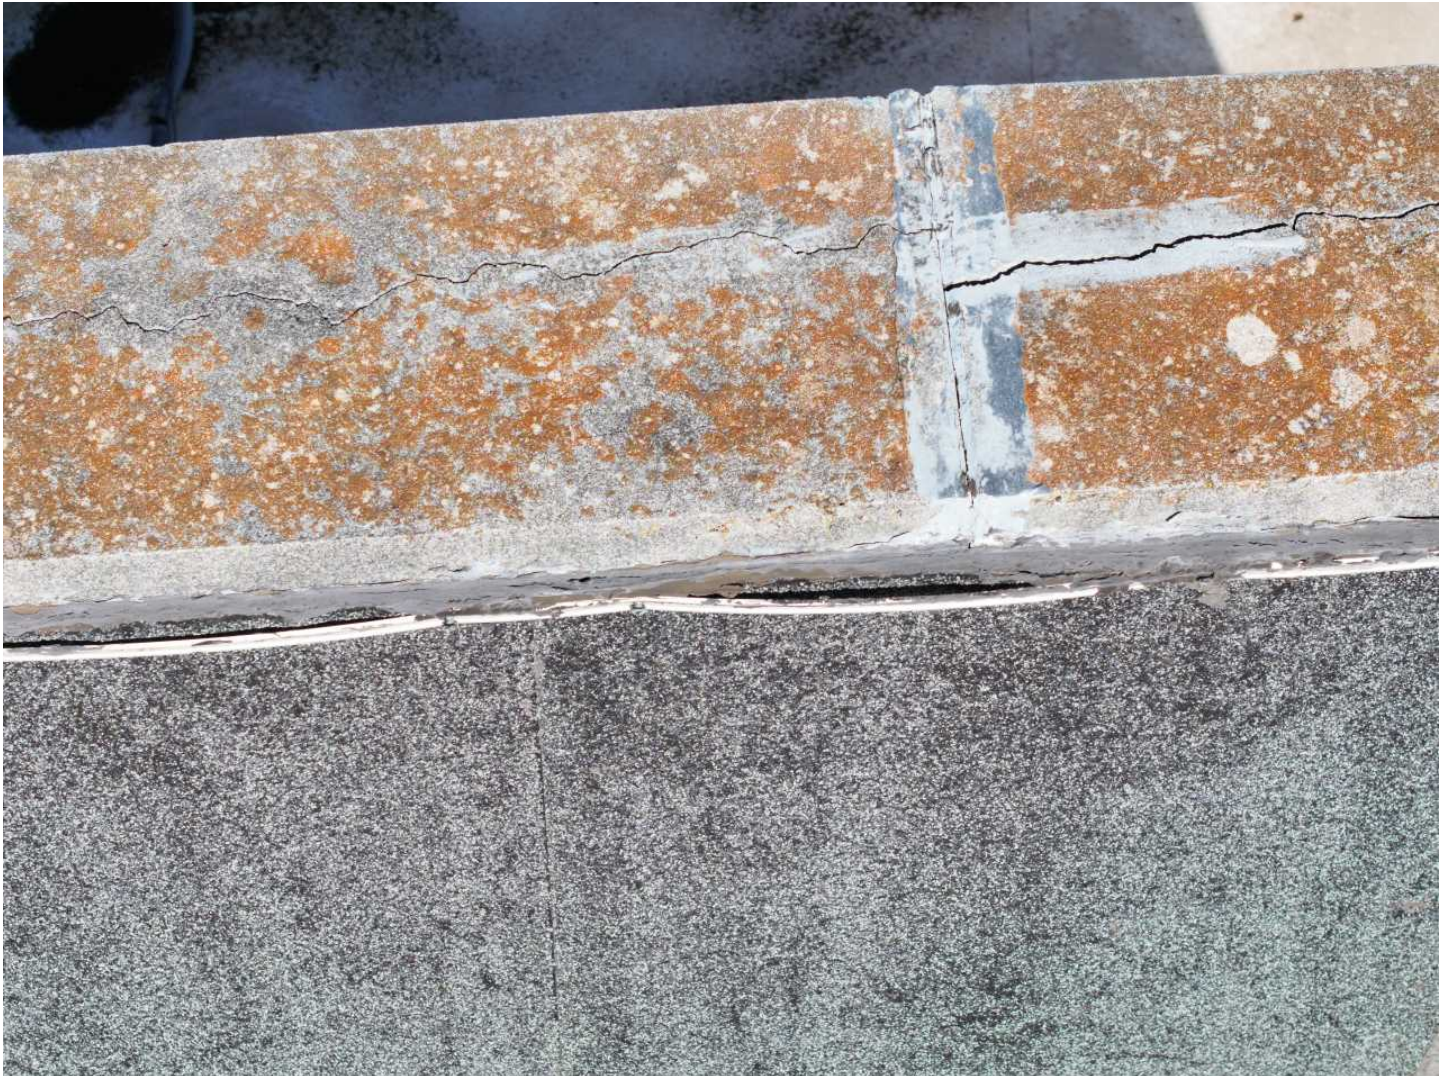
95 90-Loose Seams Date Taken: 4/21/2025 Taken By: Angela Night
Edges around the roof membrane are separating from their seams due to poor installation and gap movement.

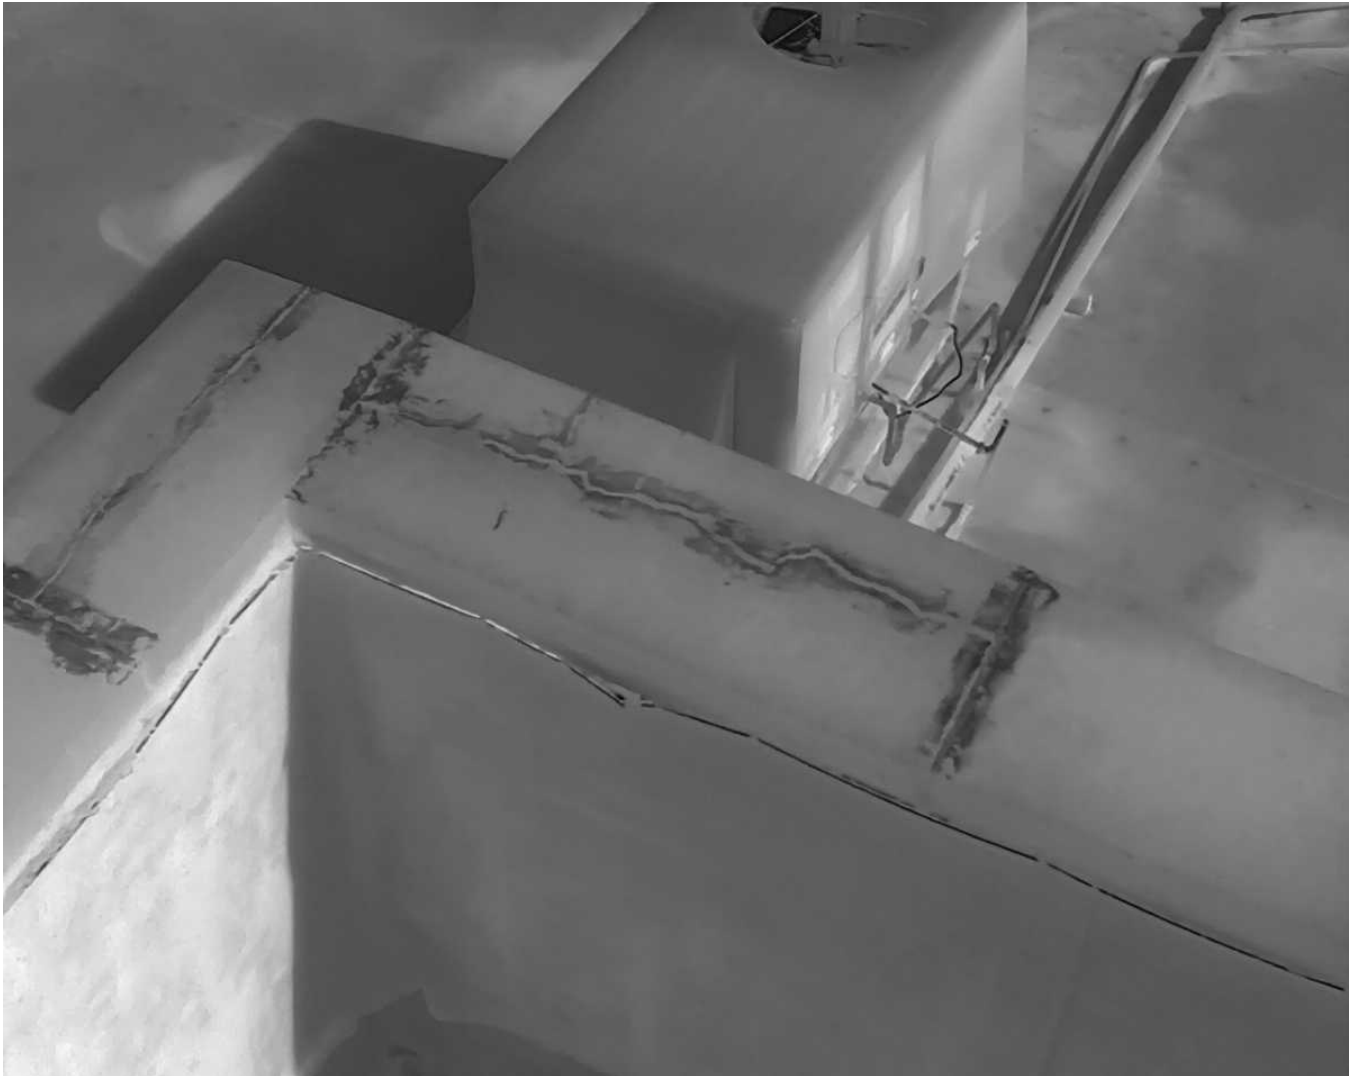
96 91-Loose Seams Date Taken: 4/21/2025 Taken By: Angela Night
Edges around the roof membrane are separating from their seams due to poor installation and gap movement.

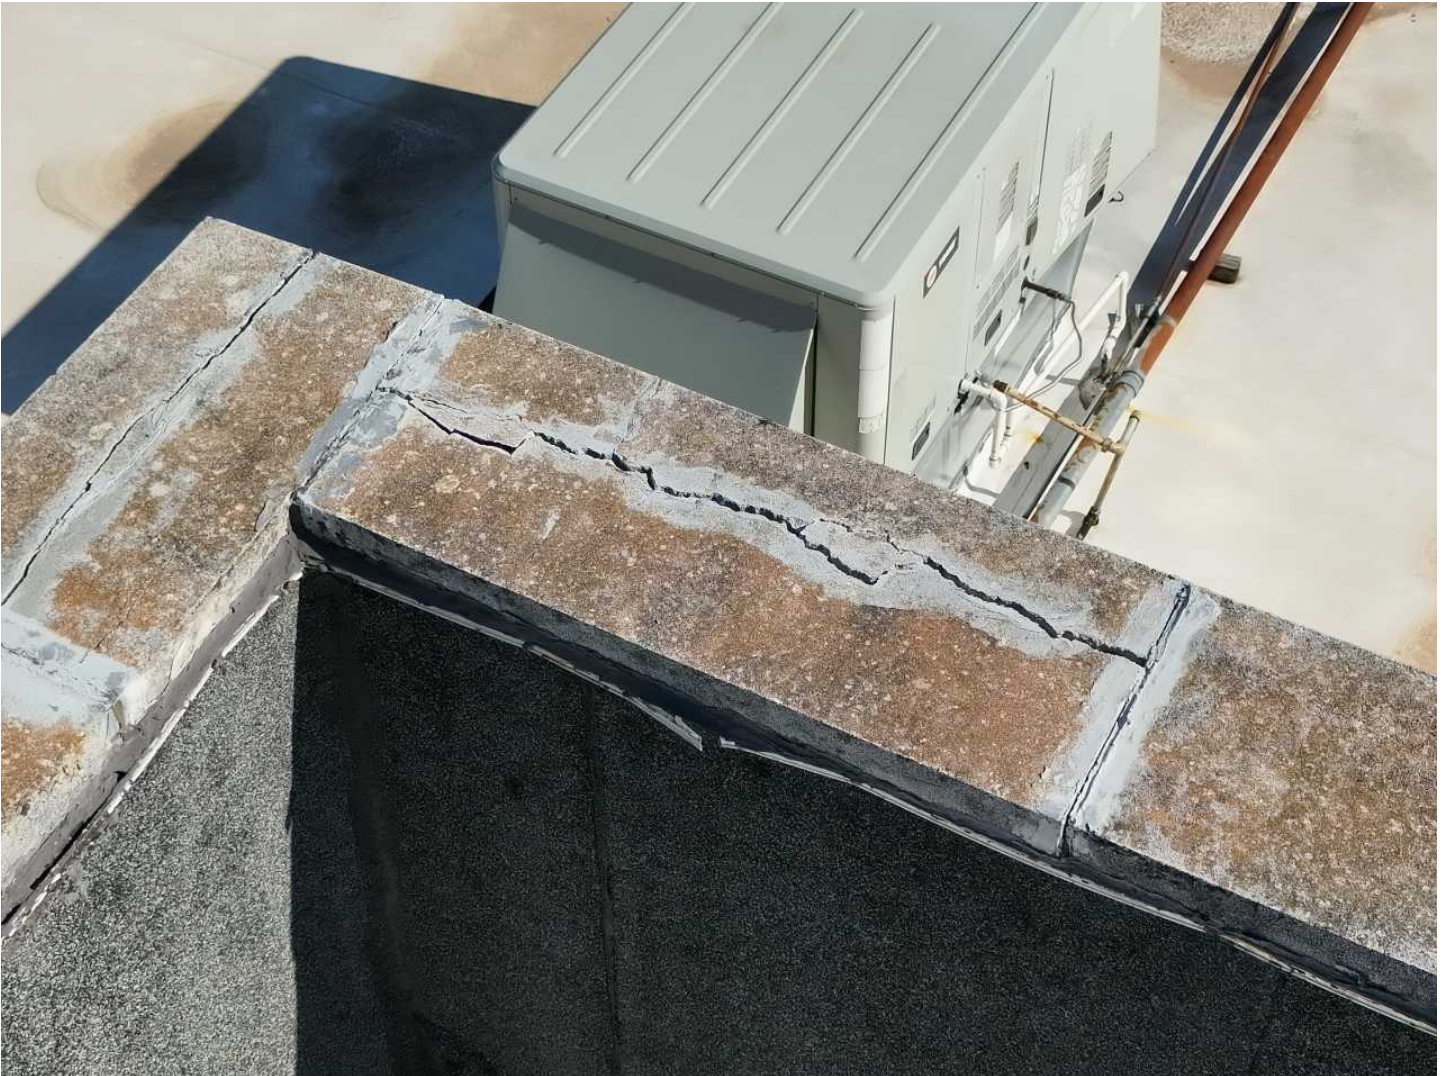
97 92-Loose Seams Date Taken: 4/21/2025 Taken By: Angela Night
Edges around the roof membrane are separating from their seams due to poor installation and gap movement.

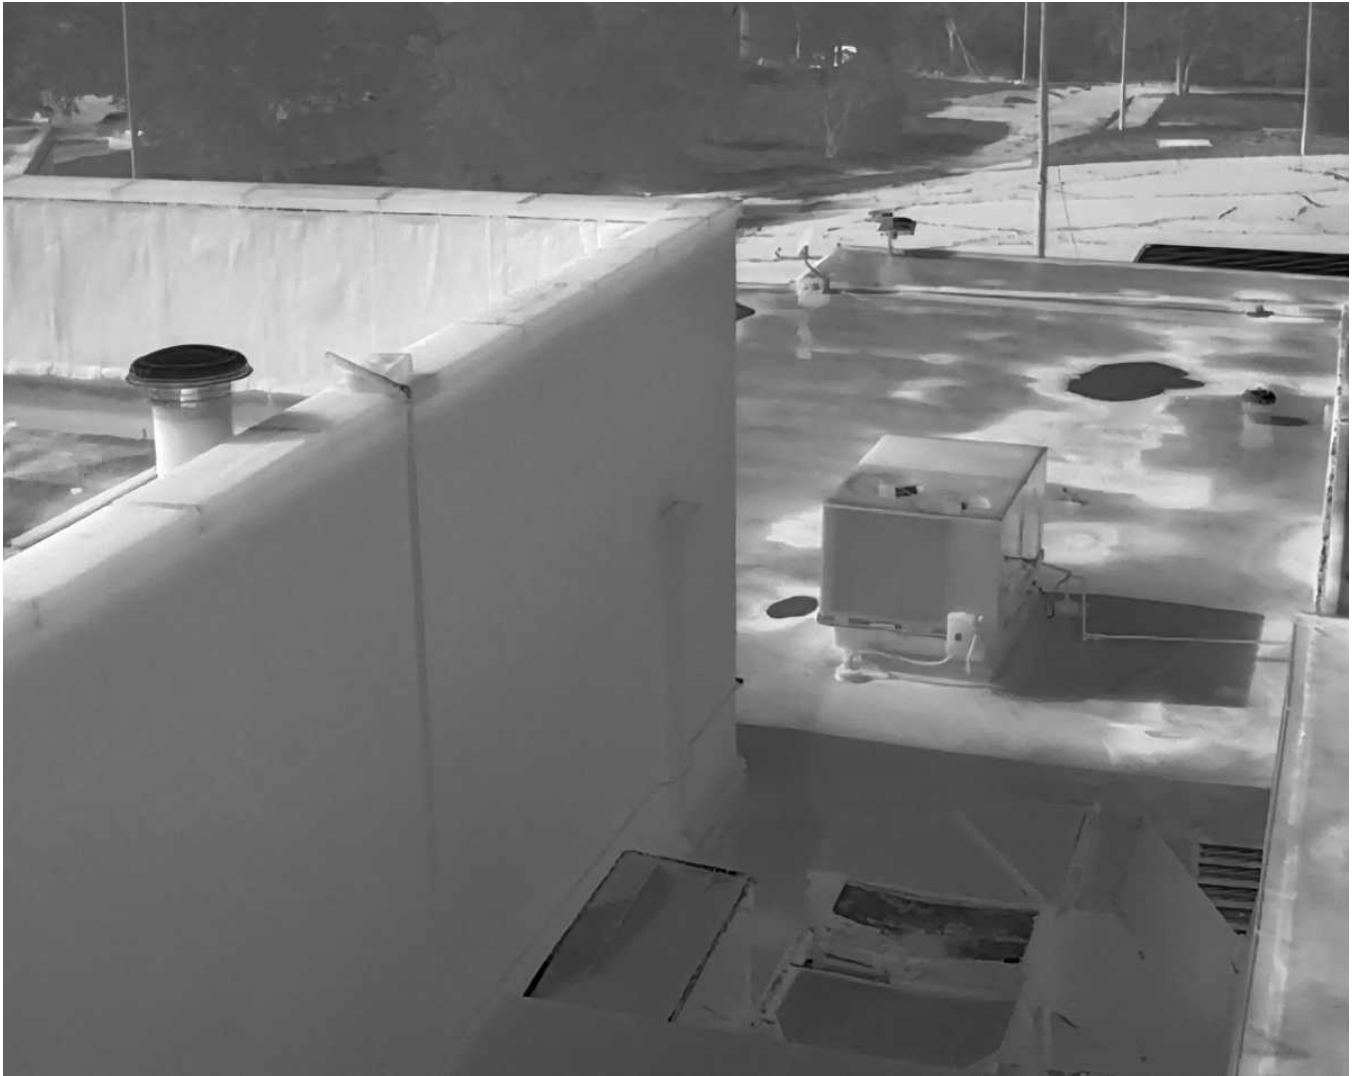
98 93-Loose Seams Date Taken: 4/21/2025 Taken By: Angela Night
Edges around the roof membrane are separating from their seams due to poor installation and gap movement.

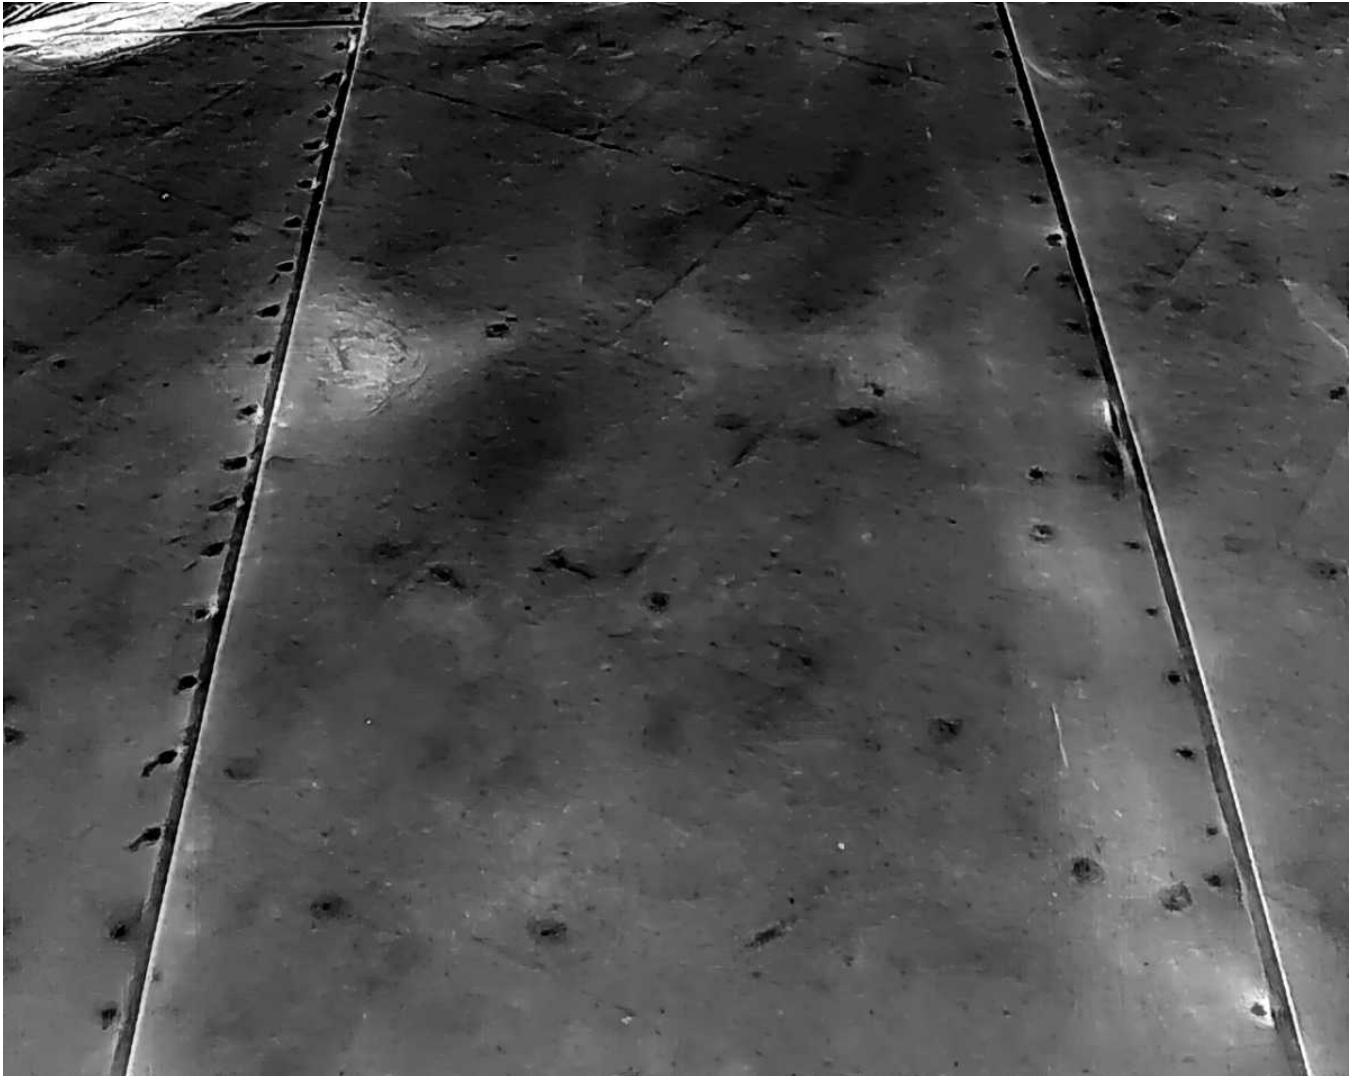
99 94-Loose Seams Date Taken: 4/21/2025 Taken By: Angela Night
Edges around the roof membrane are separating from their seams due to poor installation and gap movement.

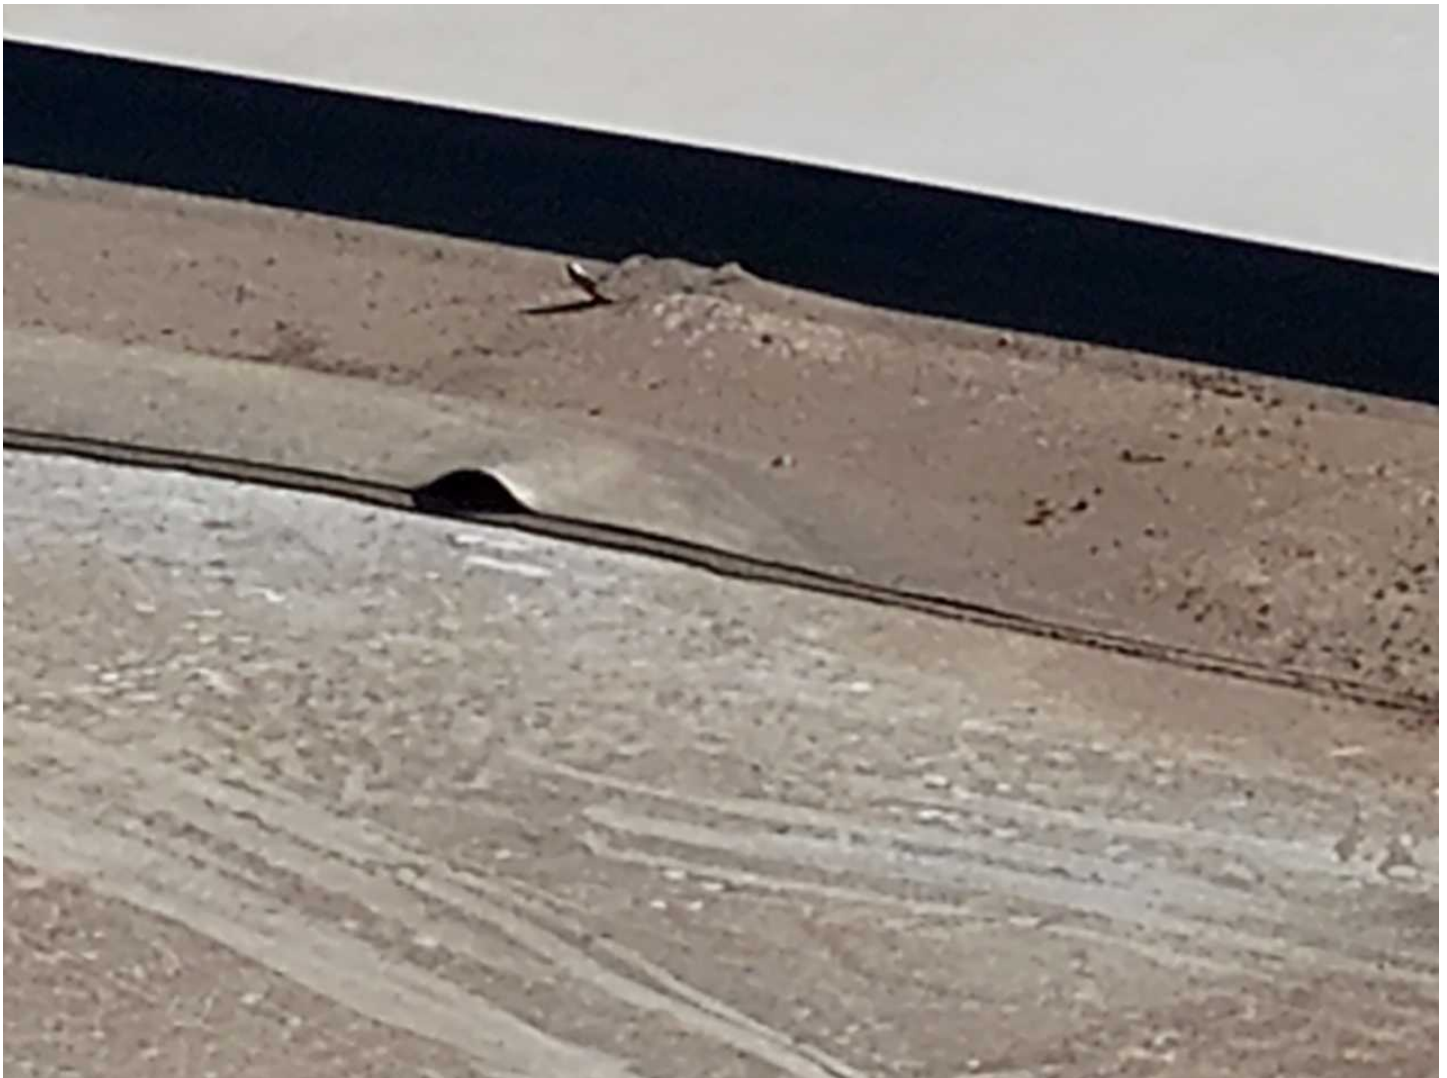
101 96-Loose Seams Date Taken: 4/21/2025 Taken By: Angela Night
Edges around the roof membrane are separating from their seams due to poor installation and gap movement.
