DIV7|ROOF Company

Estimate: FOSTER_COLLEGE

The current roofing system is a TPO (Thermoplastic Polyolefin) that is mechanically attached (there are various areas across the mapping area that were found to be improperly installed). **A fully adhered system is highly recommended in comparison to a mechanically attached system to be applied a gravel ballast built-up roof. Fully adhered systems can reduce the number of seams needed, decreasing potential leak points.**

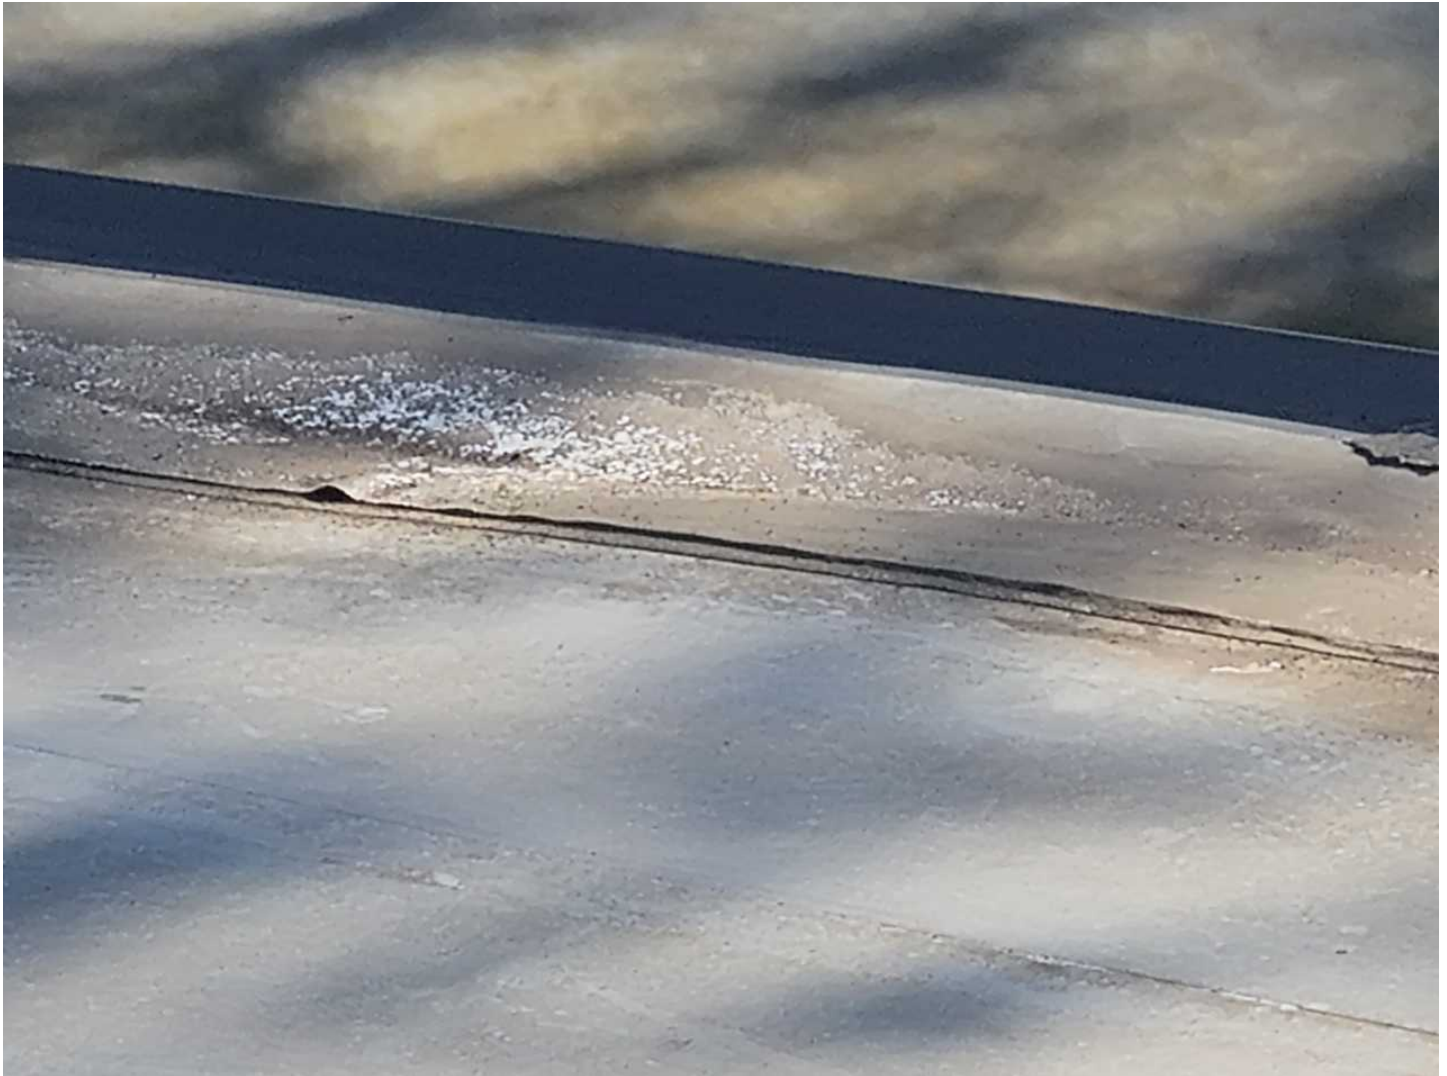
102 97-Loose Seams Date Taken: 4/21/2025 Taken By: Angela Night
Edges around the roof membrane are separating from their seams due to poor installation and gap movement.

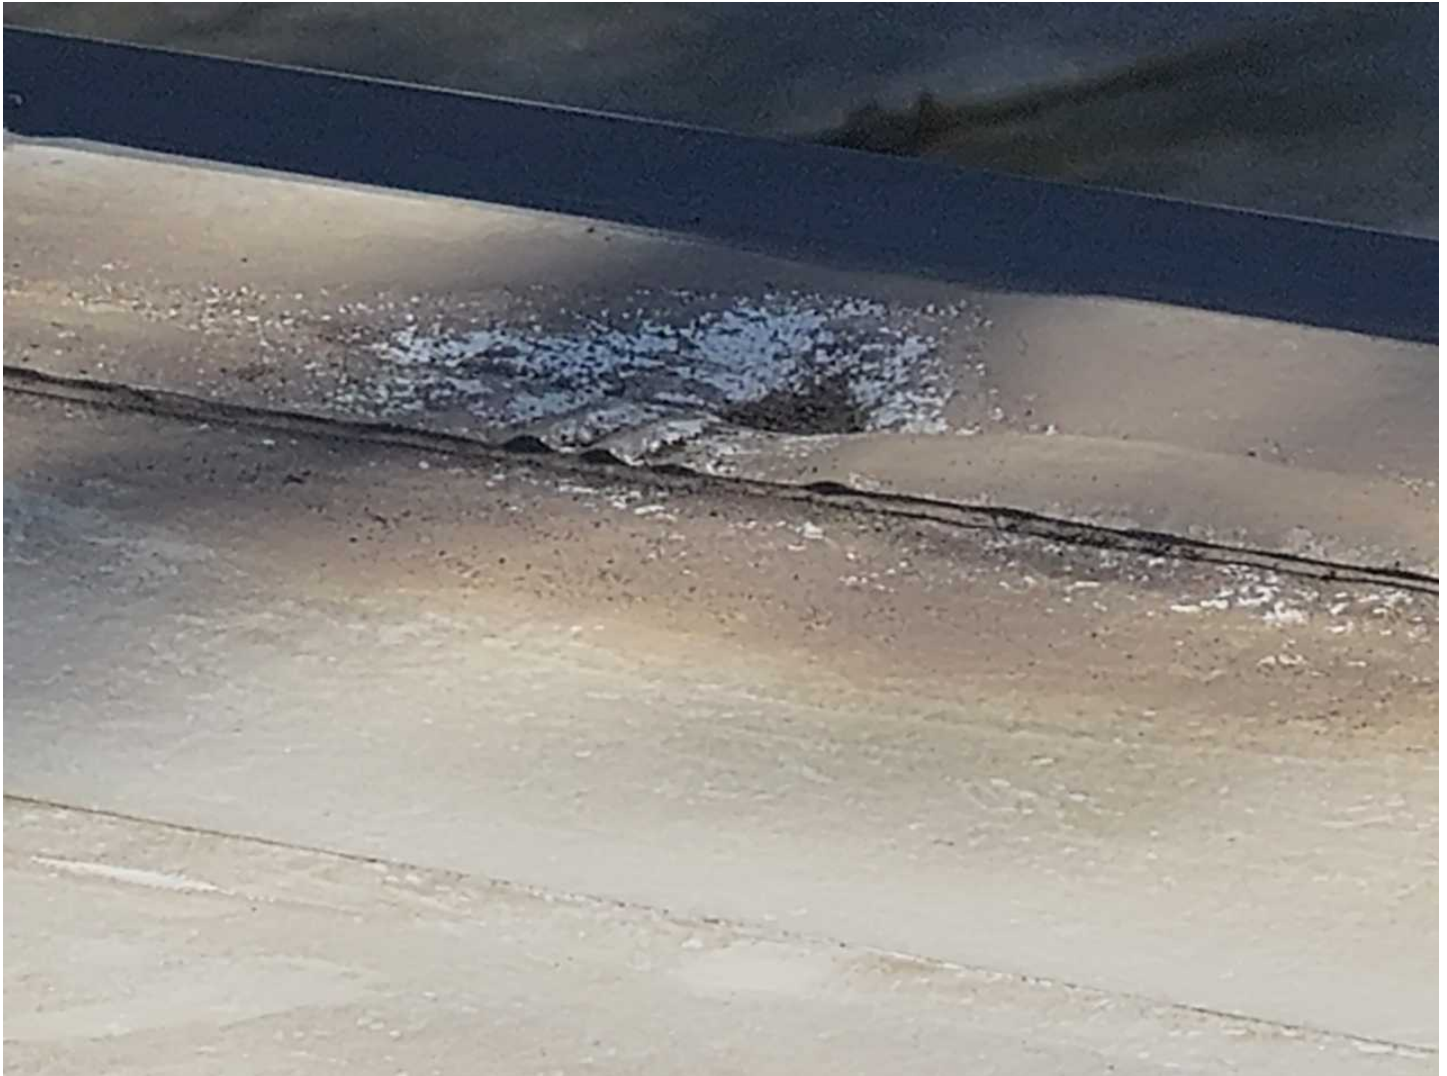
103 98-Loose Seams Date Taken: 4/21/2025 Taken By: Angela Night
Edges around the roof membrane are separating from their seams due to poor installation and gap movement.

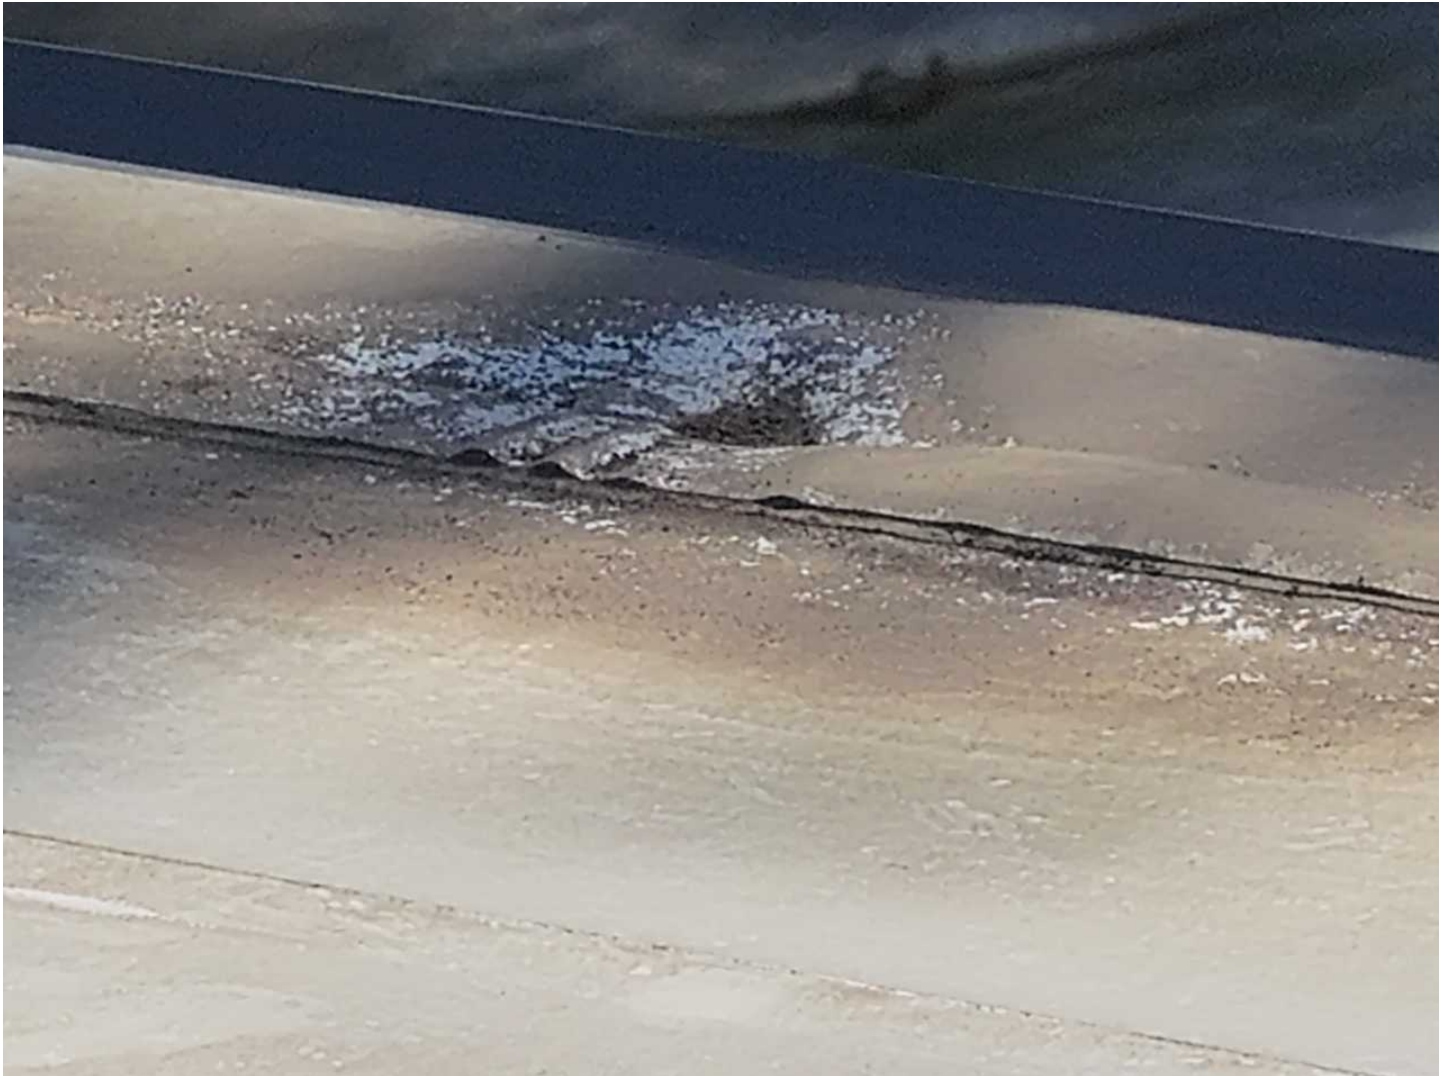
104 99-Loose Seams Date Taken: 4/21/2025 Taken By: Angela Night
Edges around the roof membrane are separating from their seams due to poor installation and gap movement.

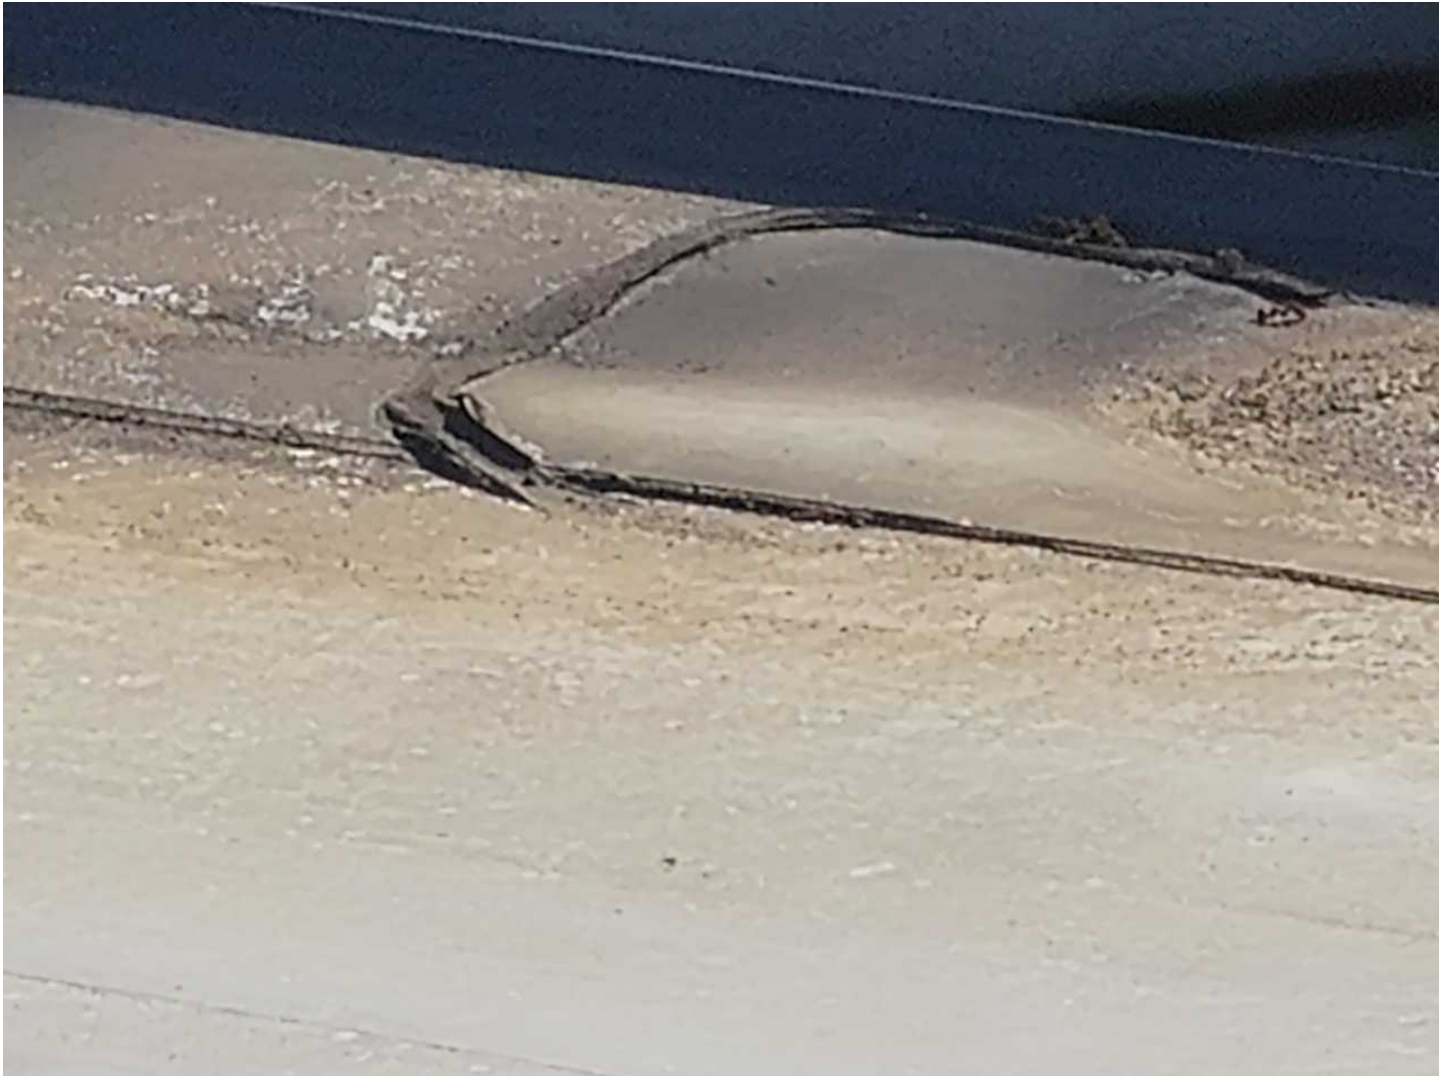
105 100-Loose Seams Date Taken: 4/21/2025 Taken By: Angela Night
Edges around the roof membrane are separating from their seams due to poor installation and gap movement.

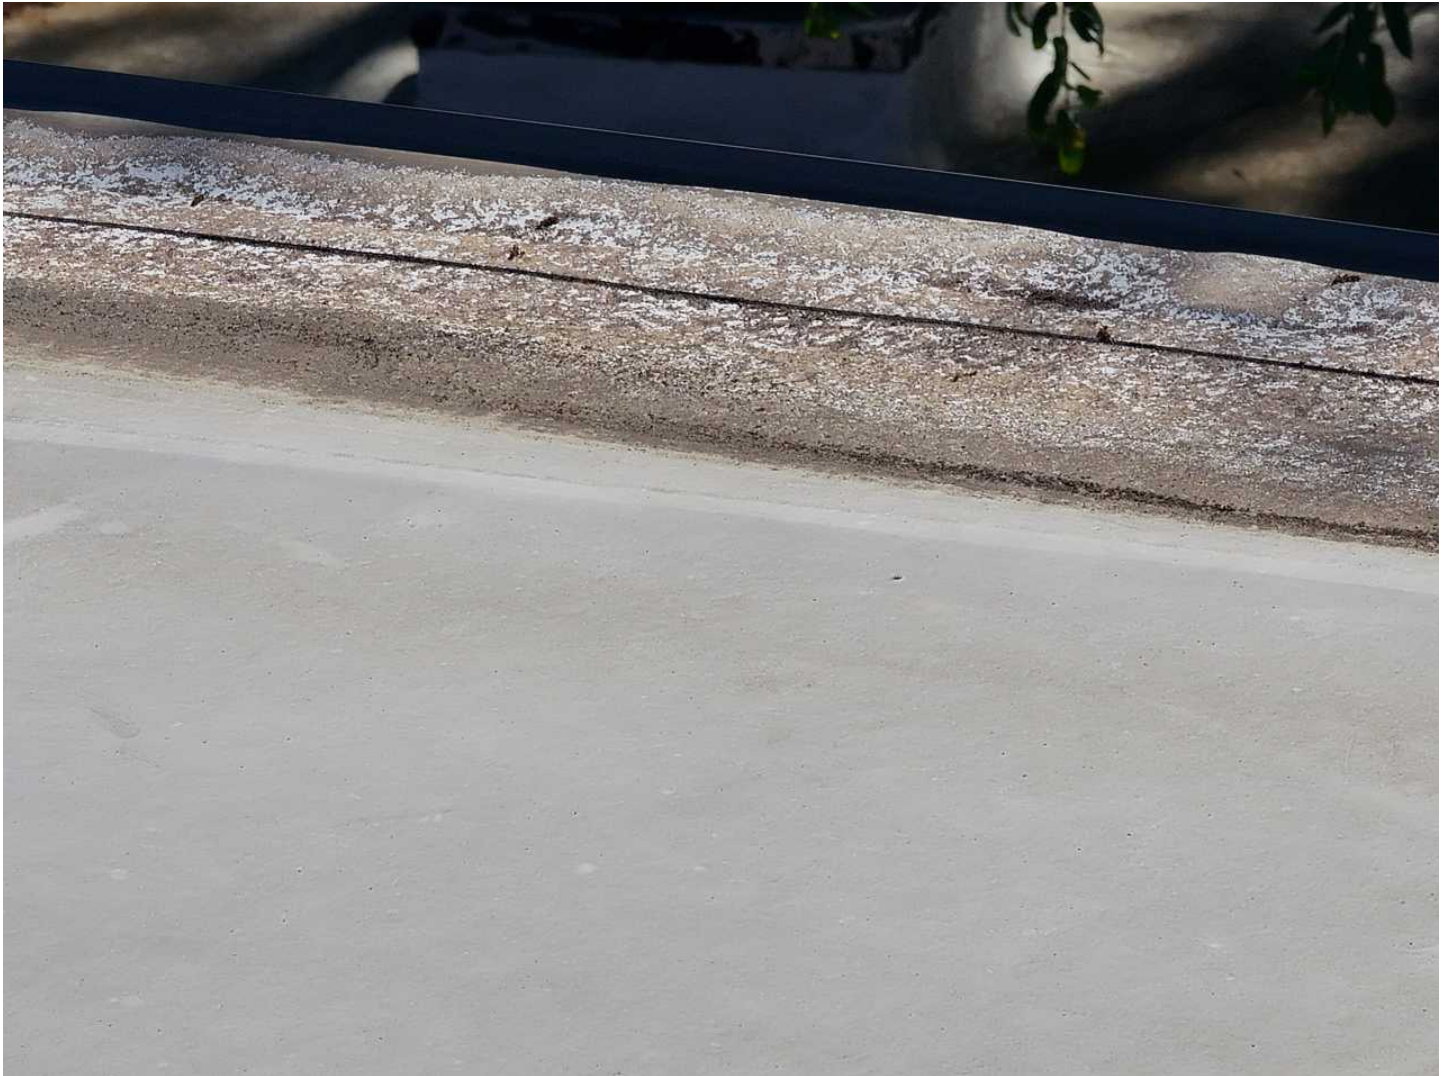
106 101-Loose Seams Date Taken: 4/21/2025 Taken By: Angela Night
Edges around the roof membrane are separating from their seams due to poor installation and gap movement.

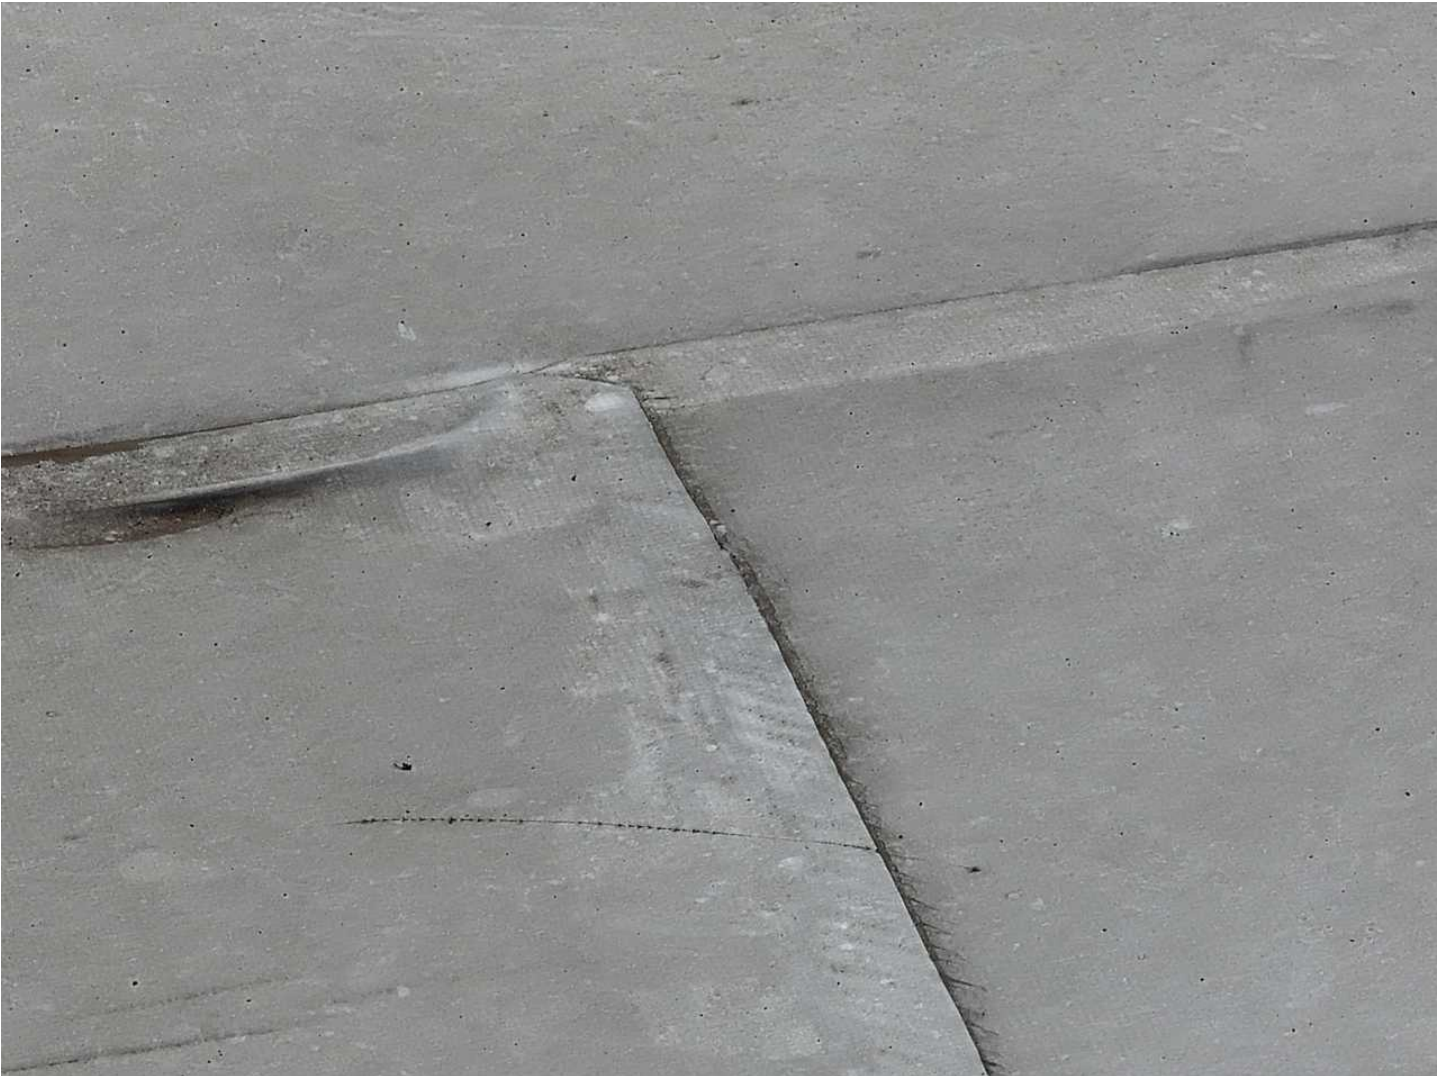
107 102-Loose Seams Date Taken: 4/21/2025 Taken By: Angela Night
Edges around the roof membrane are separating from their seams due to poor installation and gap movement.

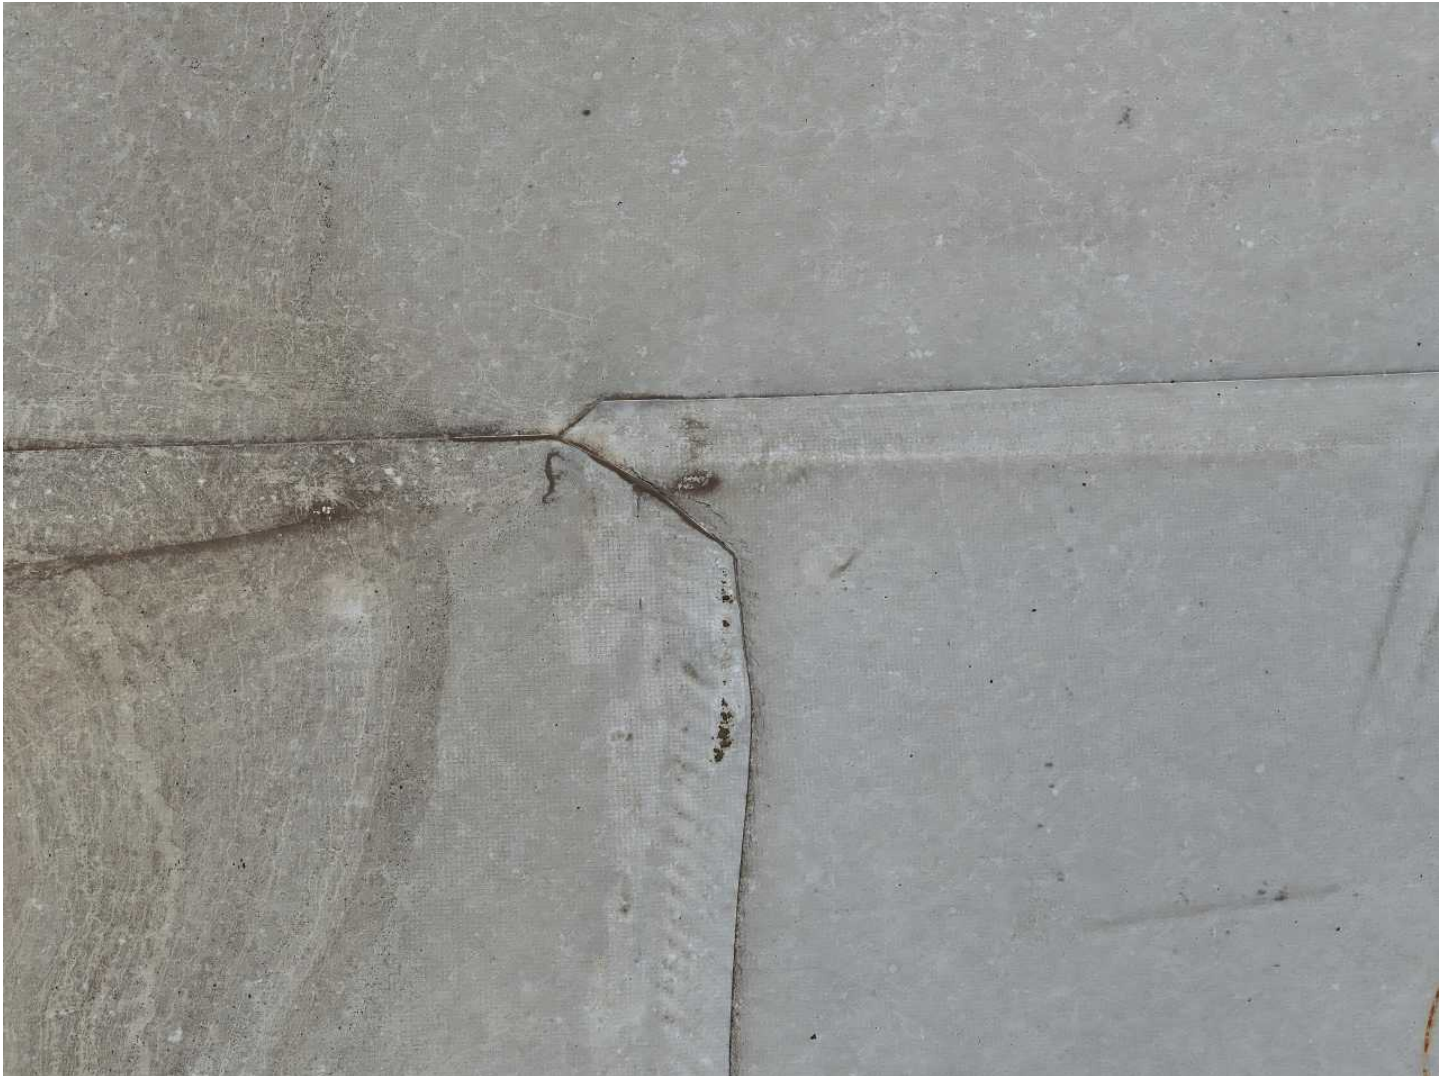
108 103-Loose Seams Date Taken: 4/21/2025 Taken By: Angela Night
Edges around the roof membrane are separating from their seams due to poor installation and gap movement.

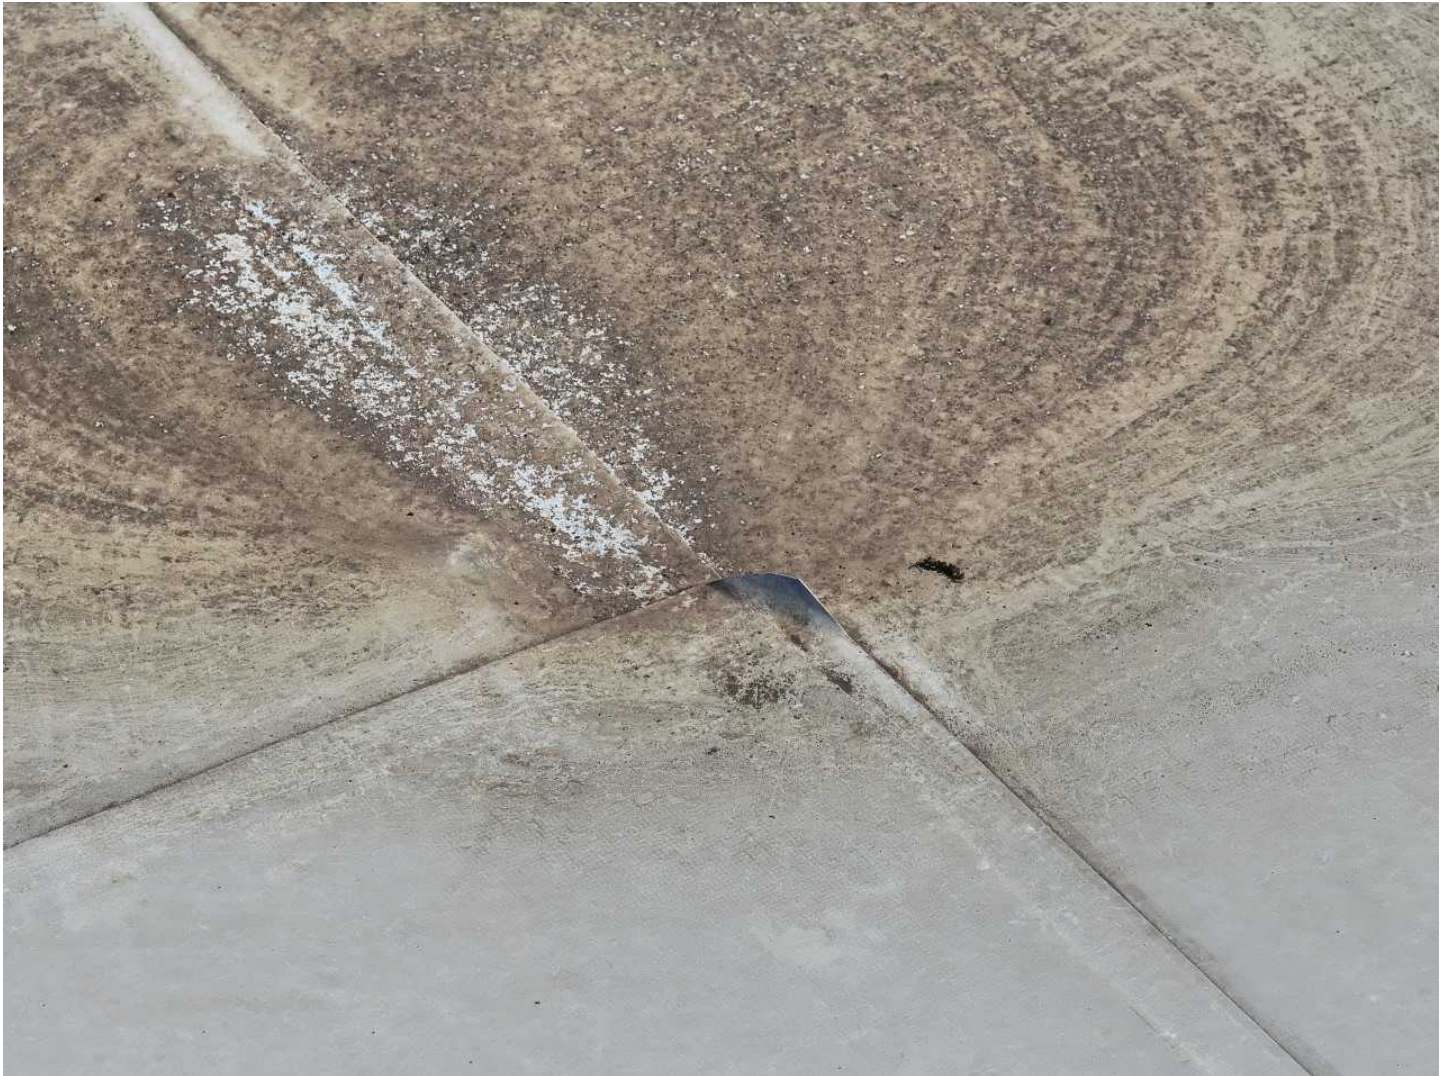
109 104-Loose Seams Date Taken: 4/21/2025 Taken By: Angela Night
Edges around the roof membrane are separating from their seams due to poor installation and gap movement.

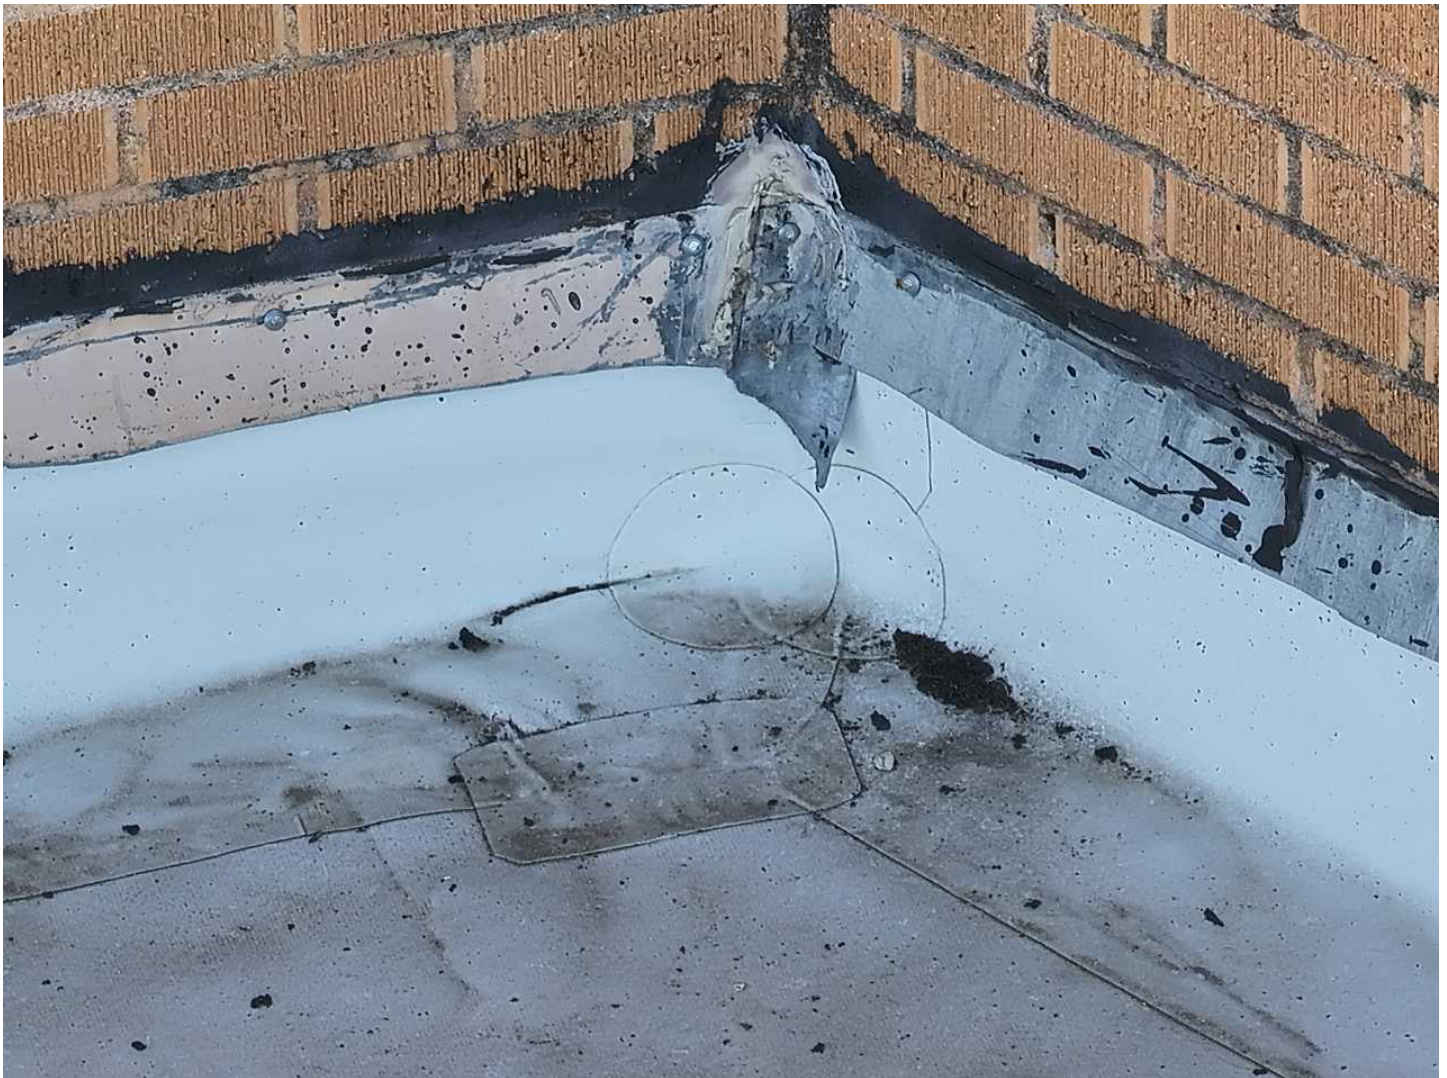
110 105-Loose Seams Date Taken: 4/21/2025 Taken By: Angela Night
Edges around the roof membrane are separating from their seams due to poor installation and gap movement.

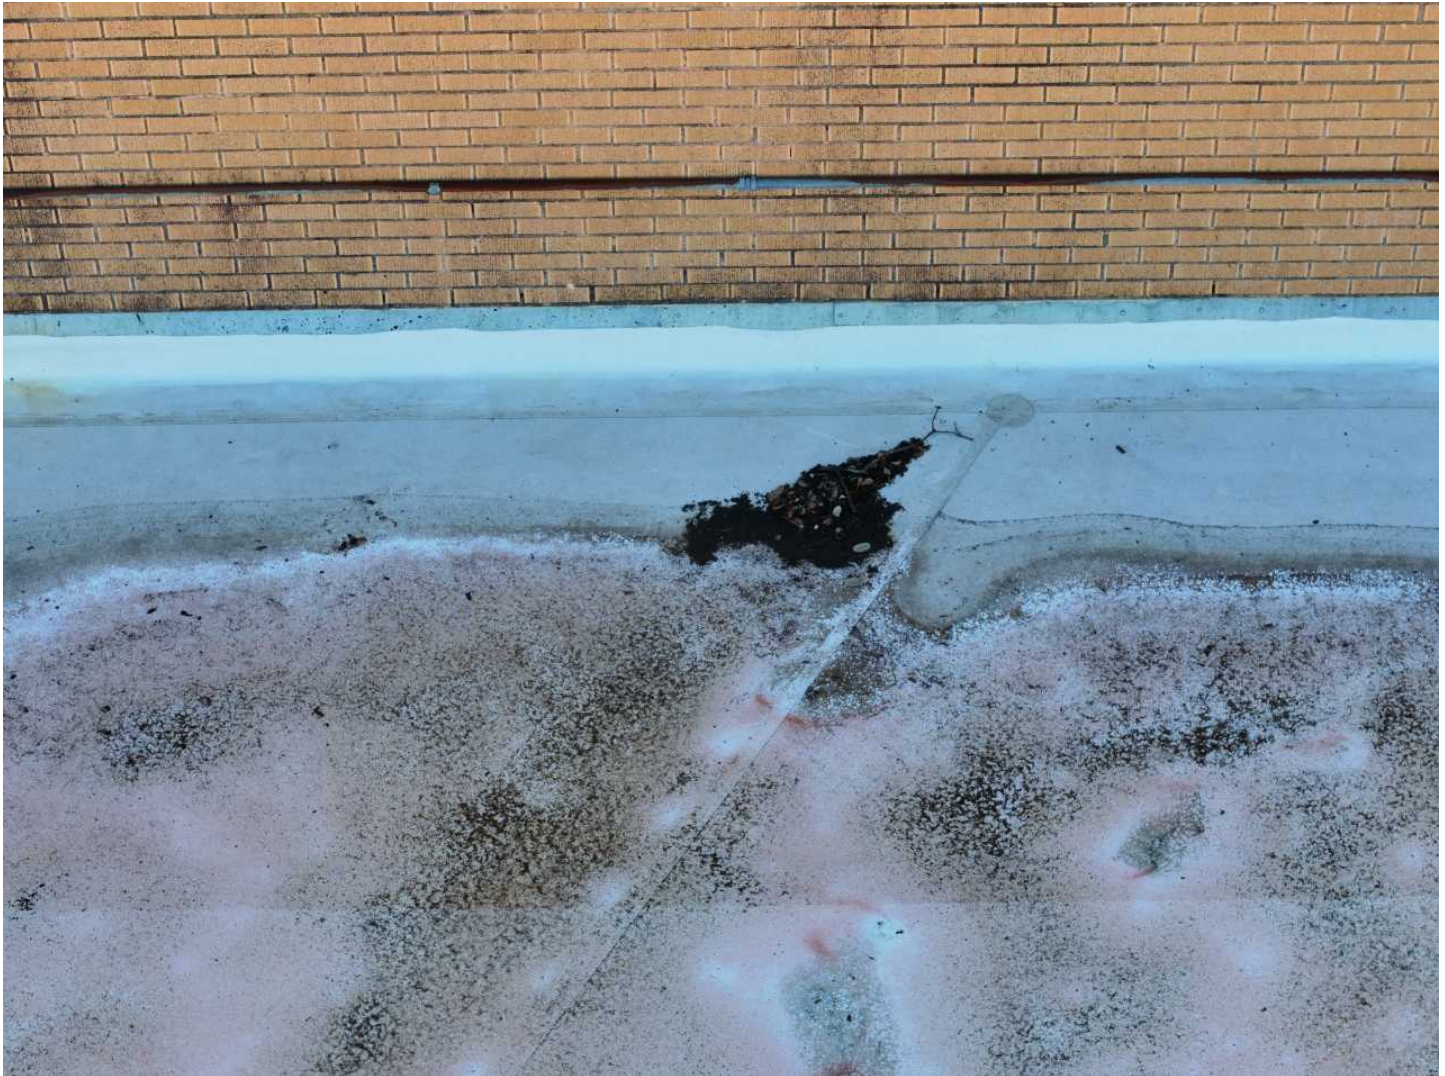
111 111-Failed Flashing Date Taken: 4/21/2025 Taken By: Angela Night
Inadequate craftsmanship and unorganized placement indicative of a poor repair job or uncertified contractor.

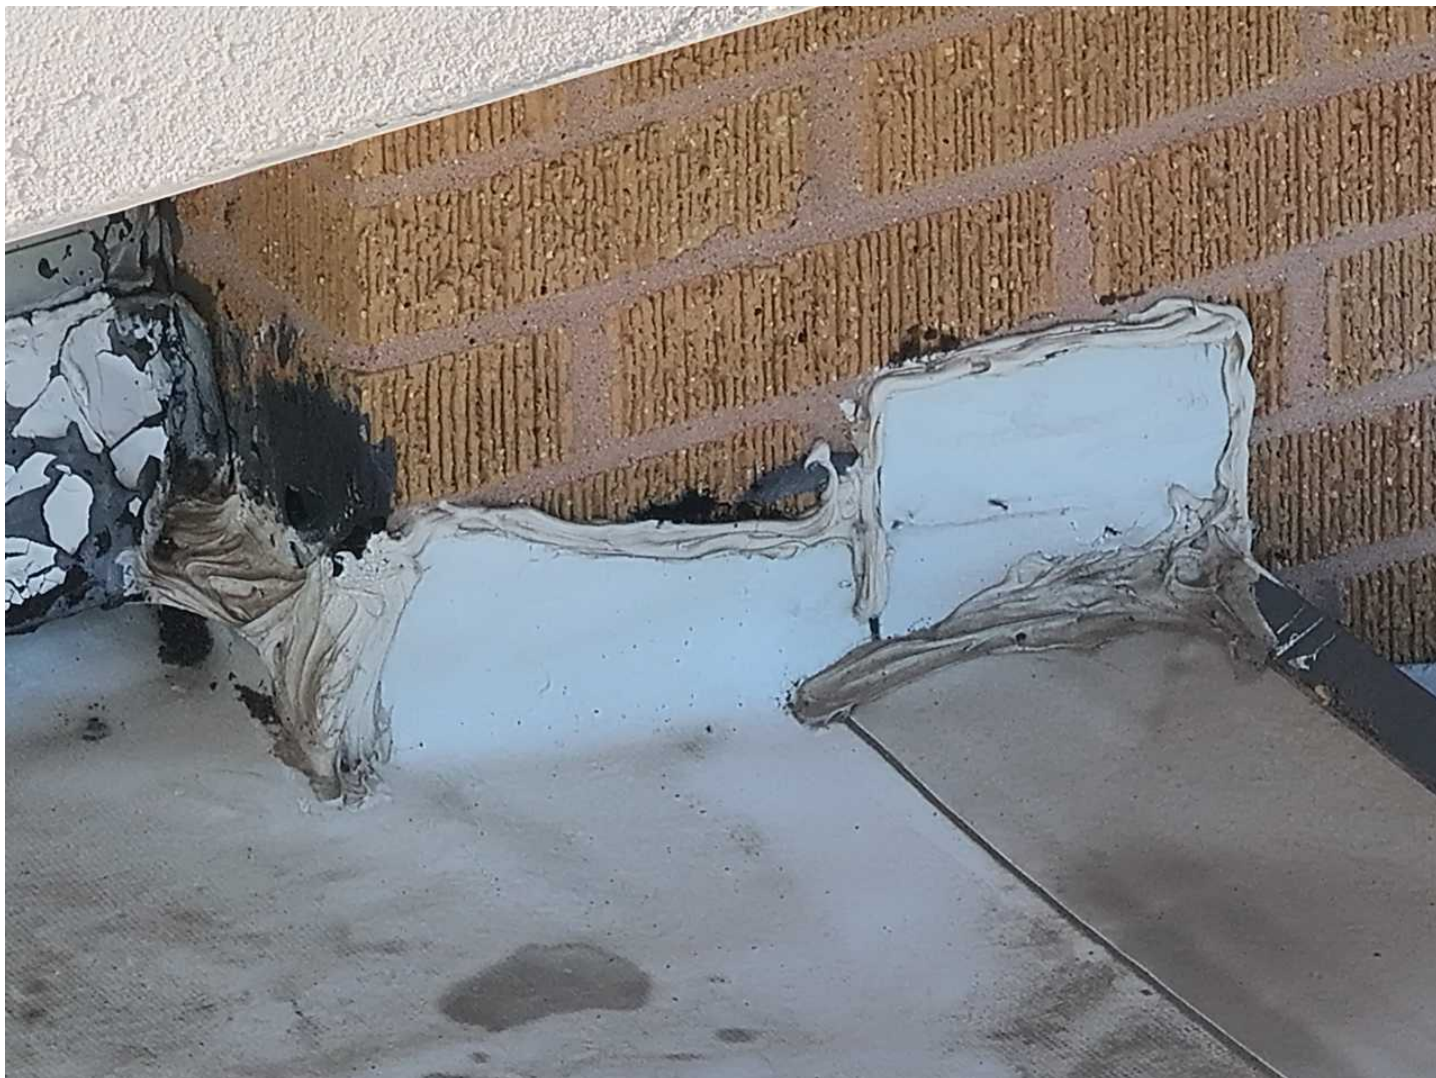
112 112-Failed Flashing Date Taken: 4/21/2025 Taken By: Angela Night
Inadequate craftsmanship and unorganized placement indicative of a poor repair job or uncertified contractor.

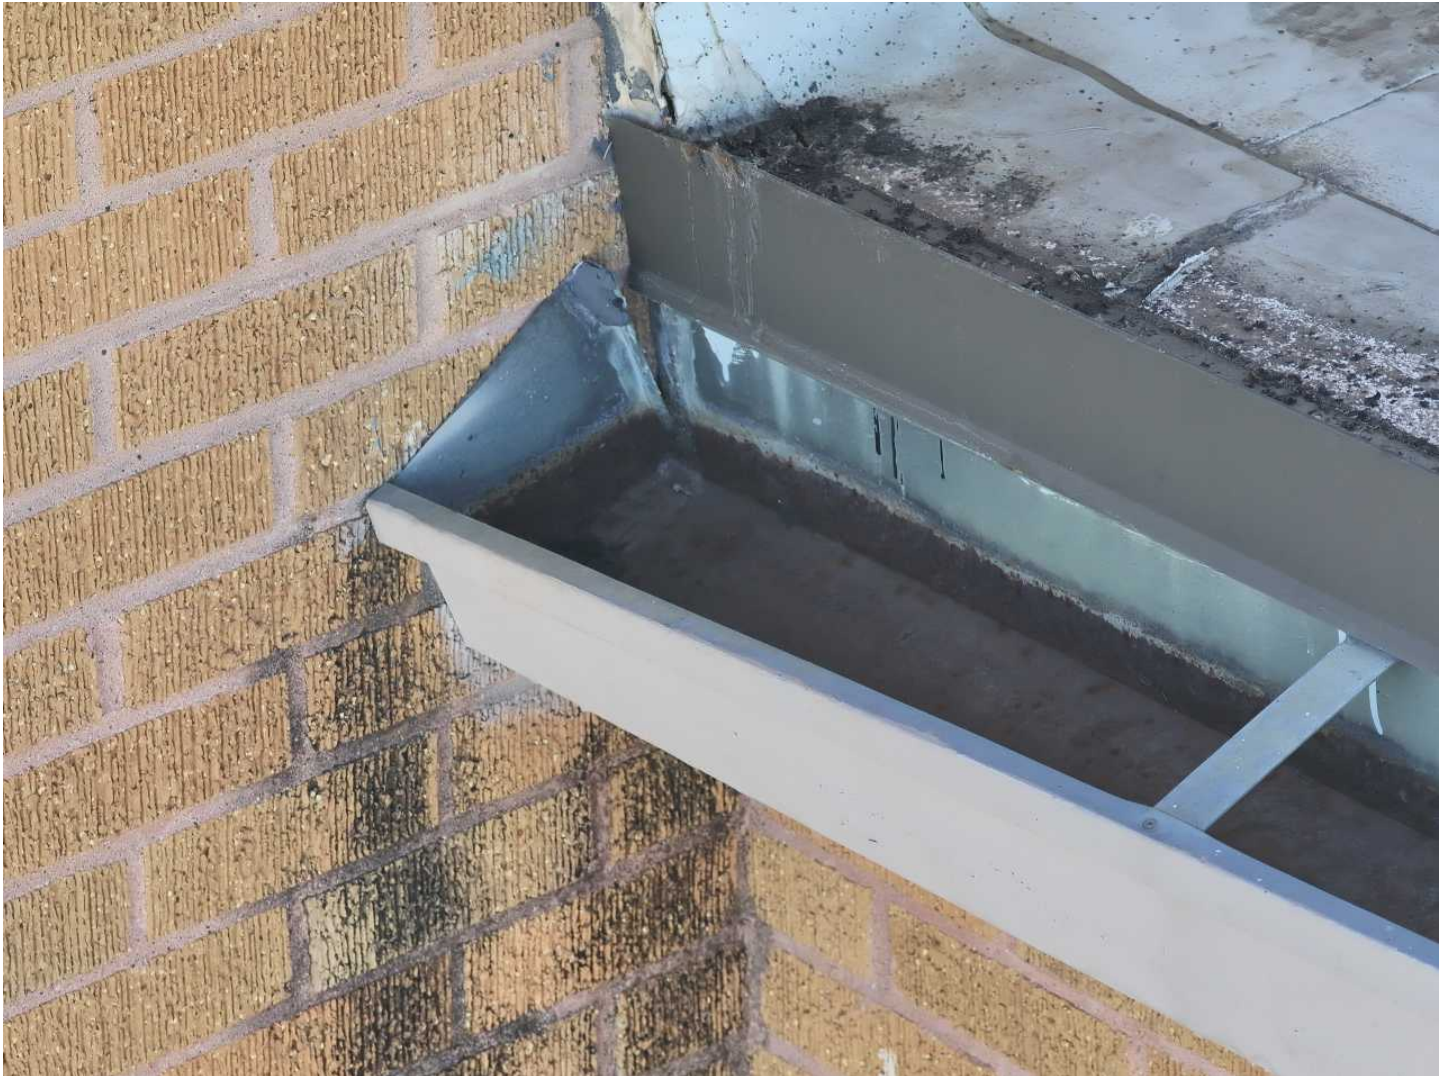
113 113-Failed Flashing Date Taken: 4/21/2025 Taken By: Angela Night
Inadequate craftsmanship and unorganized placement indicative of a poor repair job or uncertified contractor.

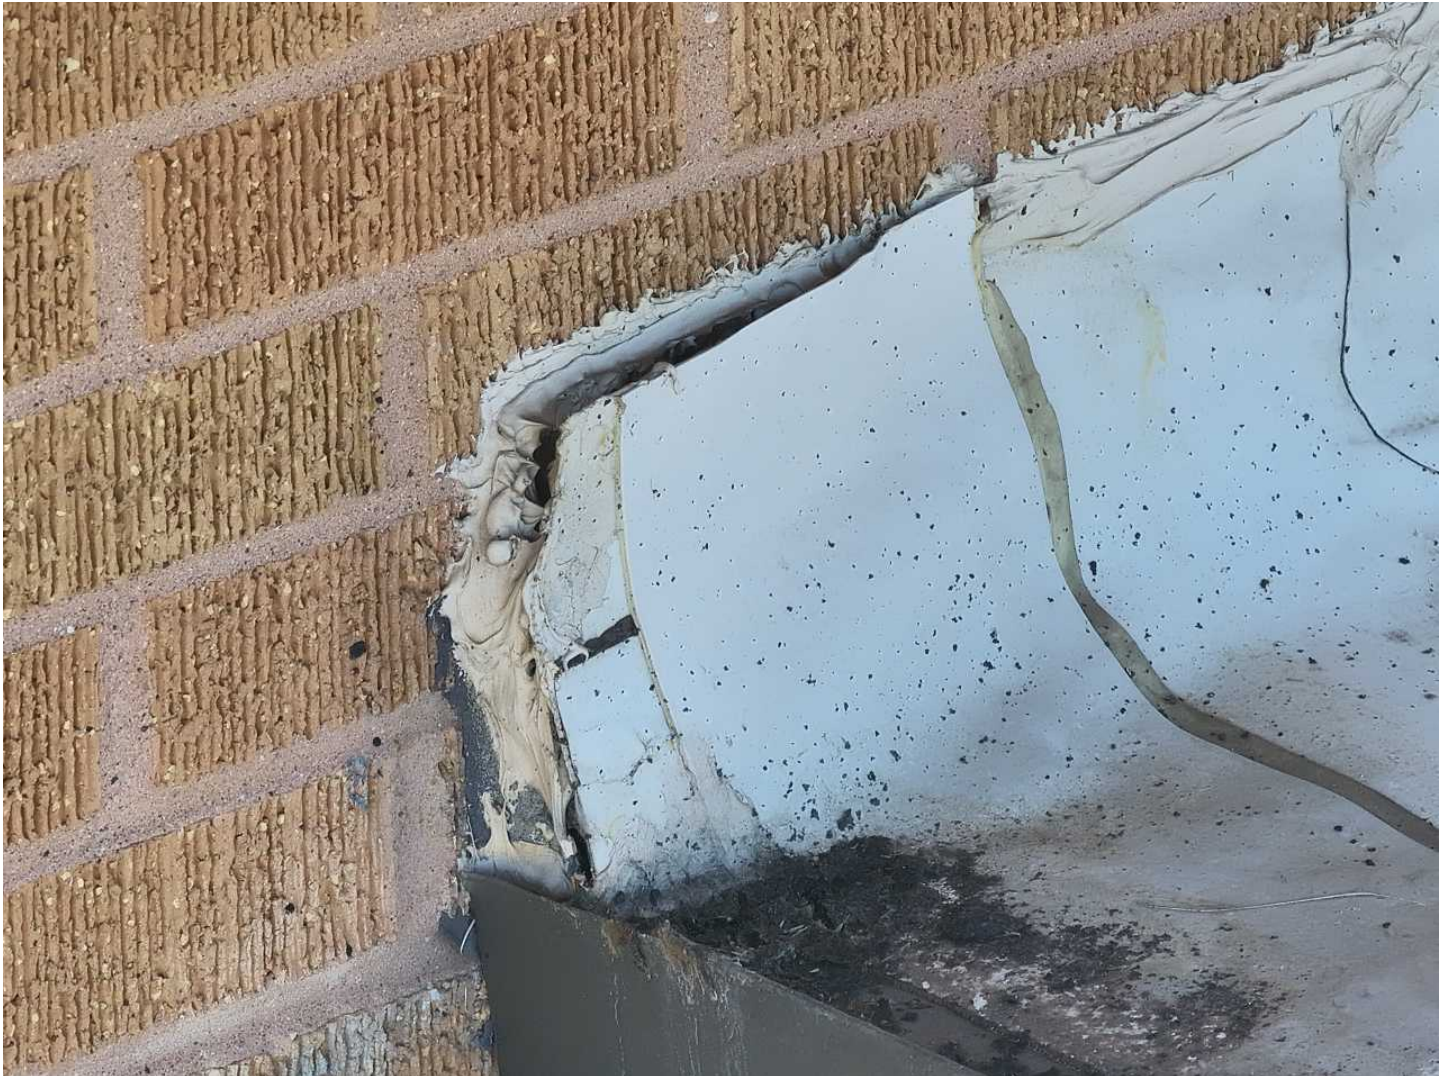
114 114-Failed Flashing Date Taken: 4/21/2025 Taken By: Angela Night
Inadequate craftsmanship and unorganized placement indicative of a poor repair job or uncertified contractor.

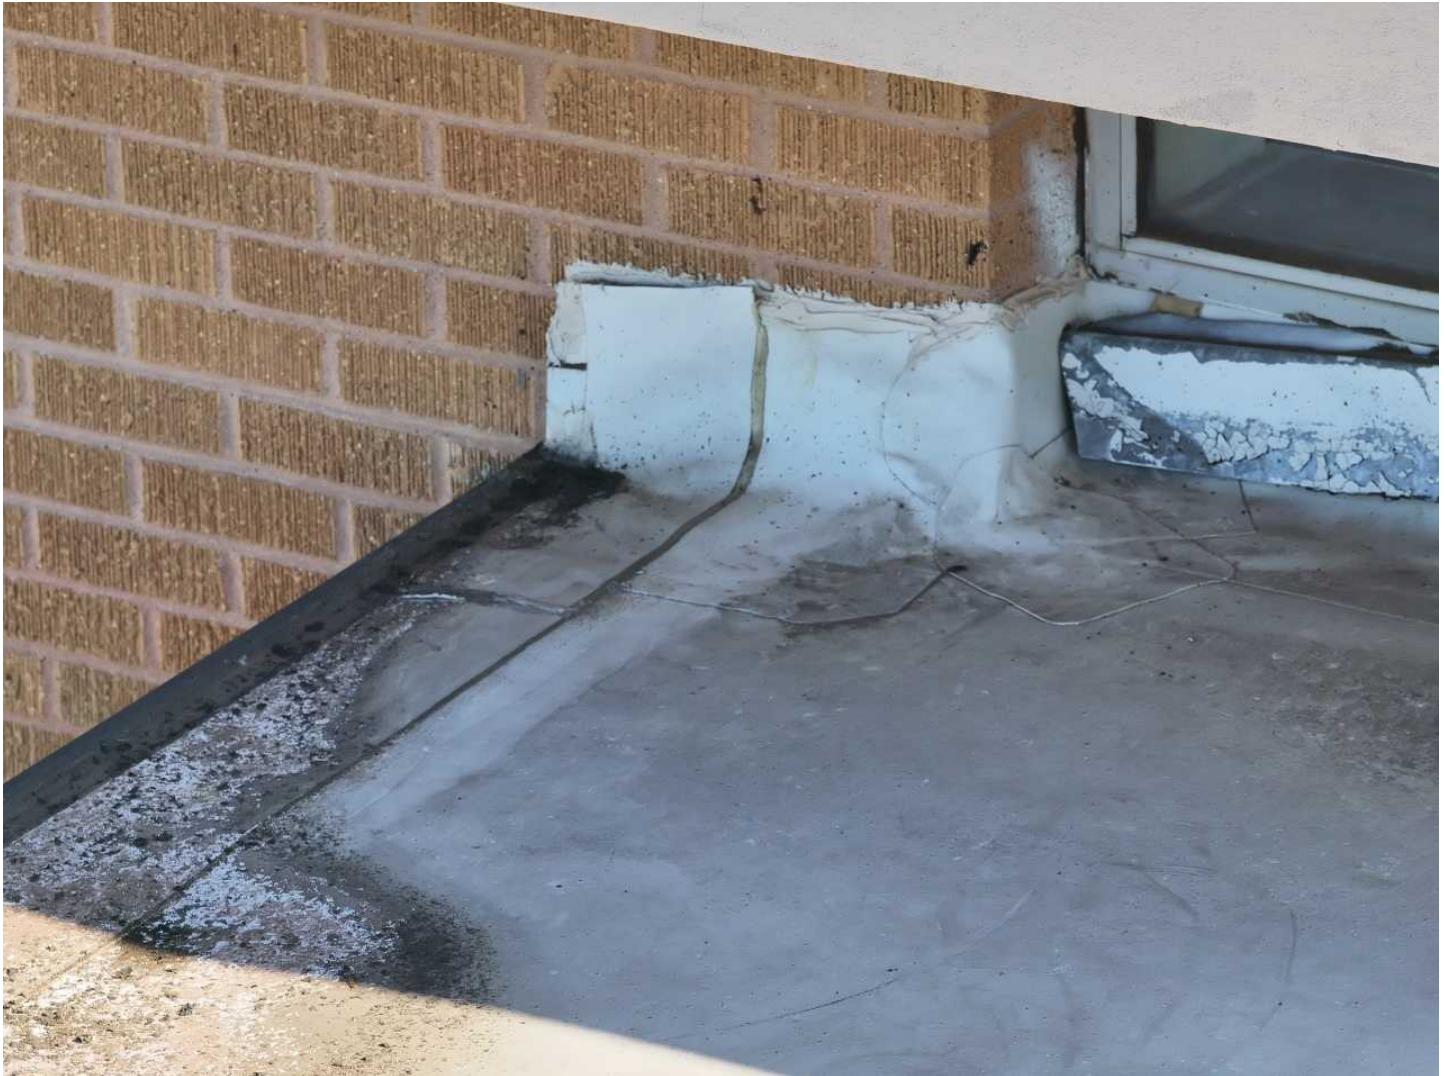
115 115-Failed Flashing Date Taken: 4/21/2025 Taken By: Angela Night
Inadequate craftsmanship and unorganized placement indicative of a poor repair job or uncertified contractor.
