DIV7|ROOF Company

Estimate: FOSTER_COLLEGE

The current roofing system is a TPO (Thermoplastic Polyolefin) that is mechanically attached (there are various areas across the mapping area that were found to be improperly installed). **A fully adhered system is highly recommended in comparison to a mechanically attached system to be applied a gravel ballast built-up roof. Fully adhered systems can reduce the number of seams needed, decreasing potential leak points.**

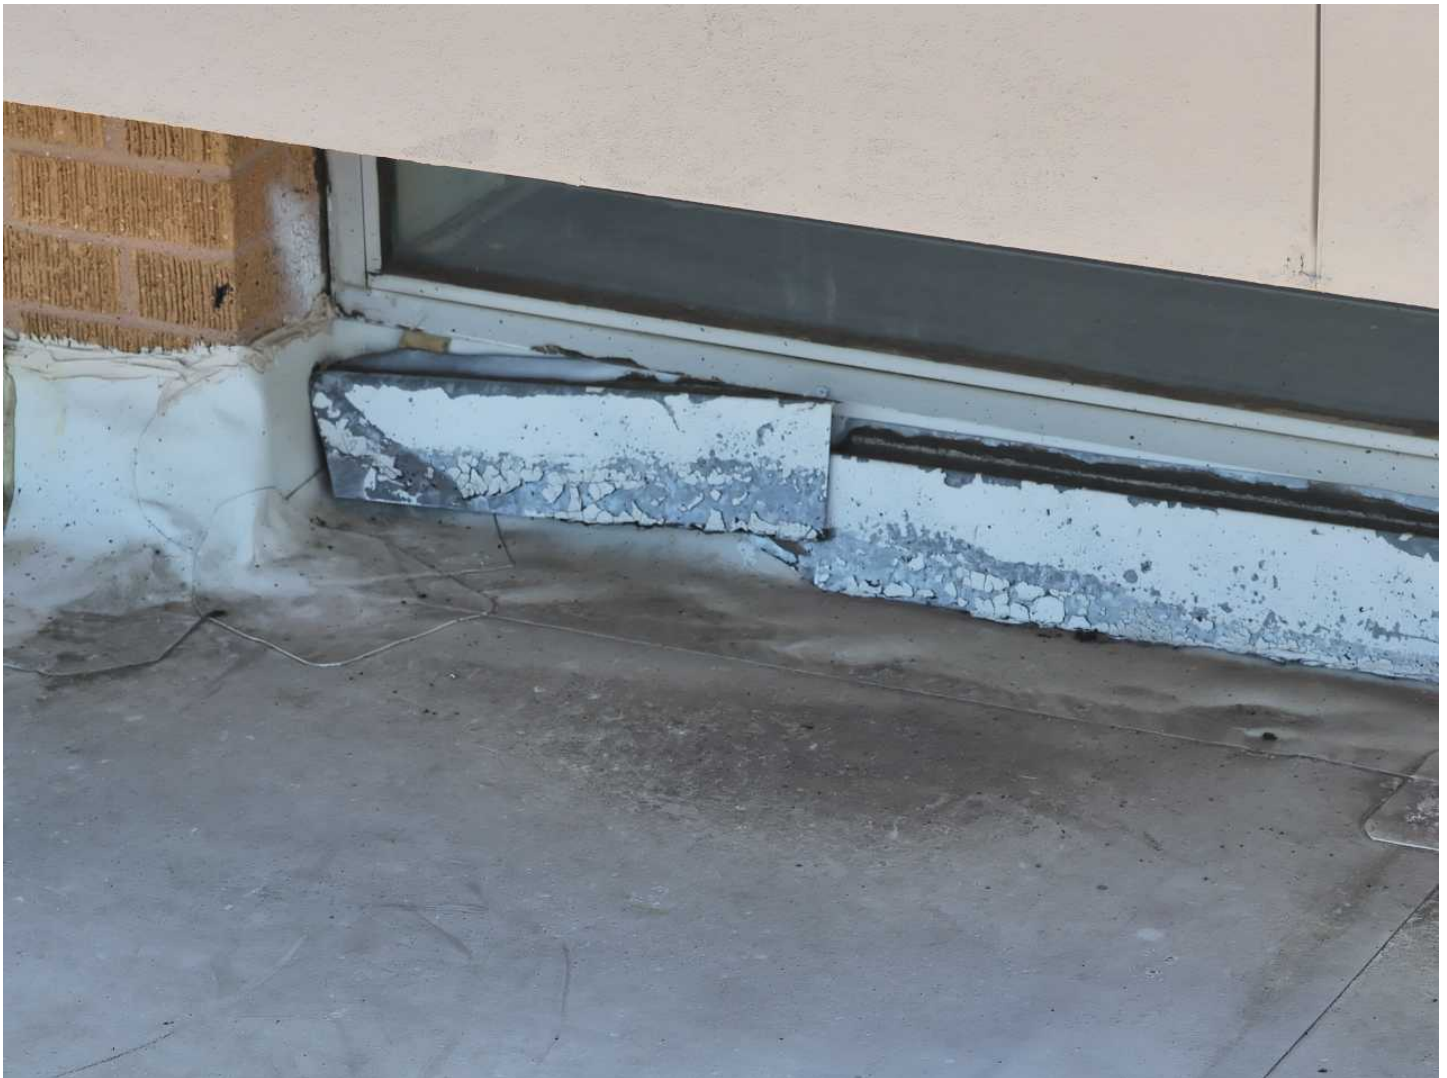
119 119-Failed Flashing Date Taken: 4/21/2025 Taken By: Angela Night
Inadequate craftsmanship and unorganized placement indicative of a poor repair job or uncertified contractor.

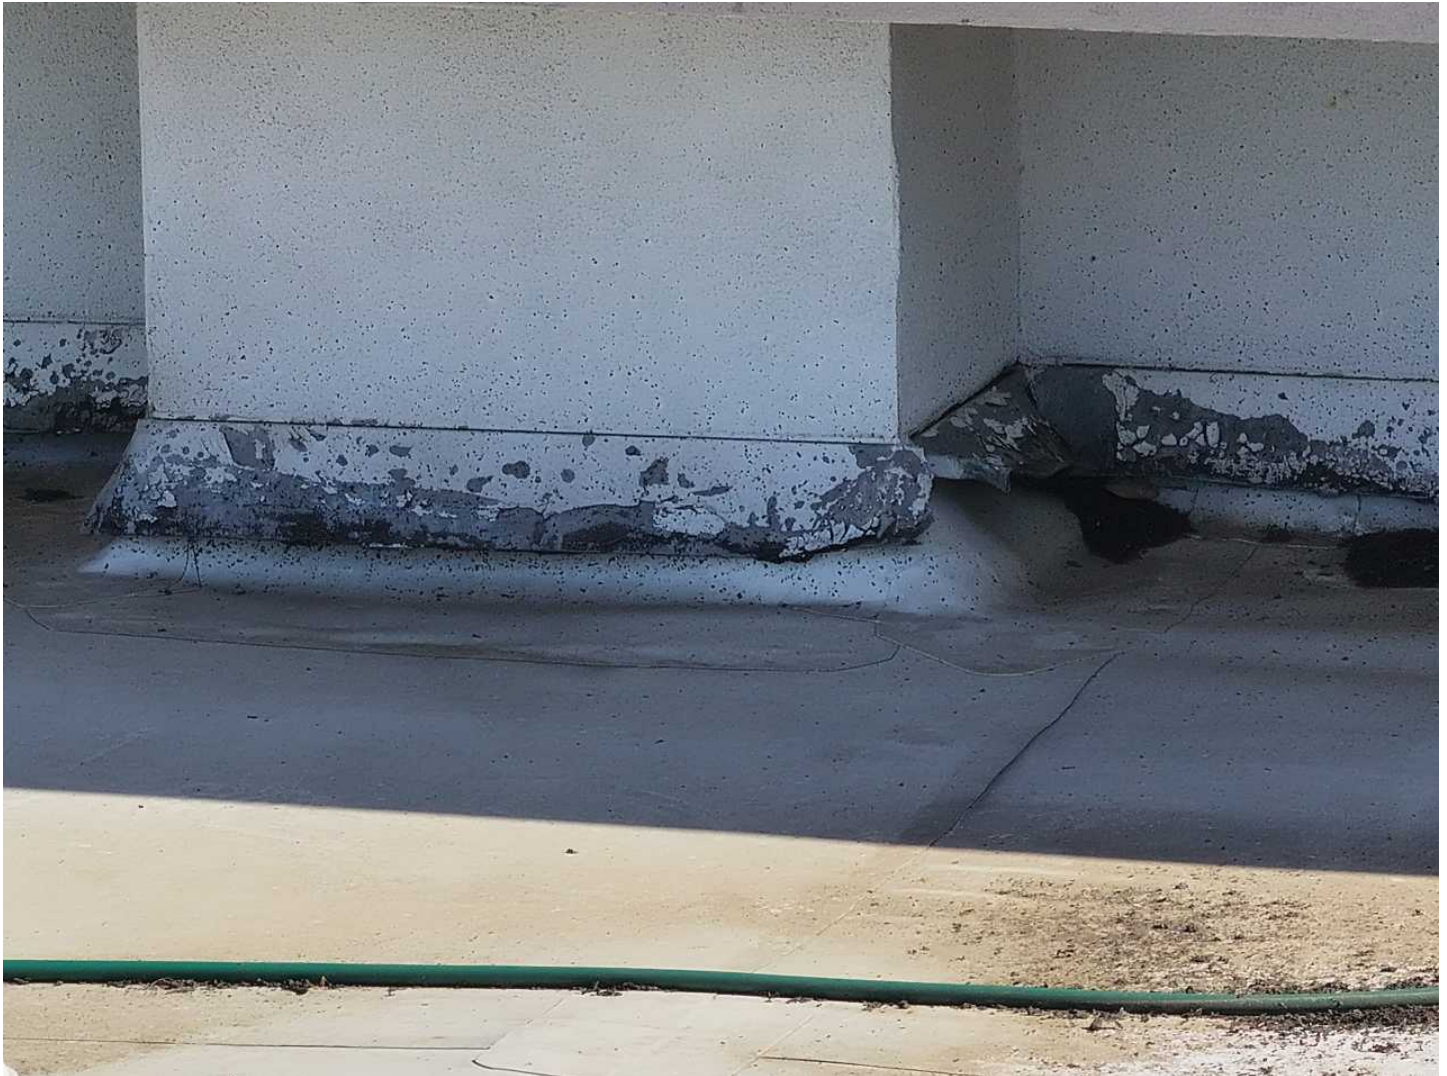
120 120-Failed Flashing Date Taken: 4/21/2025 Taken By: Angela Night
Inadequate craftsmanship and unorganized placement indicative of a poor repair job or uncertified contractor.

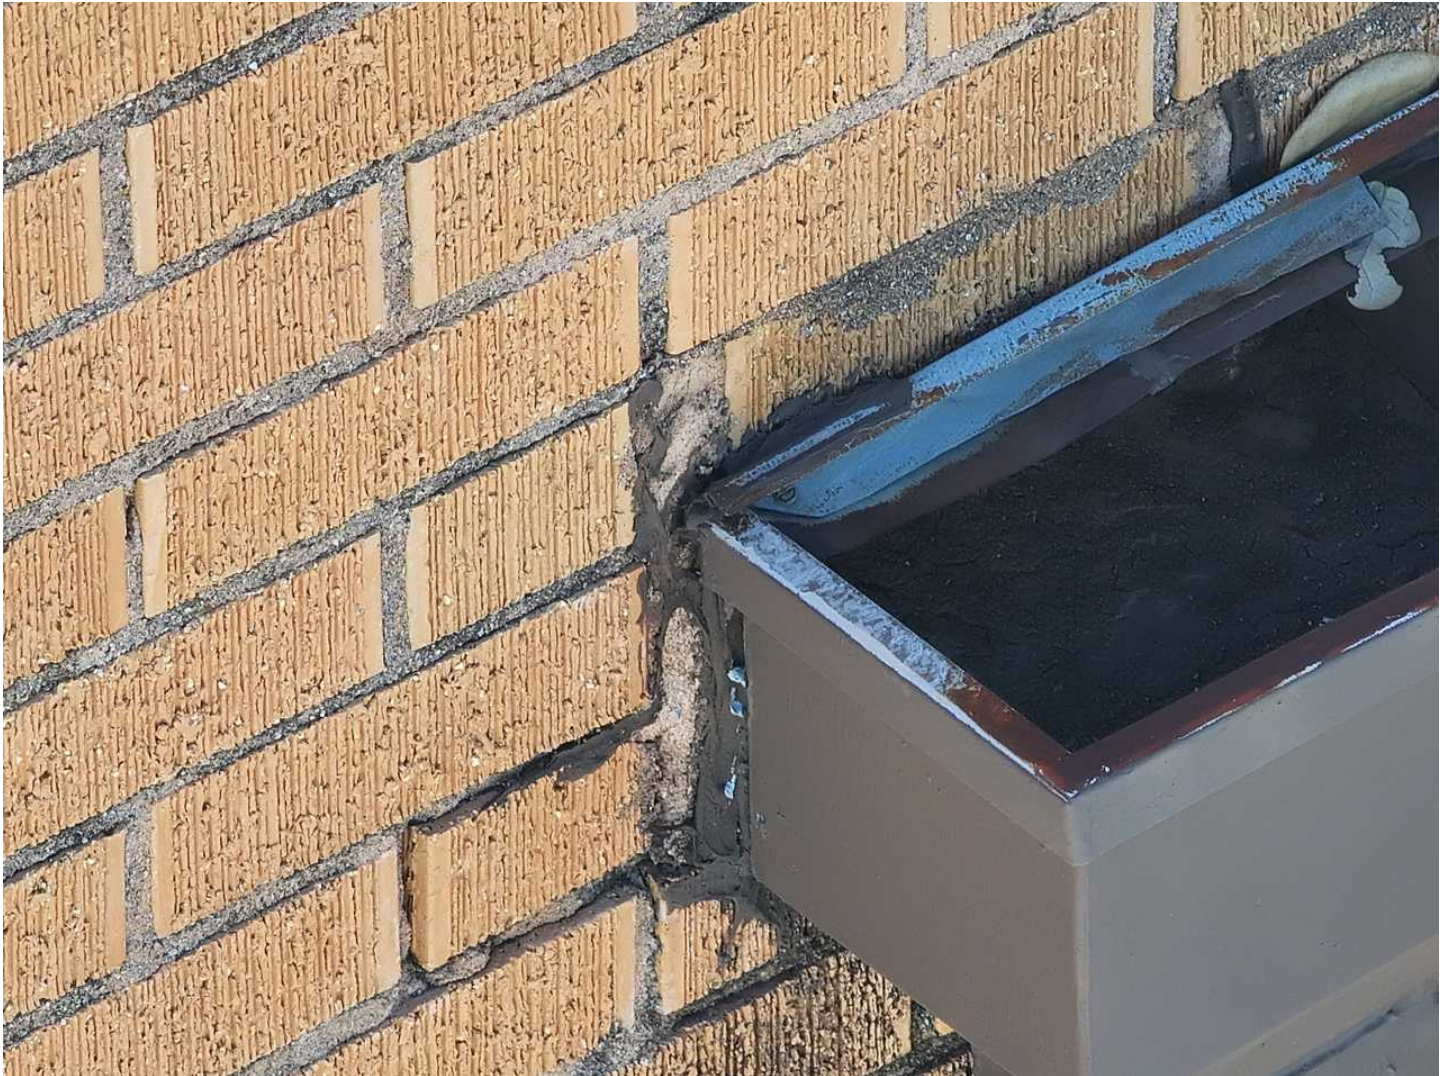
121 121-Failed Flashing Date Taken: 4/21/2025 Taken By: Angela Night
Inadequate craftsmanship and unorganized placement indicative of a poor repair job or uncertified contractor.
