DIV7|ROOF Company

Estimate: FOSTER_COLLEGE

The current roofing system is a TPO (Thermoplastic Polyolefin) that is mechanically attached (there are various areas across the mapping area that were found to be improperly installed). **A fully adhered system is highly recommended in comparison to a mechanically attached system to be applied a gravel ballast built-up roof. Fully adhered systems can reduce the number of seams needed, decreasing potential leak points.**

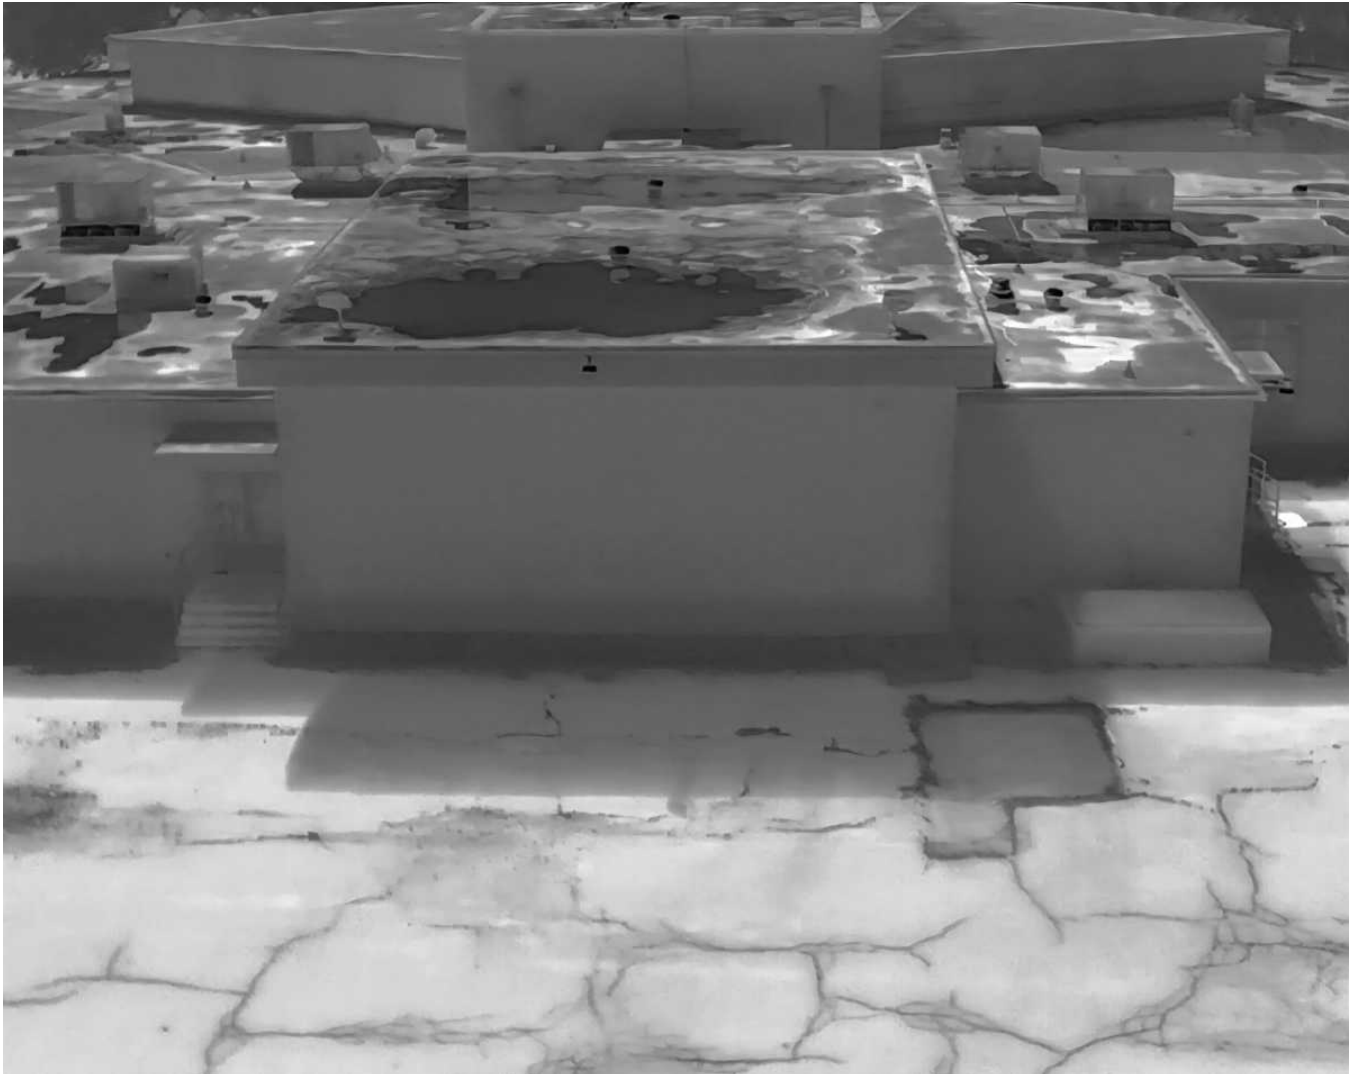
3 3-Ponding Date Taken: 4/21/2025 Taken By: Angela Night
IR photos were taken in this instance to reflect the ponding of water due to leveling issues.

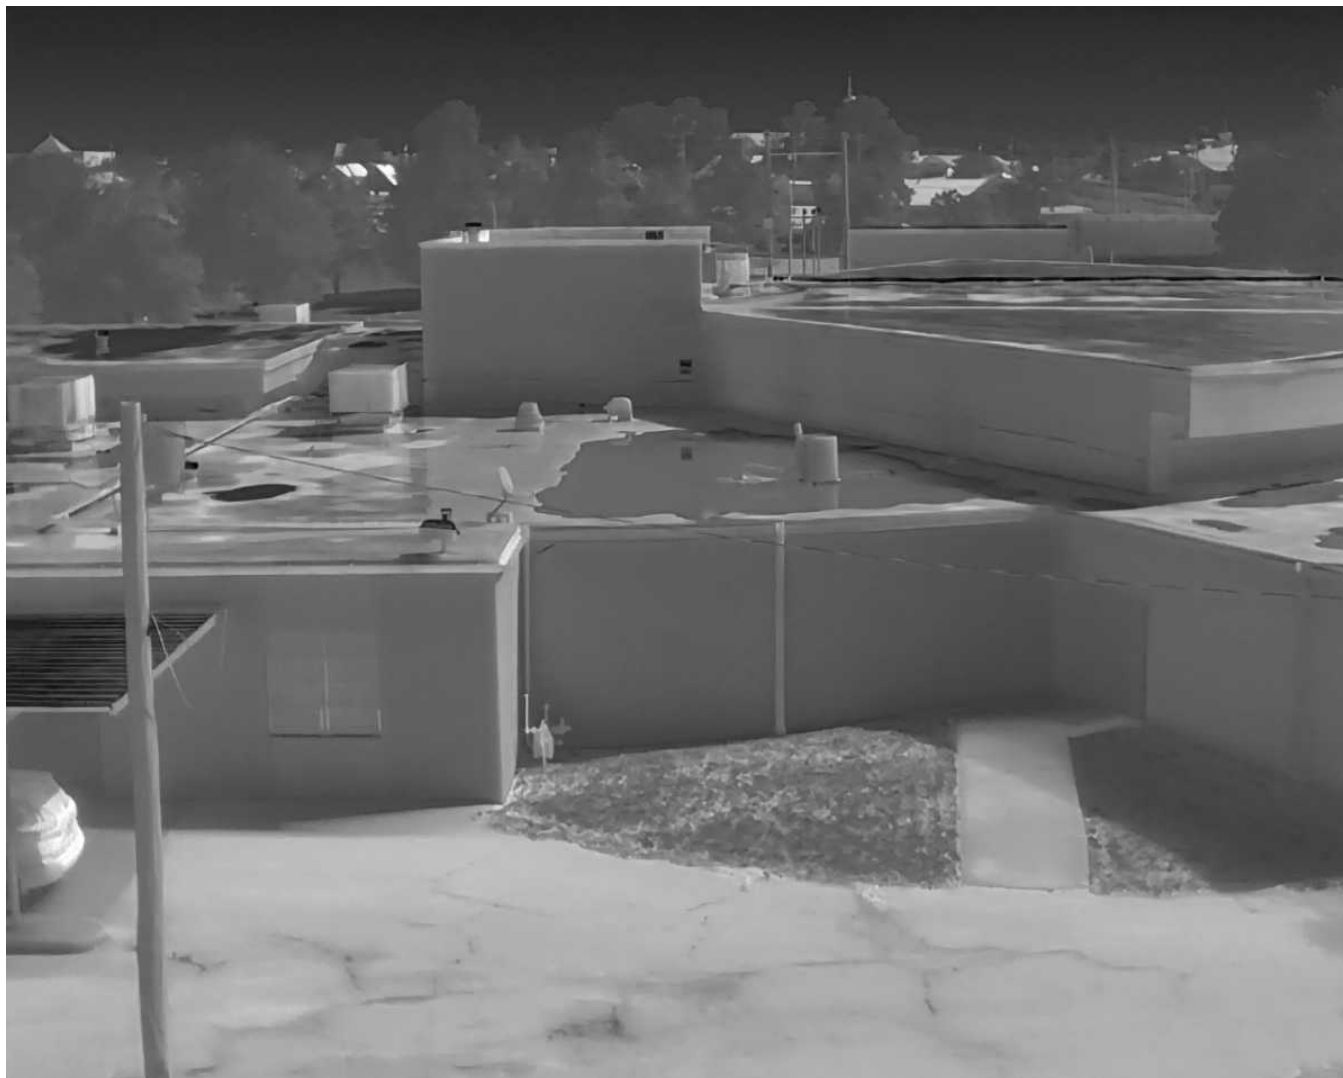
5 5-Ponding Date Taken: 4/21/2025 Taken By: Angela Night
IR photos were taken in this instance to reflect the ponding of water due to leveling issues.

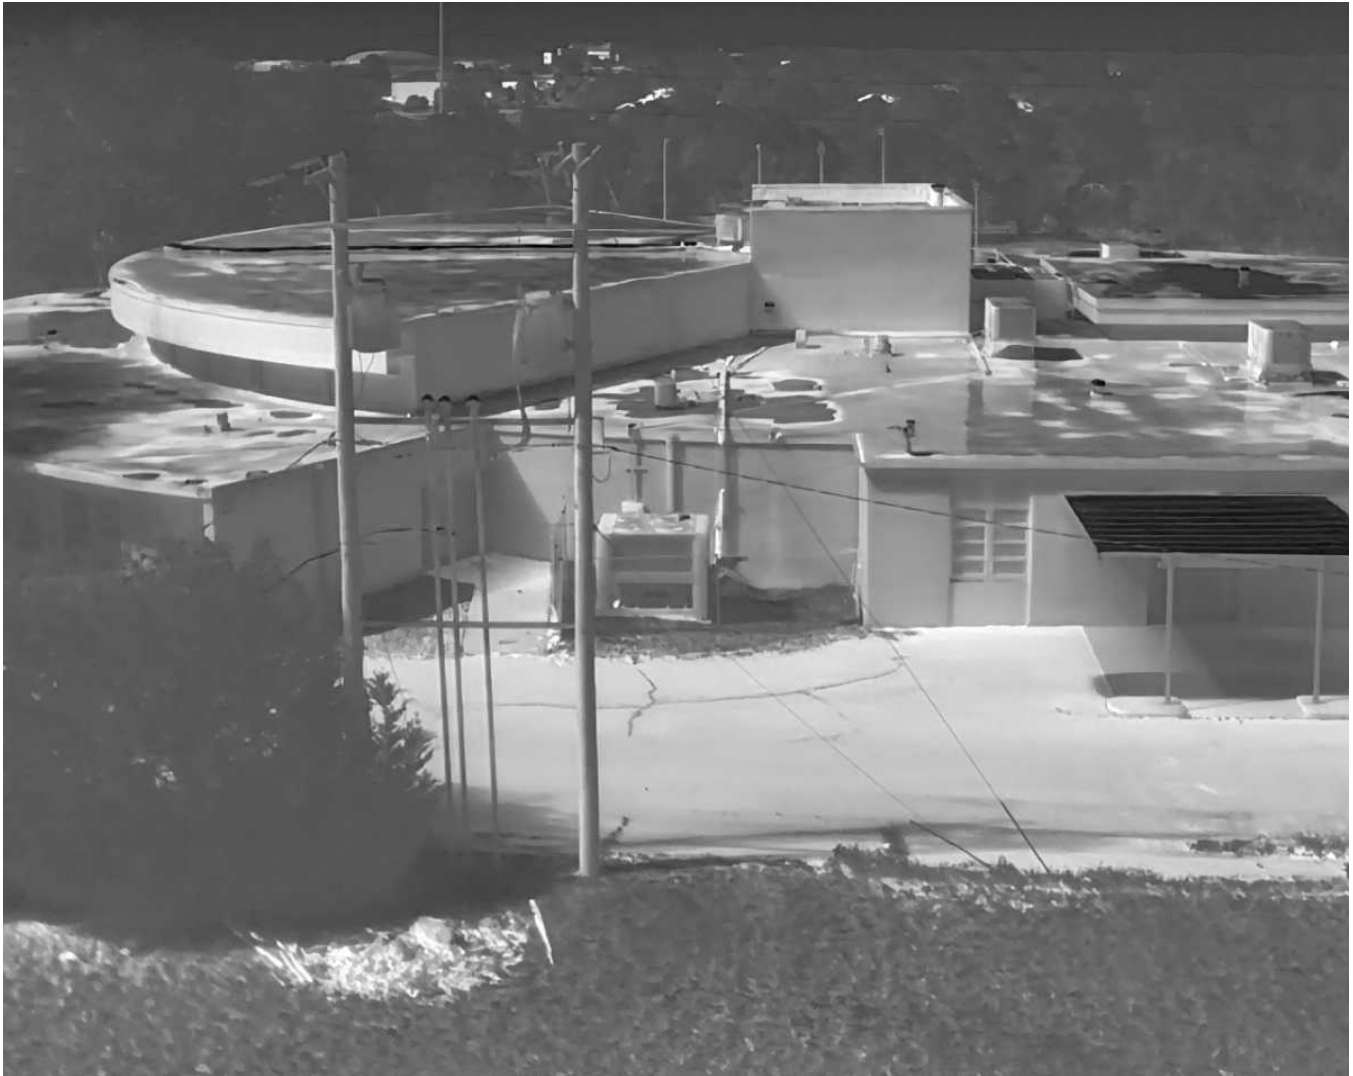
6 6-Ponding Date Taken: 4/21/2025 Taken By: Angela Night
IR photos were taken in this instance to reflect the ponding of water due to leveling issues.

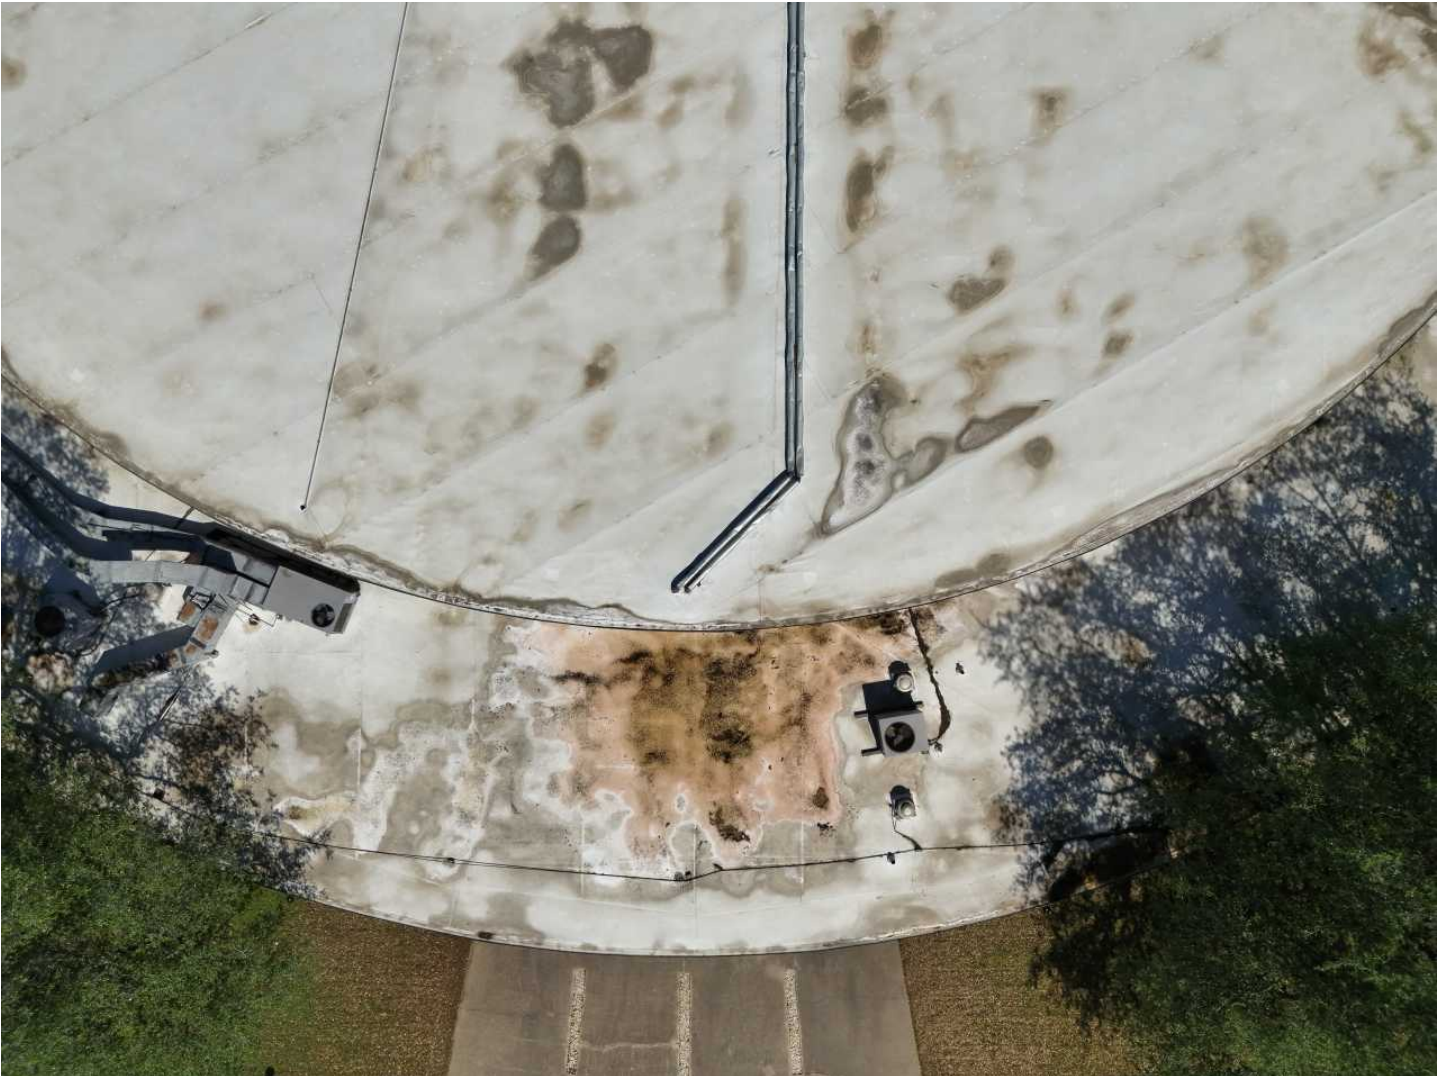
7 7-Boiling Temperatures Date Taken: 4/21/2025 Taken By: Angela Night

Ponding water creates dark areas on the roof surface. These dark areas absorb more sunlight than a white roof, leading to a significant temperature increase.

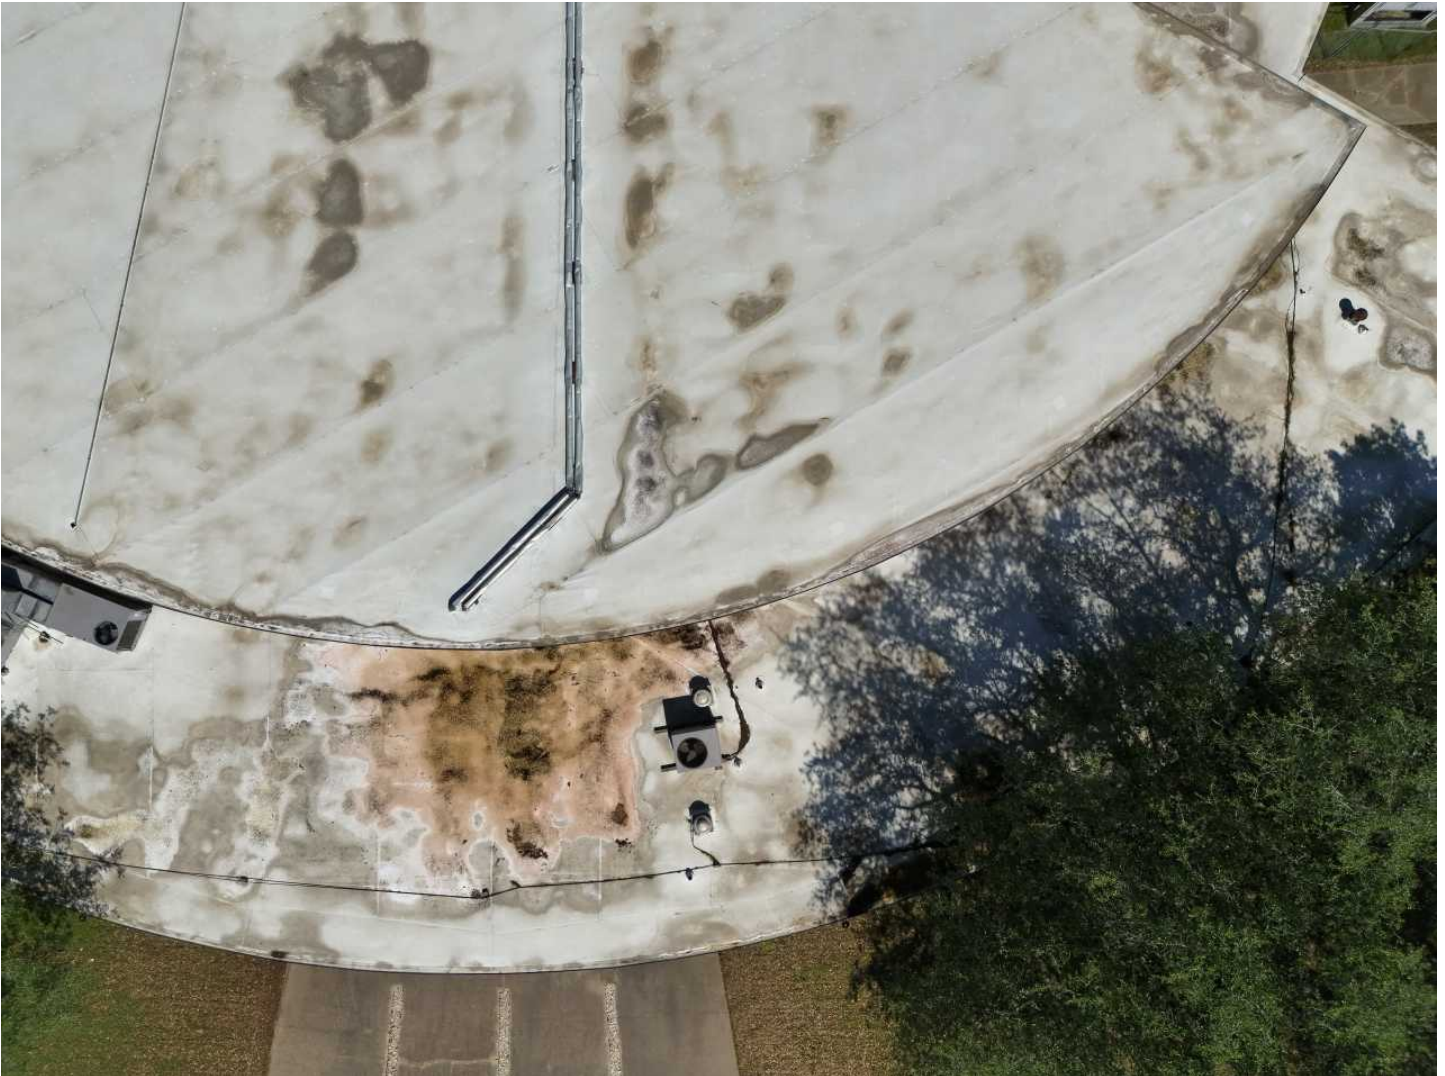
8 8-Boiling Temperatures Date Taken: 4/21/2025 Taken By: Angela Night

Ponding water creates dark areas on the roof surface. These dark areas absorb more sunlight than a white roof, leading to a significant temperature increase.

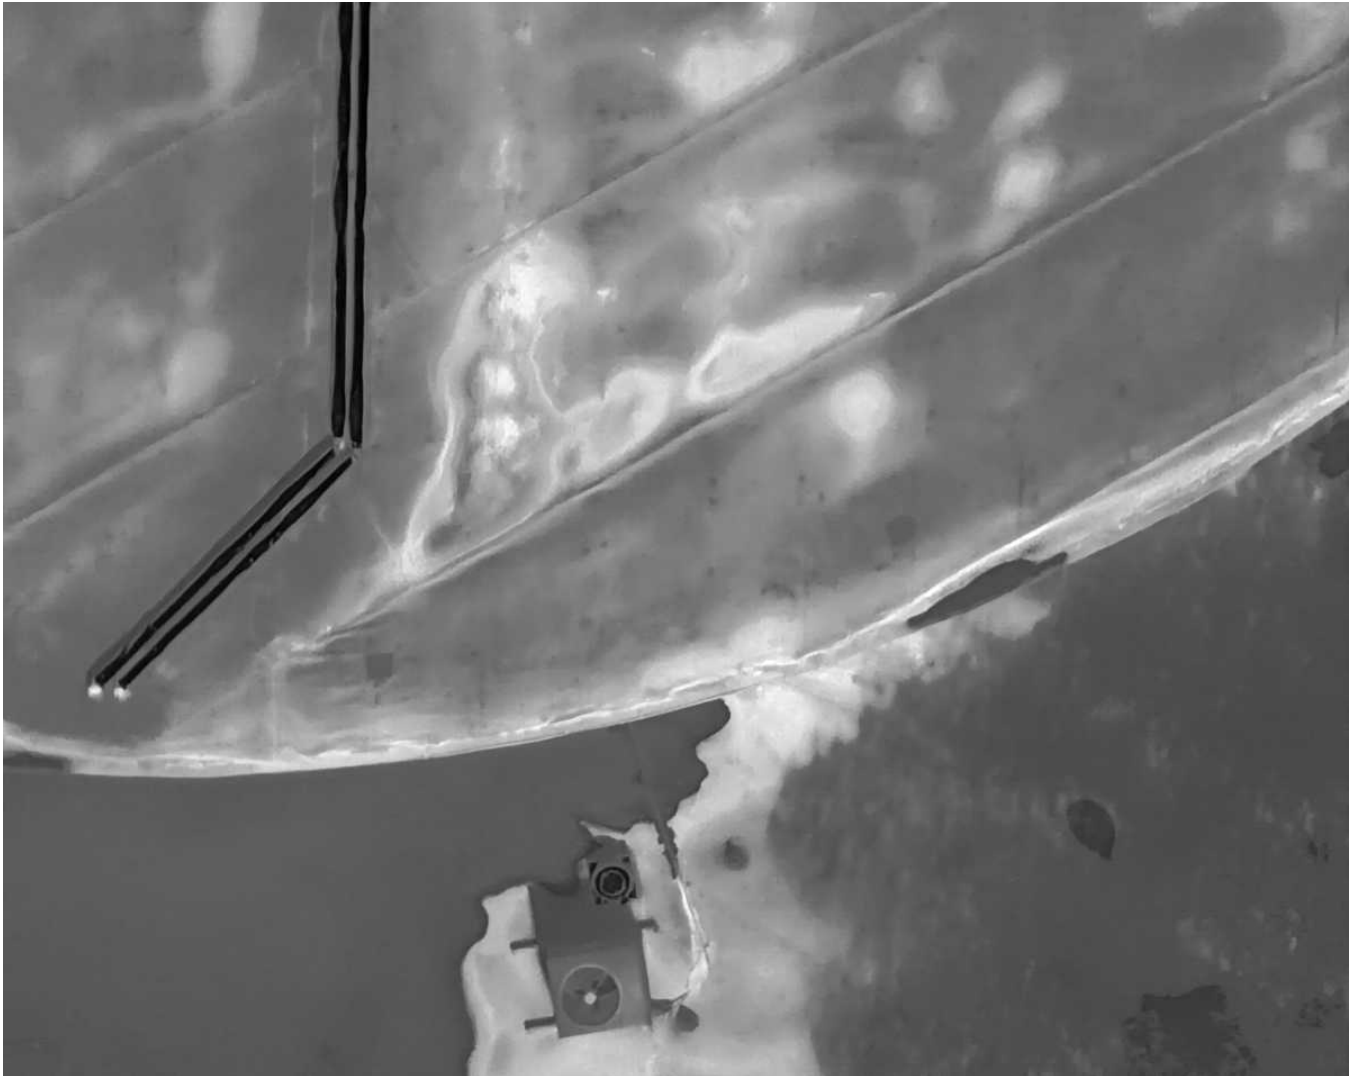
9

9-UV Degredation

While white TPO membranes are designed to reflect UV radiation, ponding water can concentrate the sun's rays, increasing UV damage to the membrane

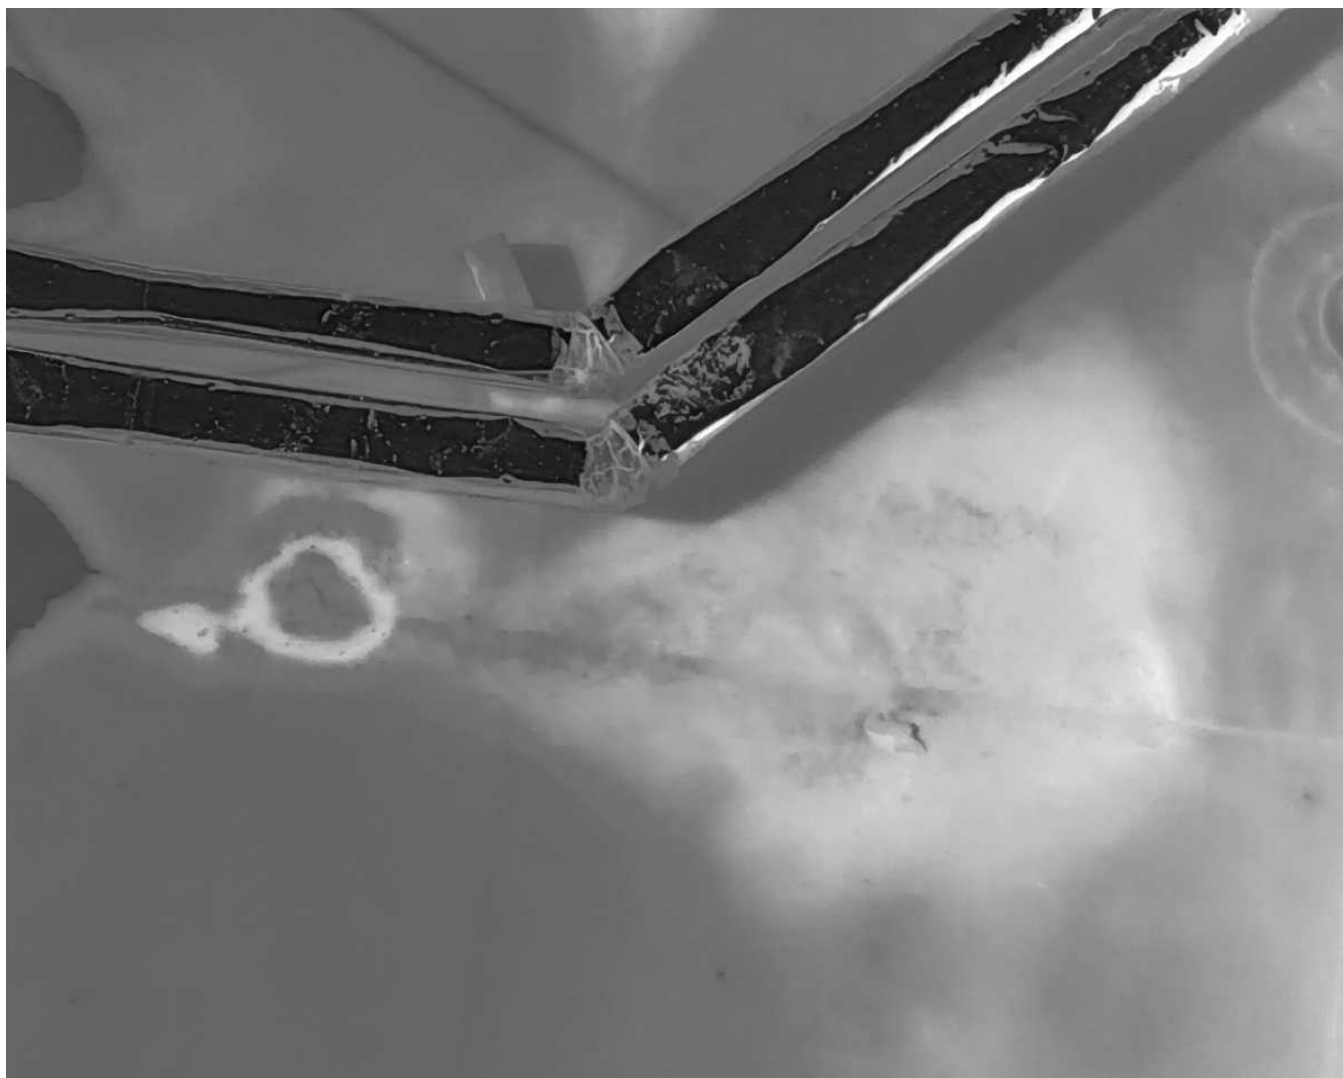
12 12-UV Degredation Date Taken: 4/21/2025 Taken By: Angela Night

While white TPO membranes are designed to reflect UV radiation, ponding water can concentrate the sun's rays, increasing UV damage to the membrane

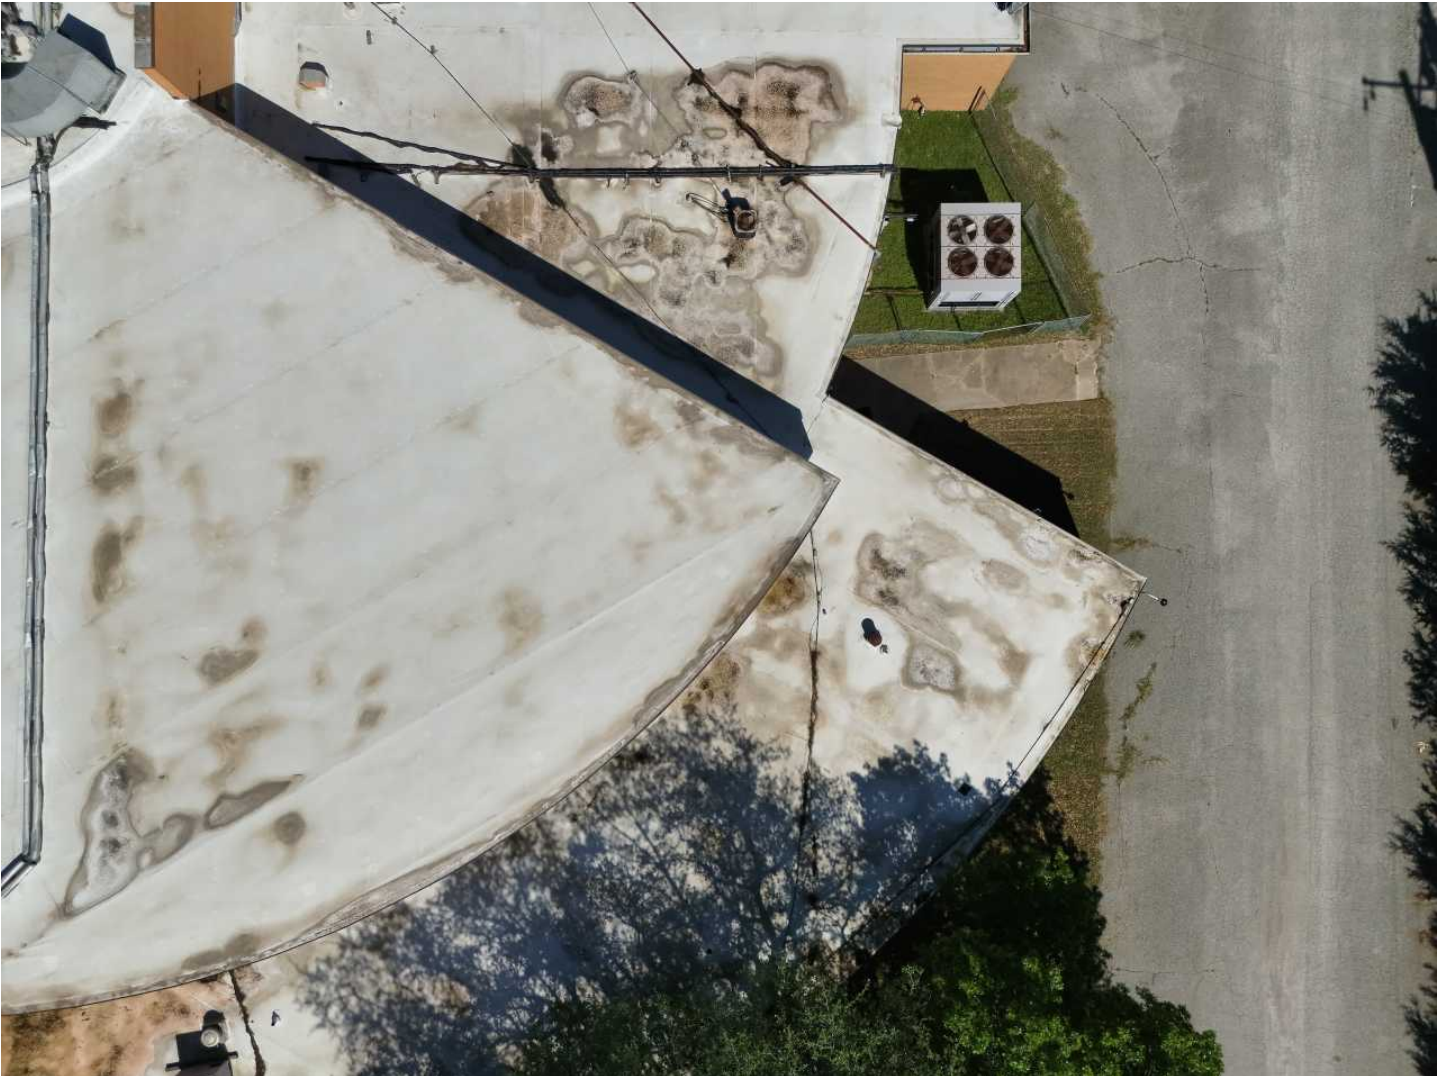
13 13-Boiling Temperatures Date Taken: 4/21/2025 Taken By: Angela Night

Ponding water creates dark areas on the roof surface. These dark areas absorb more sunlight than a white roof, leading to a significant temperature increase.

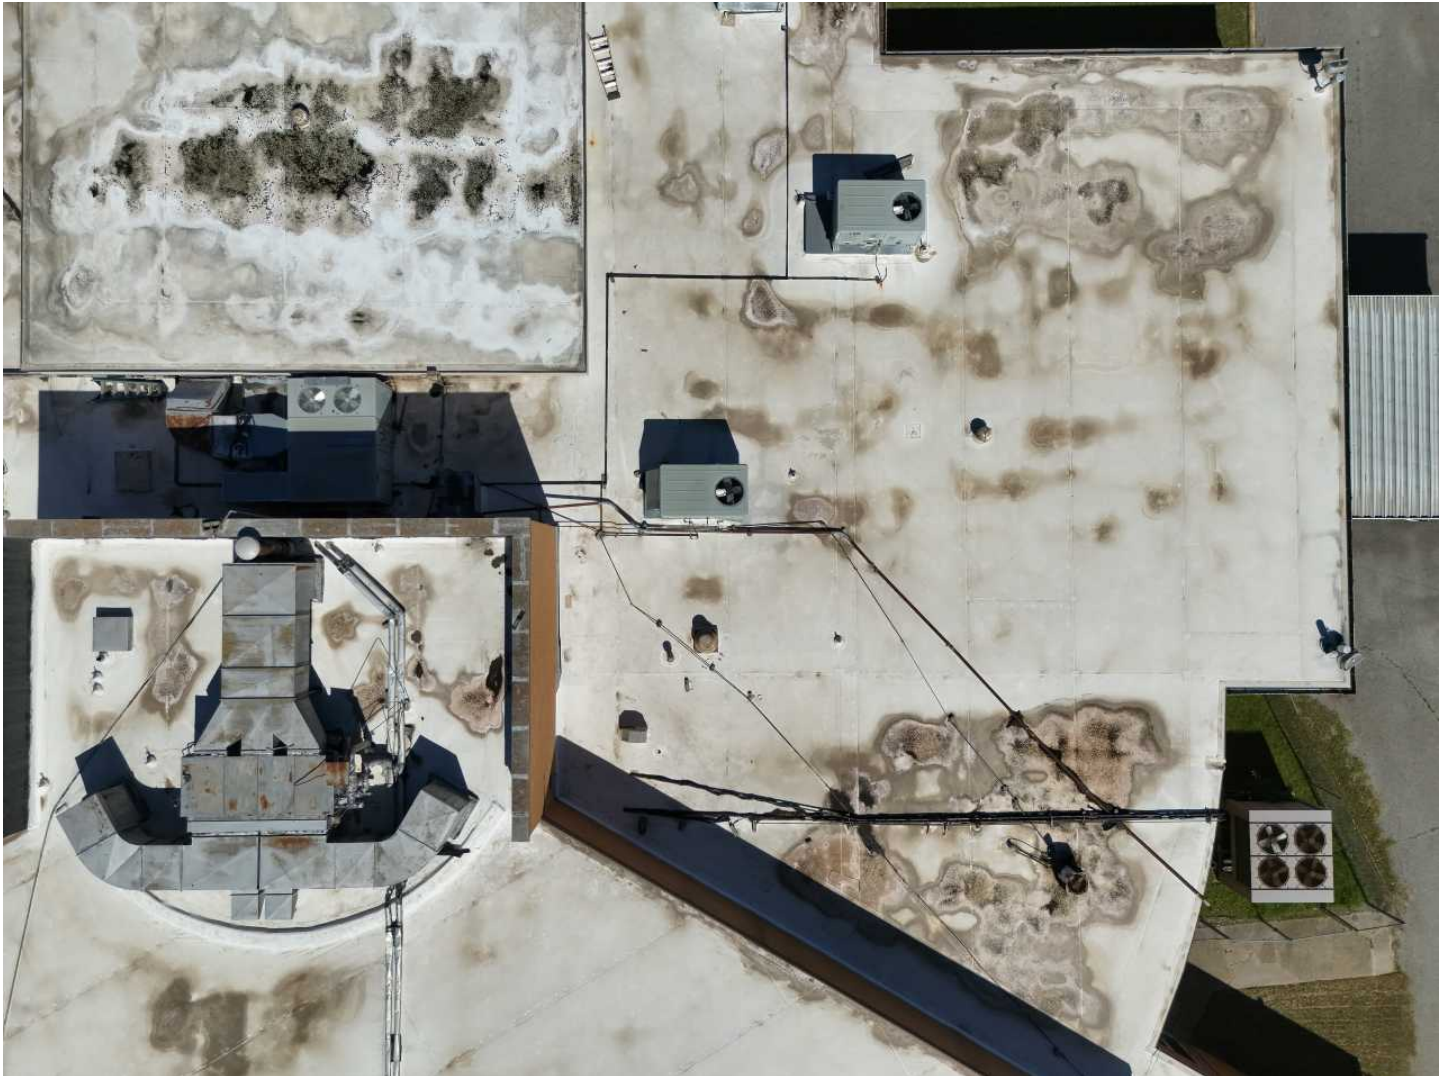
14 14-Boiling Temperatures Date Taken: 4/21/2025 Taken By: Angela Night

Ponding water creates dark areas on the roof surface. These dark areas absorb more sunlight than a white roof, leading to a significant temperature increase.

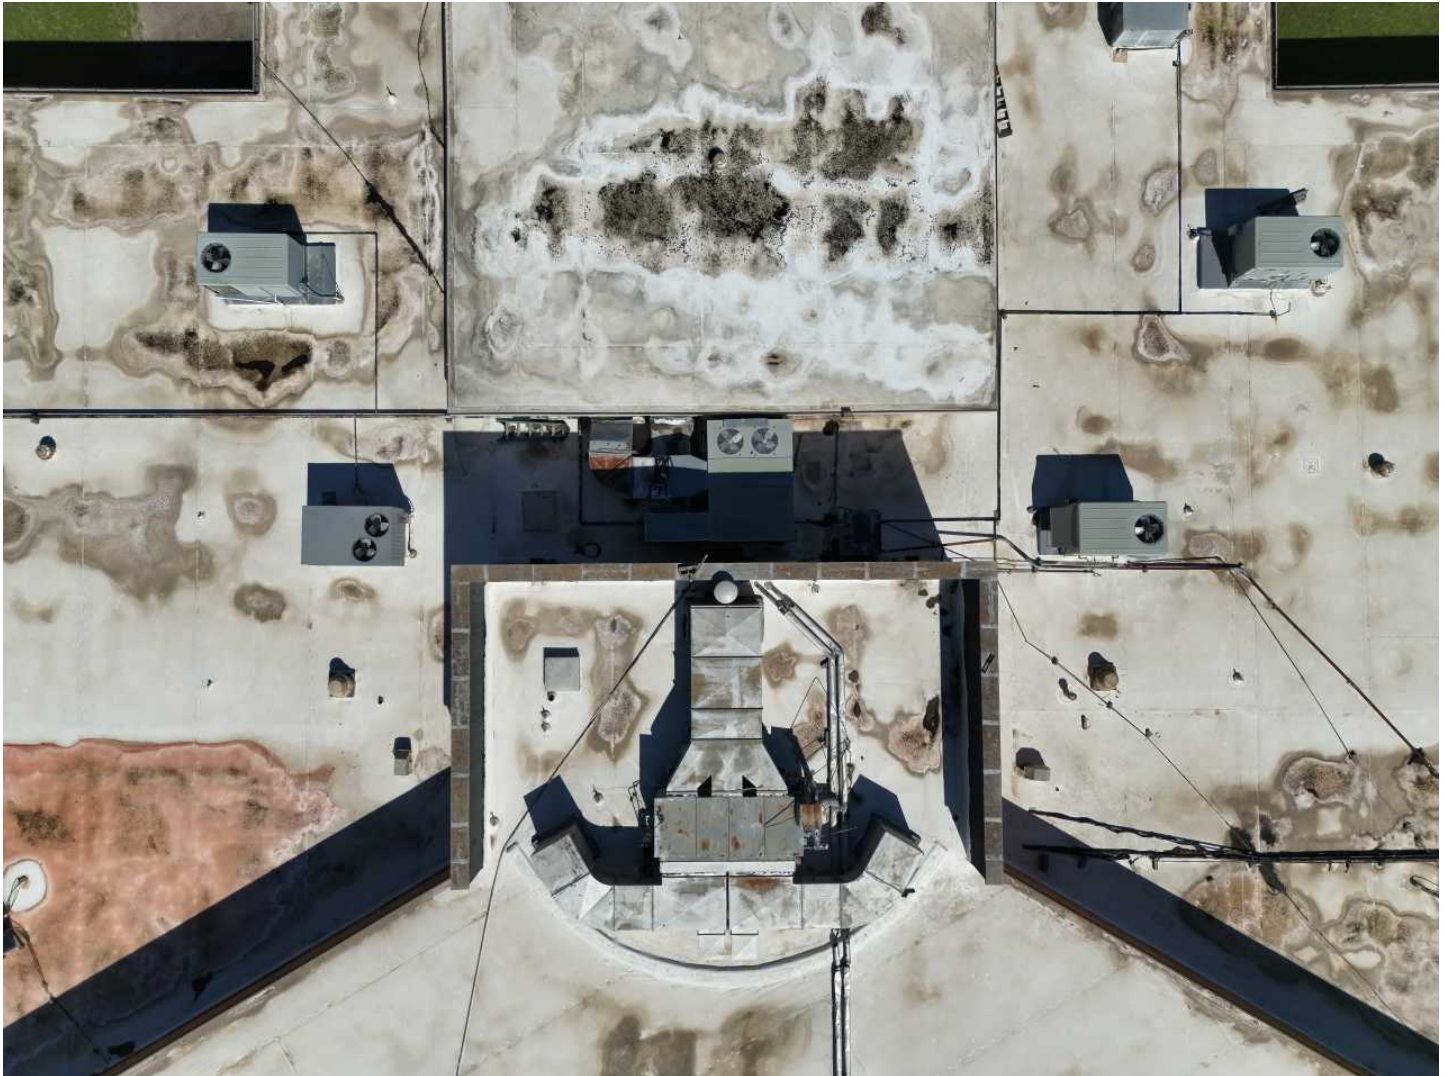
15 15-Boiling Temperatures

Ponding water creates dark areas on the roof surface. These dark areas absorb more sunlight than a white roof, leading to a significant temperature increase.

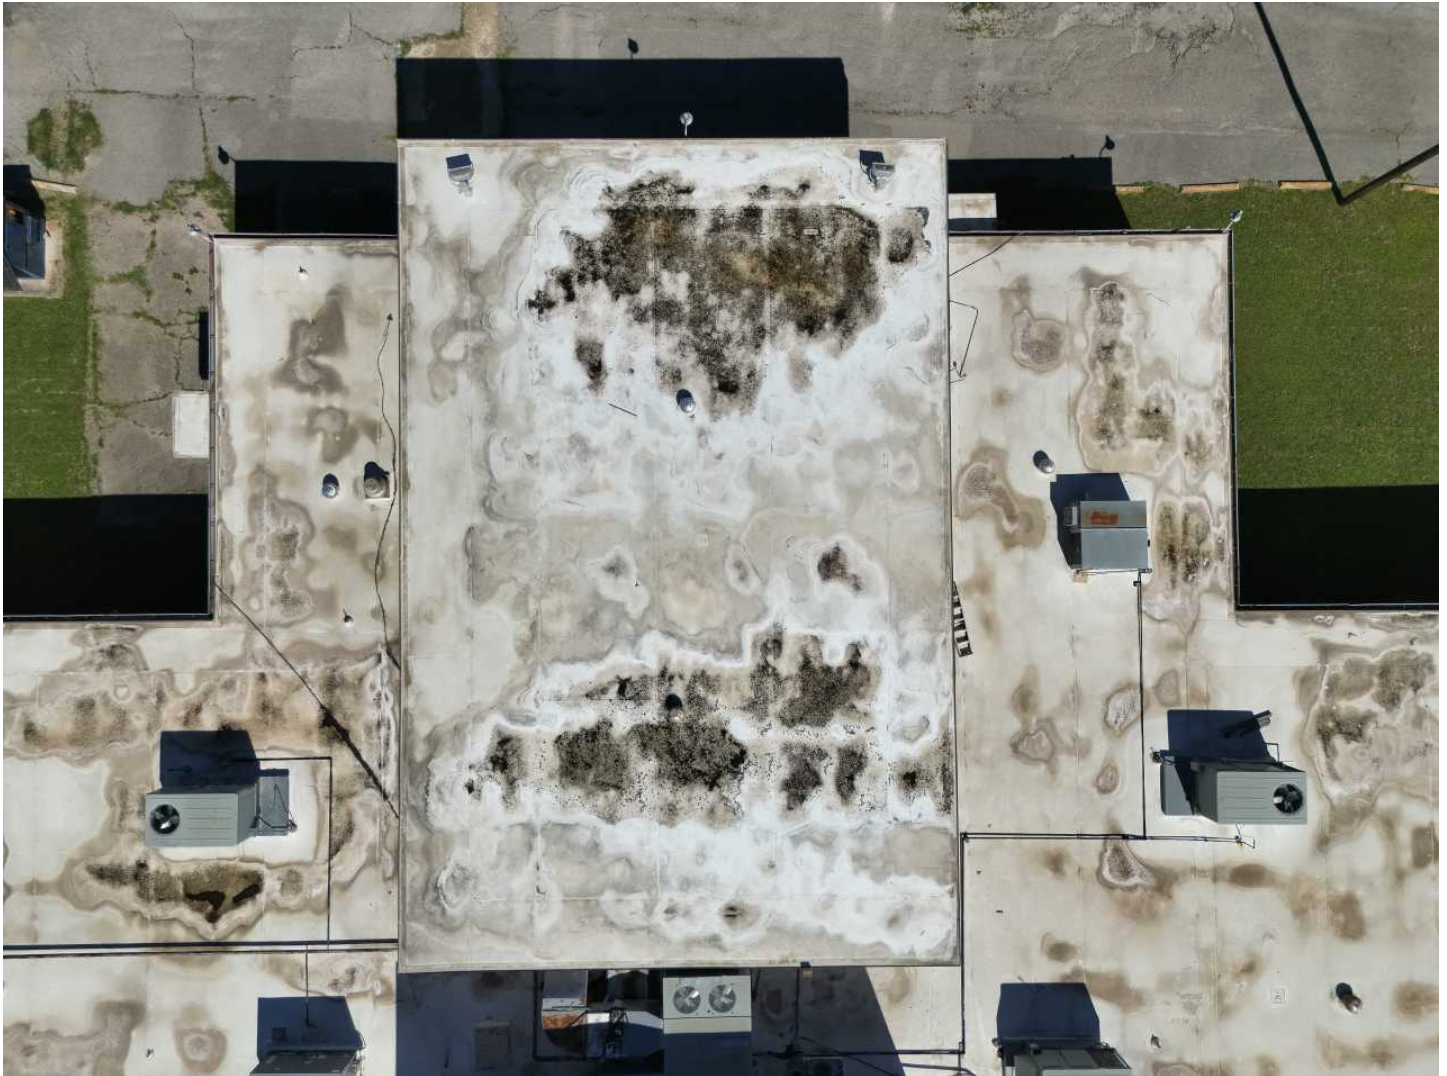
16 16-Boiling Temperatures

Ponding water creates dark areas on the roof surface. These dark areas absorb more sunlight than a white roof, leading to a significant temperature increase.

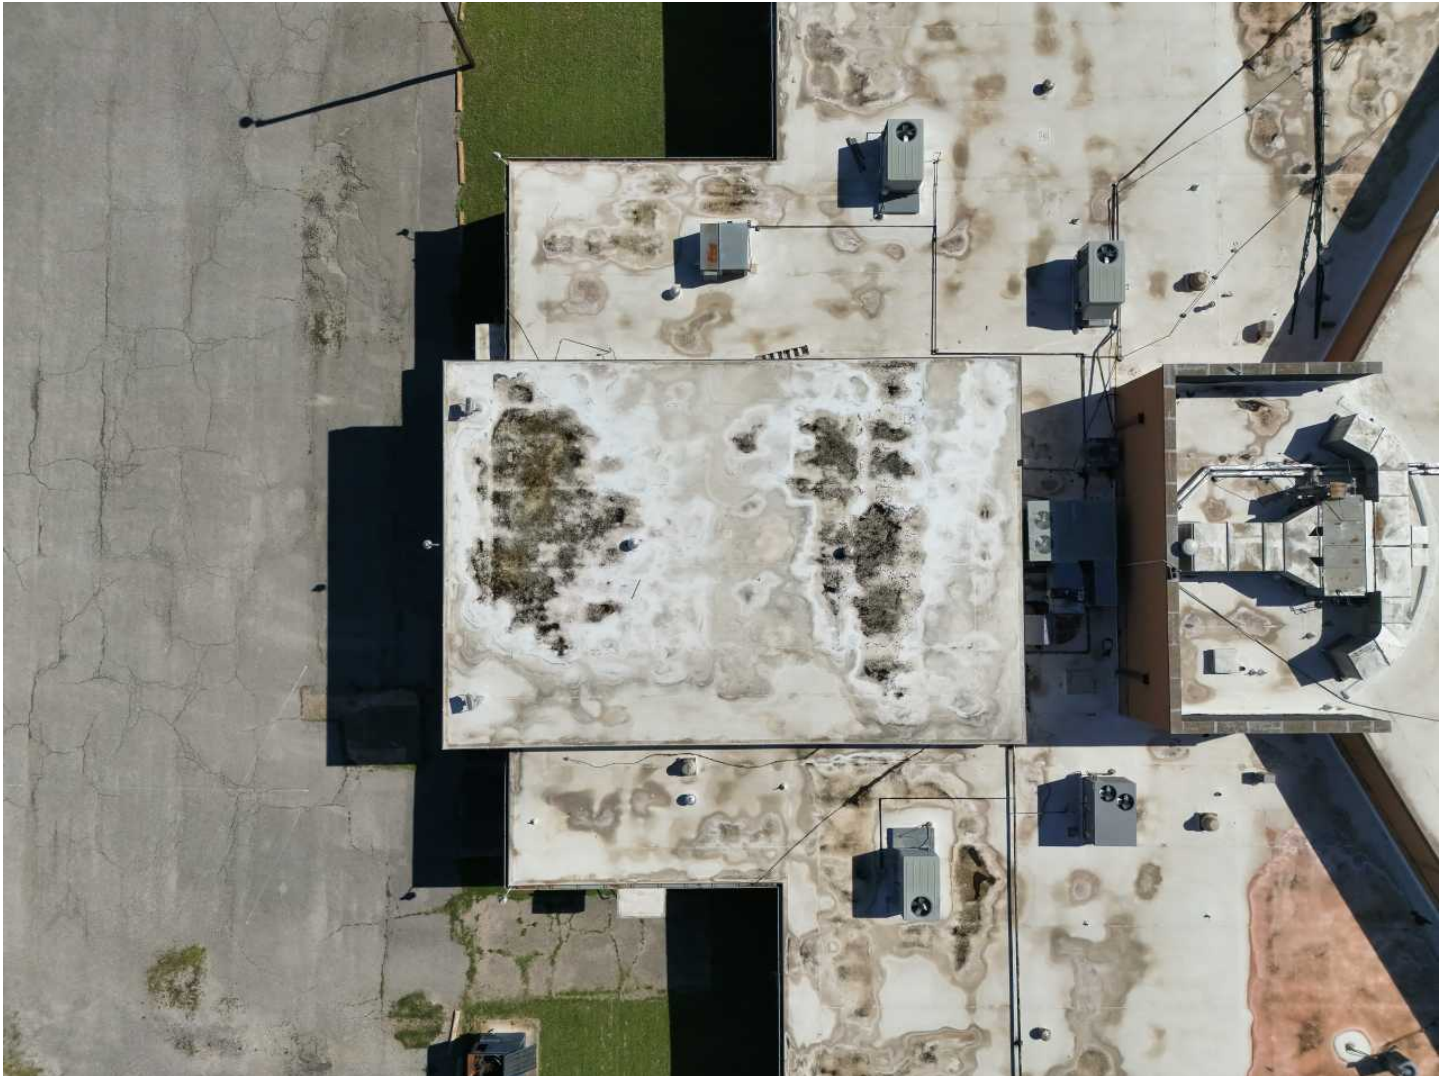
17 17-Boiling Temperatures Date Taken: 4/21/2025 Taken By: Angela Night

Ponding water creates dark areas on the roof surface. These dark areas absorb more sunlight than a white roof, leading to a significant temperature increase.

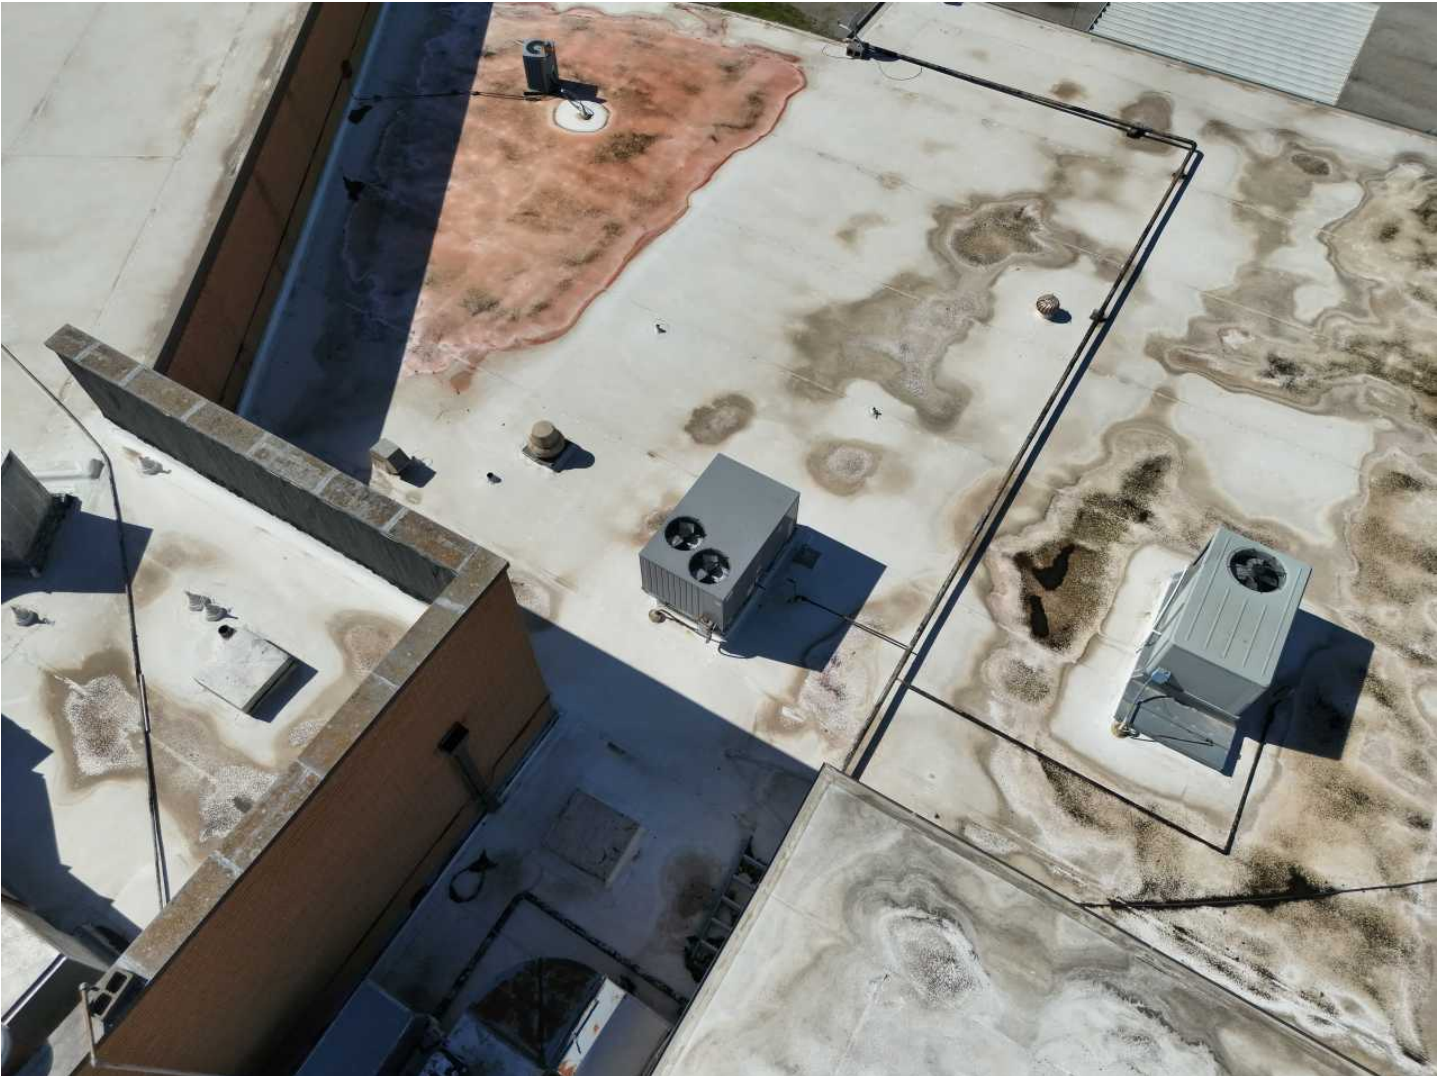
18 18-Boiling Temperatures Date Taken: 4/21/2025 Taken By: Angela Night

Ponding water creates dark areas on the roof surface. These dark areas absorb more sunlight than a white roof, leading to a significant temperature increase.

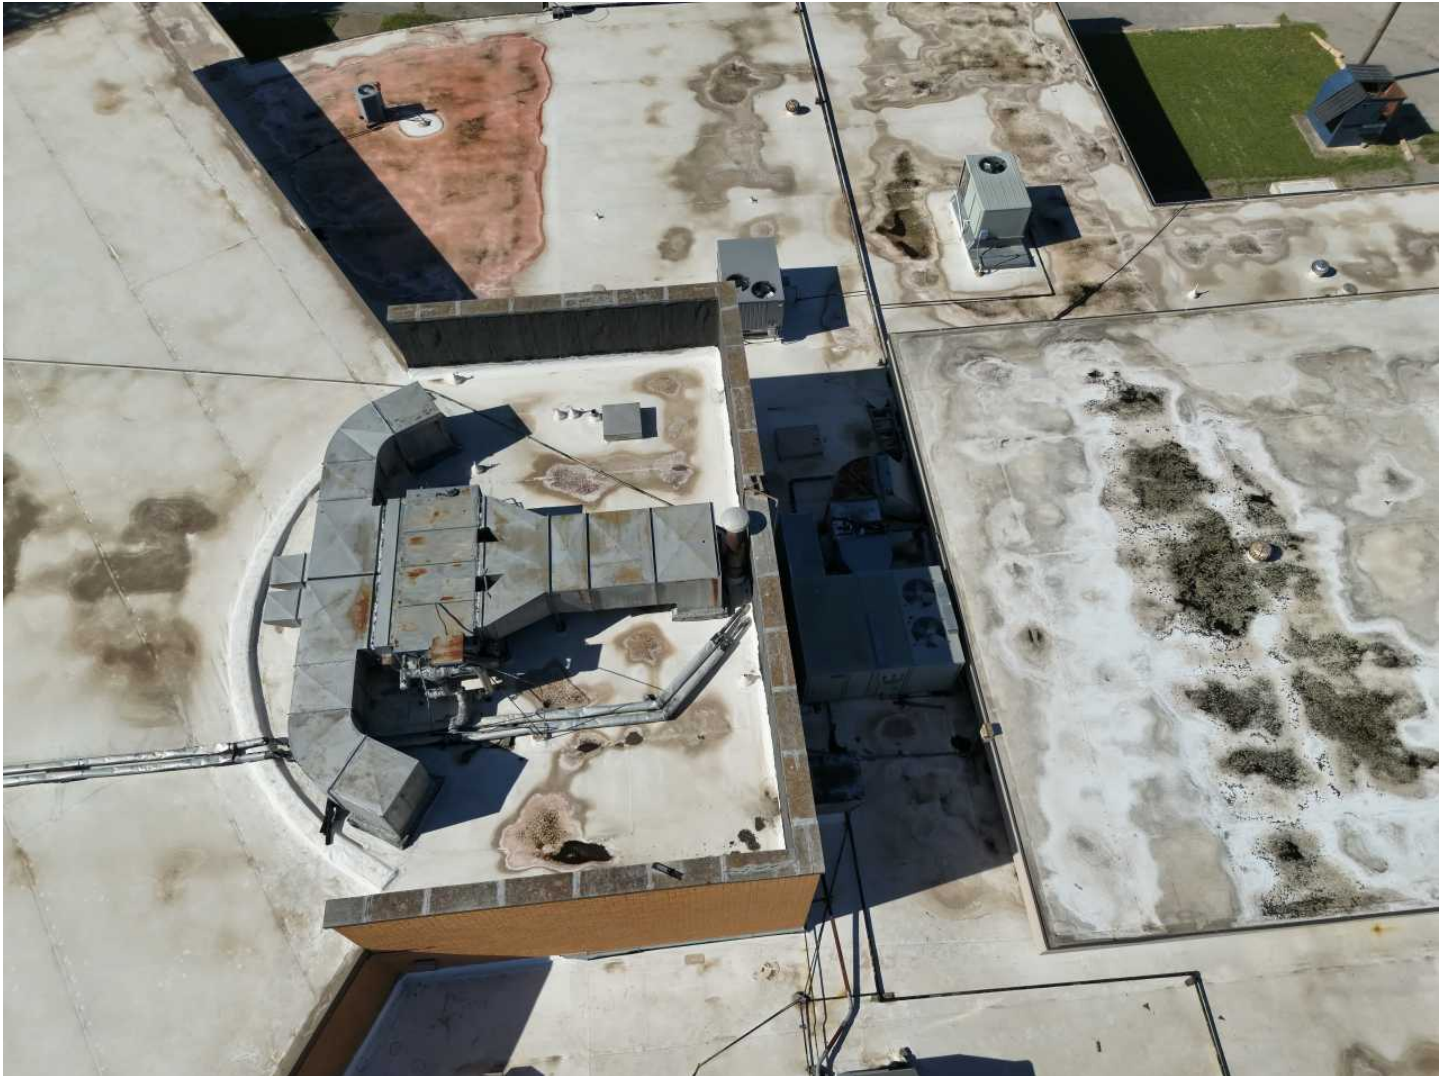
19 19-Boiling Temperatures Date Taken: 4/21/2025 Taken By: Angela Night

Ponding water creates dark areas on the roof surface. These dark areas absorb more sunlight than a white roof, leading to a significant temperature increase.
