DIV7|ROOF Company

Estimate: FOSTER_COLLEGE

The current roofing system is a TPO (Thermoplastic Polyolefin) that is mechanically attached (there are various areas across the mapping area that were found to be improperly installed). **A fully adhered system is highly recommended in comparison to a mechanically attached system to be applied a gravel ballast built-up roof. Fully adhered systems can reduce the number of seams needed, decreasing potential leak points.**

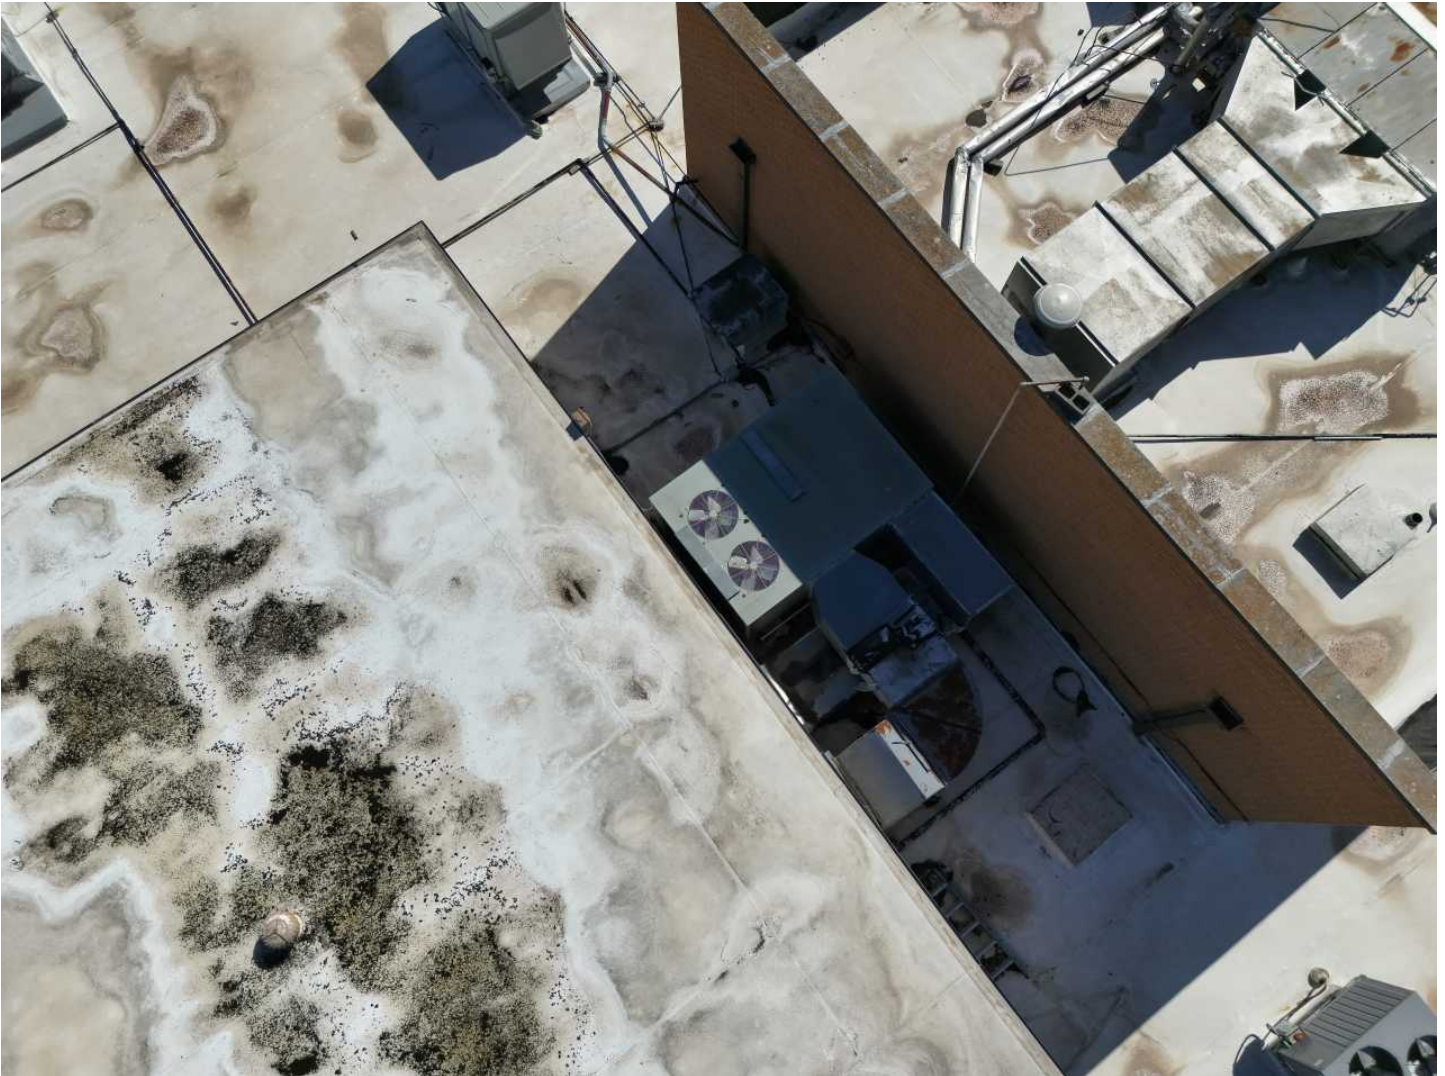
20

20-Boiling Temperatures

Ponding water creates dark areas on the roof surface. These dark areas absorb more sunlight than a white roof, leading to a significant temperature increase.

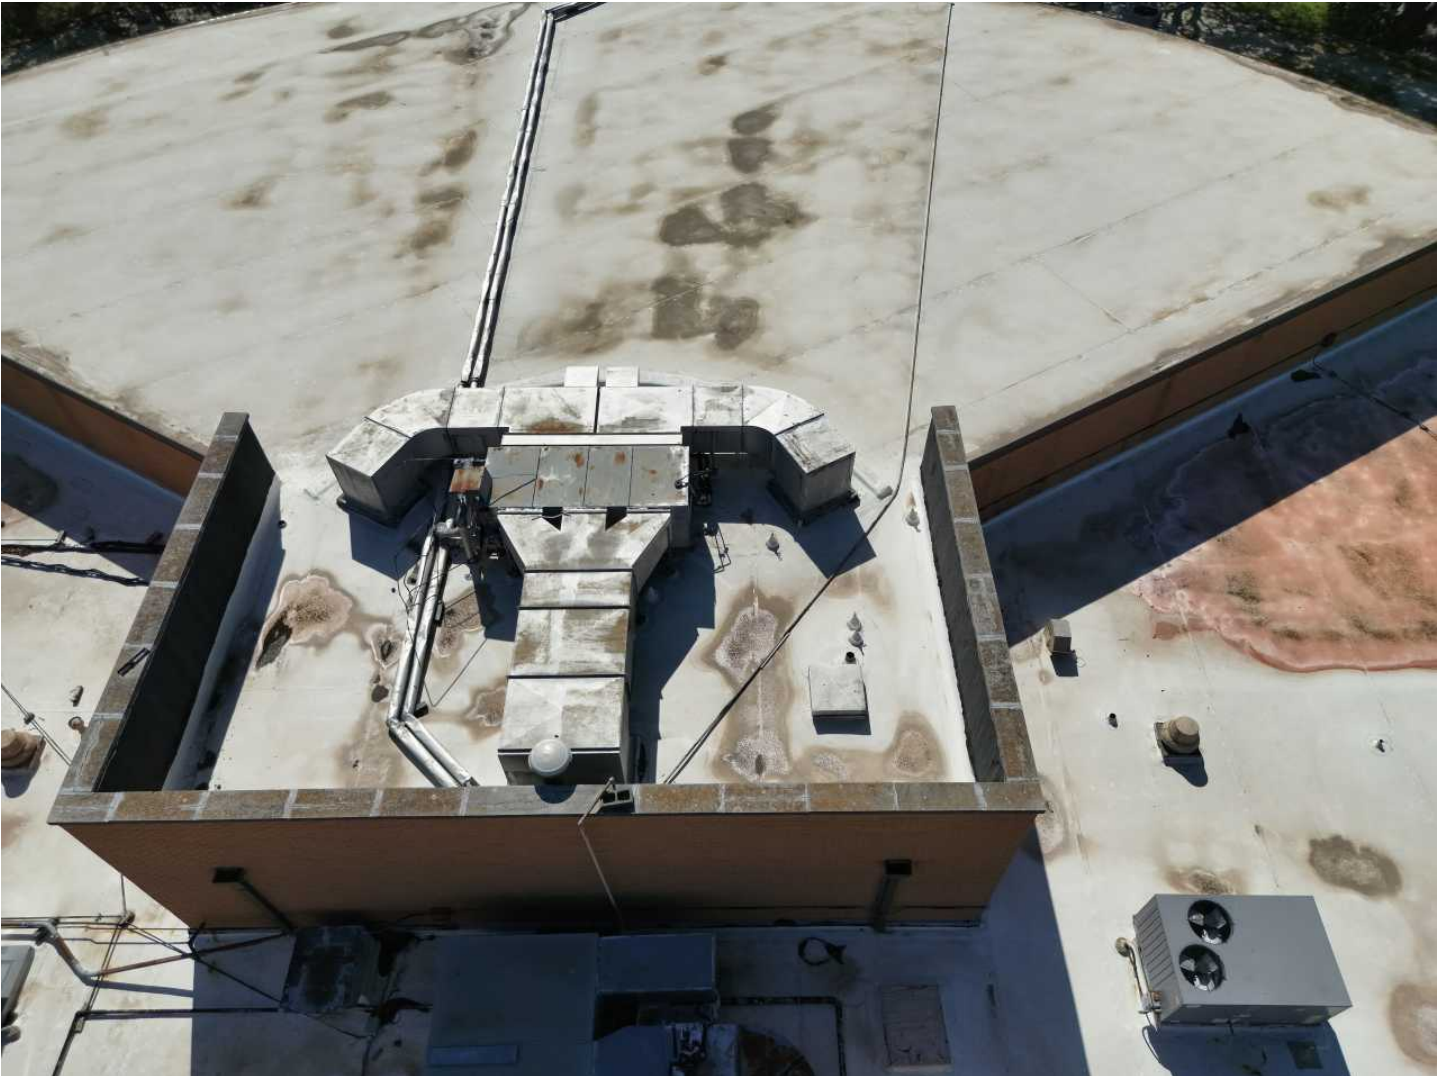
21 21-Boiling Temperatures Date Taken: 4/21/2025 Taken By: Angela Night

Ponding water creates dark areas on the roof surface. These dark areas absorb more sunlight than a white roof, leading to a significant temperature increase.

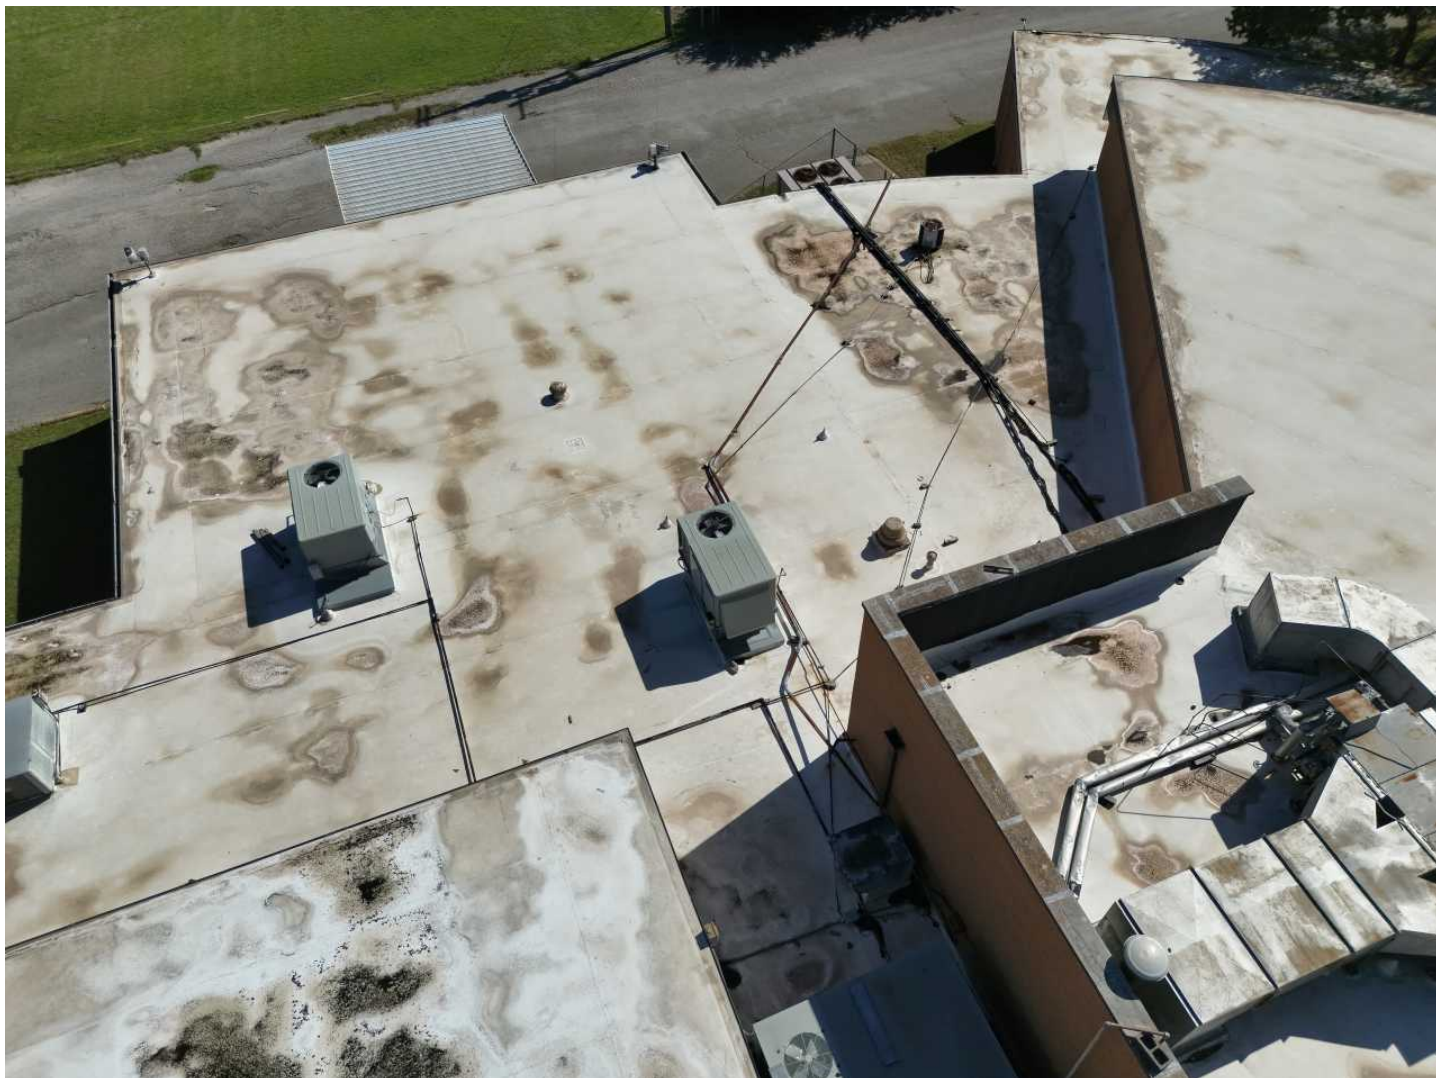
22 22-Boiling Temperatures Date Taken: 4/21/2025 Taken By: Angela Night

Ponding water creates dark areas on the roof surface. These dark areas absorb more sunlight than a white roof, leading to a significant temperature increase.

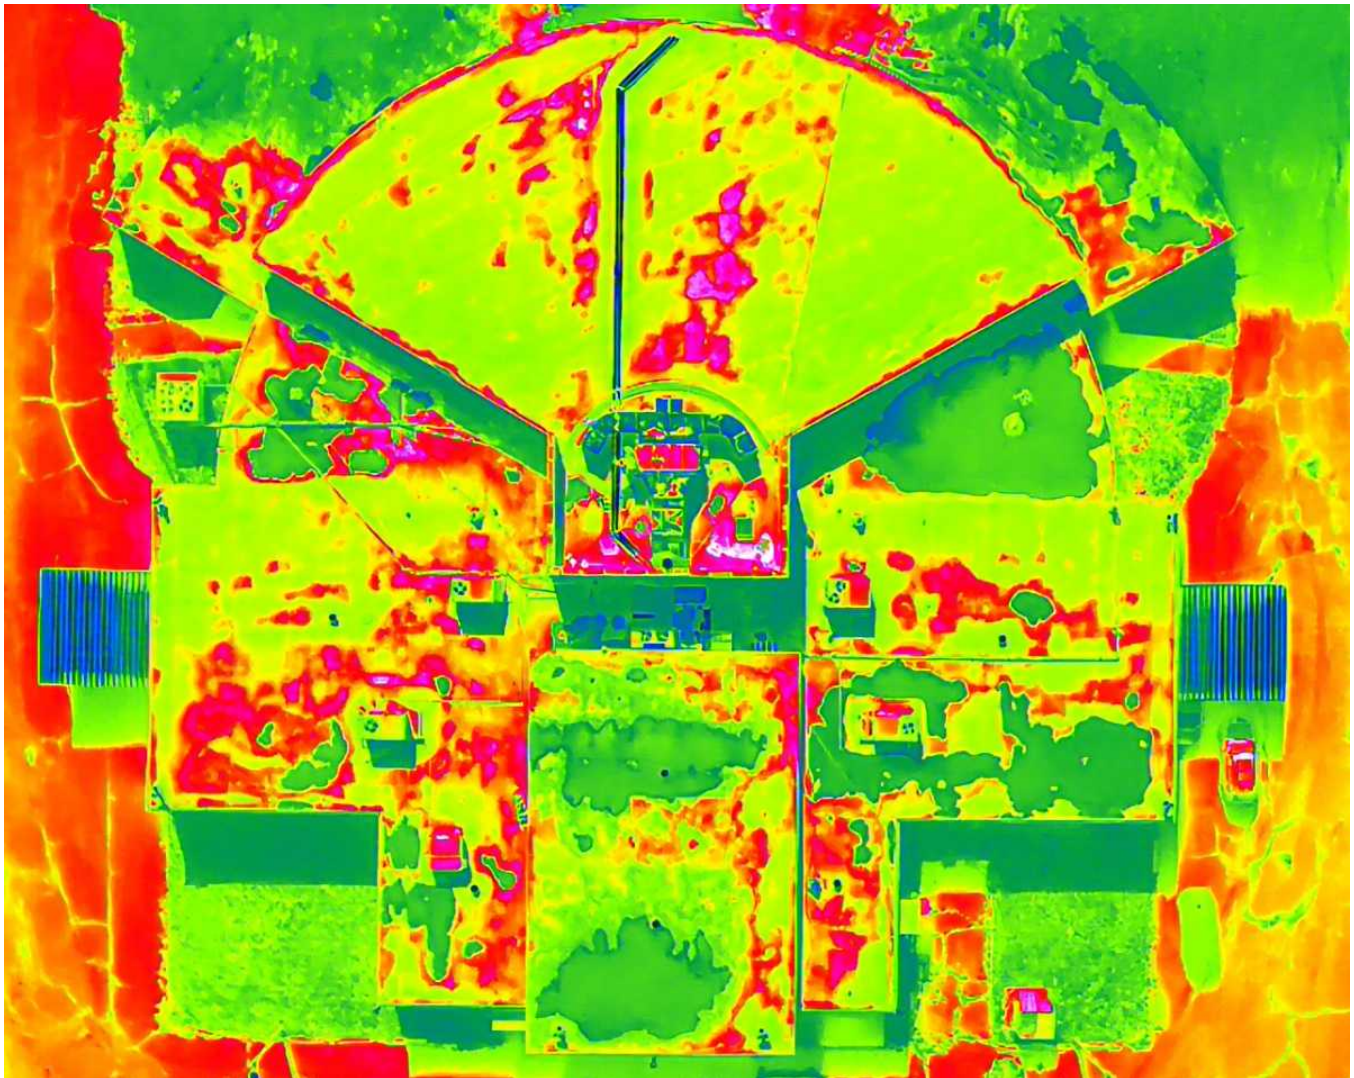
23 23-Boiling Temperatures Date Taken: 4/21/2025 Taken By: Angela Night

Ponding water creates dark areas on the roof surface. These dark areas absorb more sunlight than a white roof, leading to a significant temperature increase.

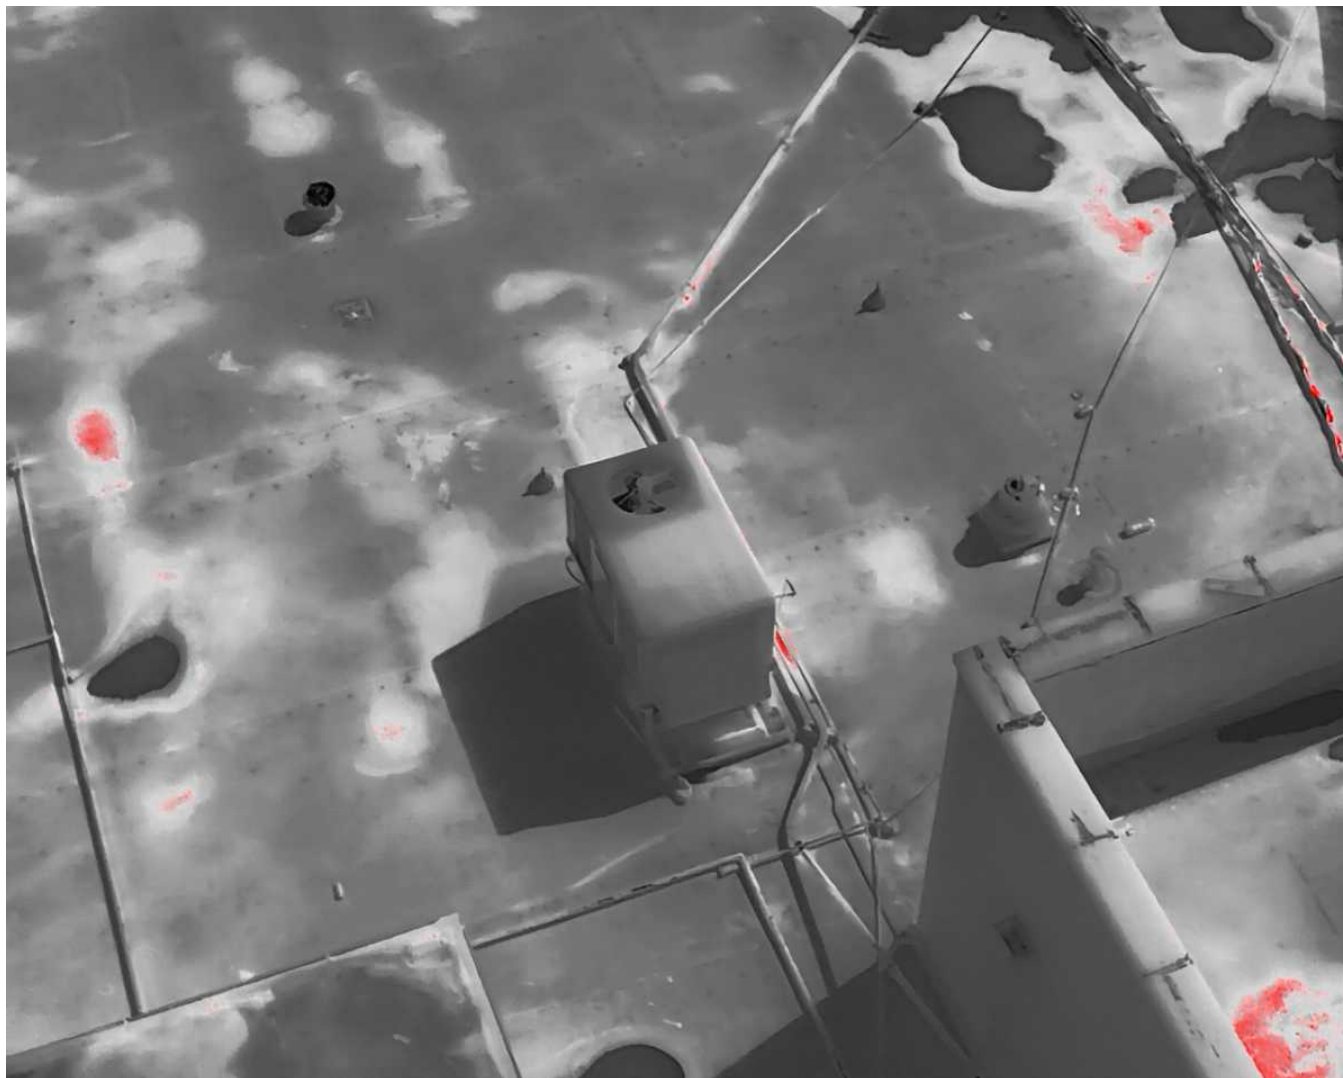
While white TPO membranes are designed to reflect UV radiation, ponding water can concentrate the sun's rays, increasing UV damage to the membrane

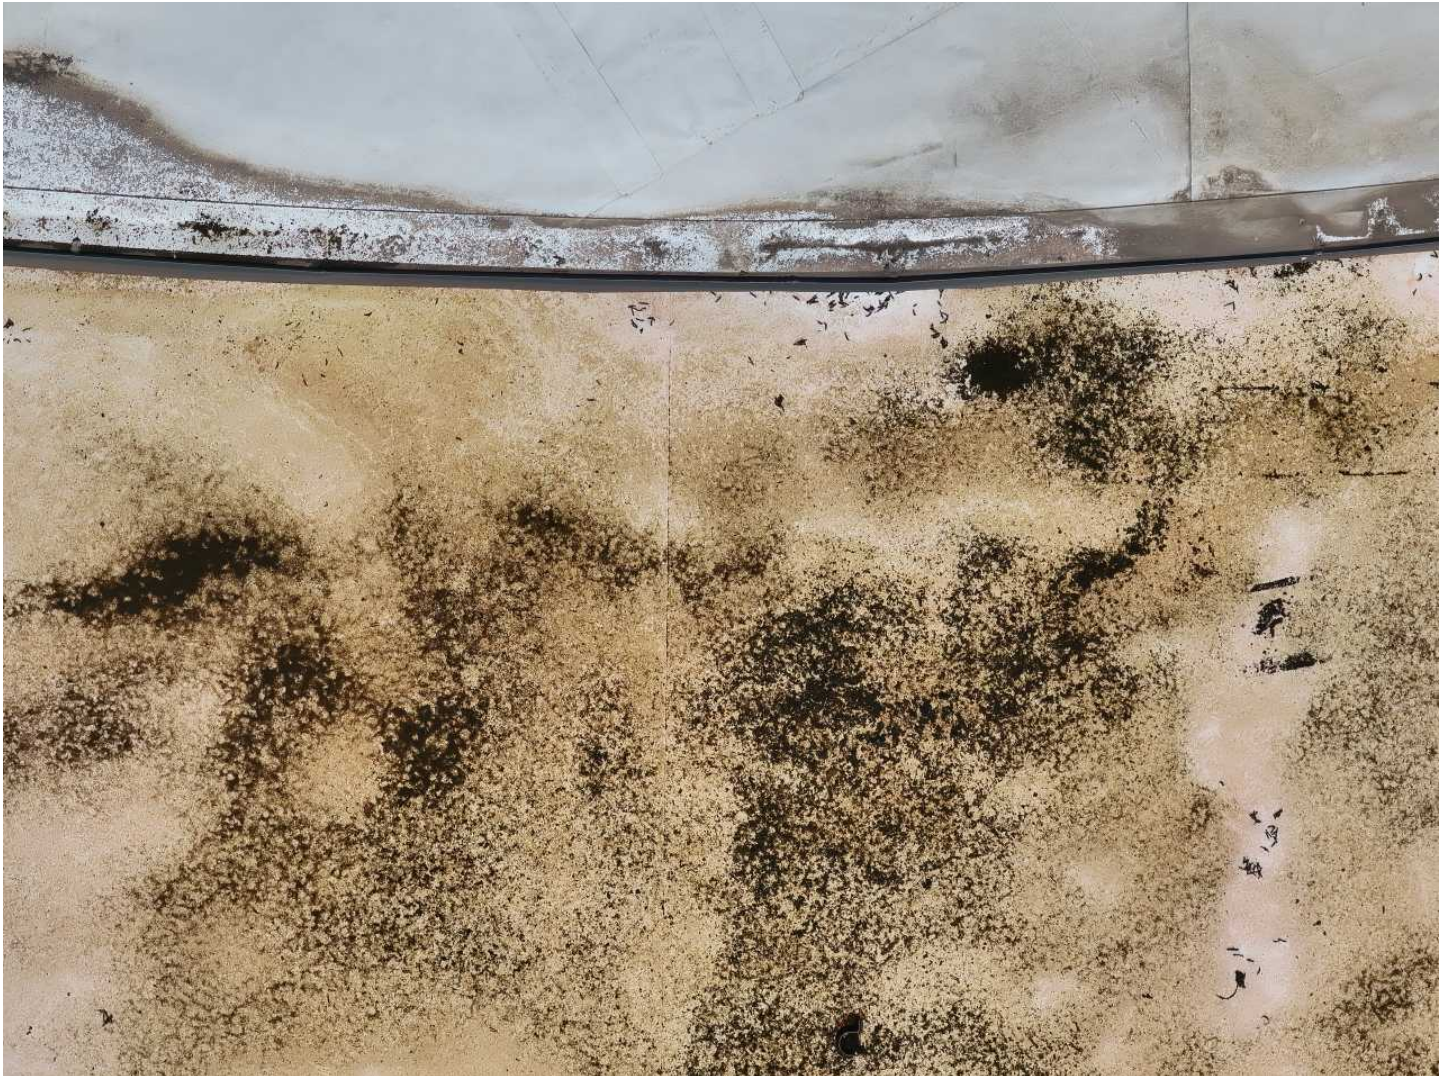
Ponding water creates dark areas on the roof surface. These dark areas absorb more sunlight than a white roof, leading to a significant temperature increase.

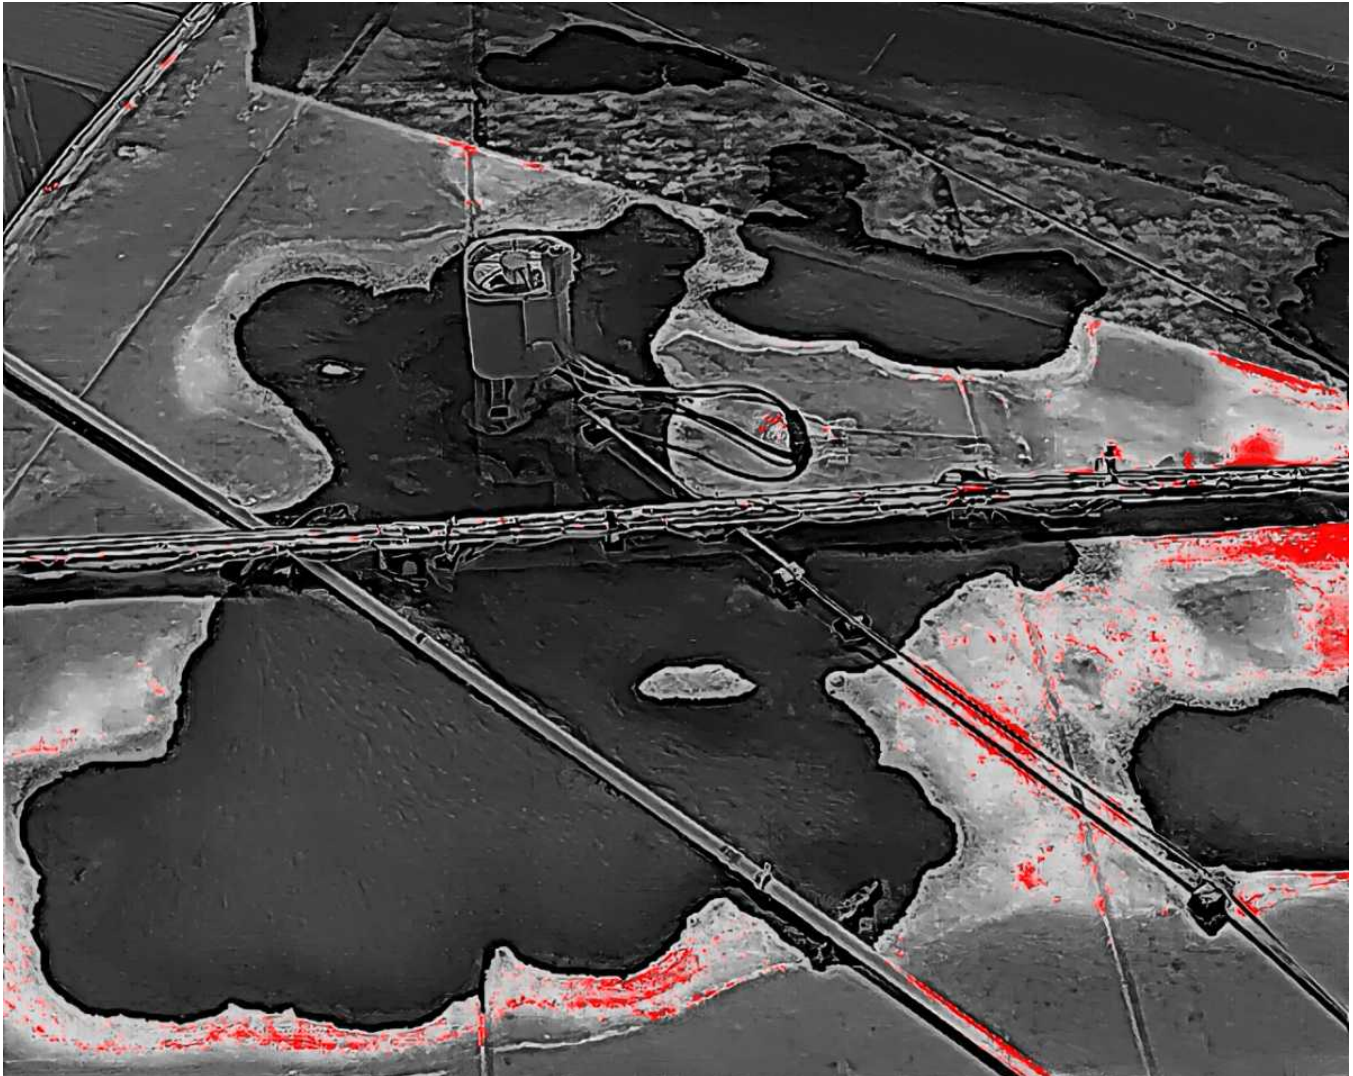
32 32-Boiling Temperatures Date Taken: 4/21/2025 Taken By: Angela Night

Ponding water creates dark areas on the roof surface. These dark areas absorb more sunlight than a white roof, leading to a significant temperature increase.

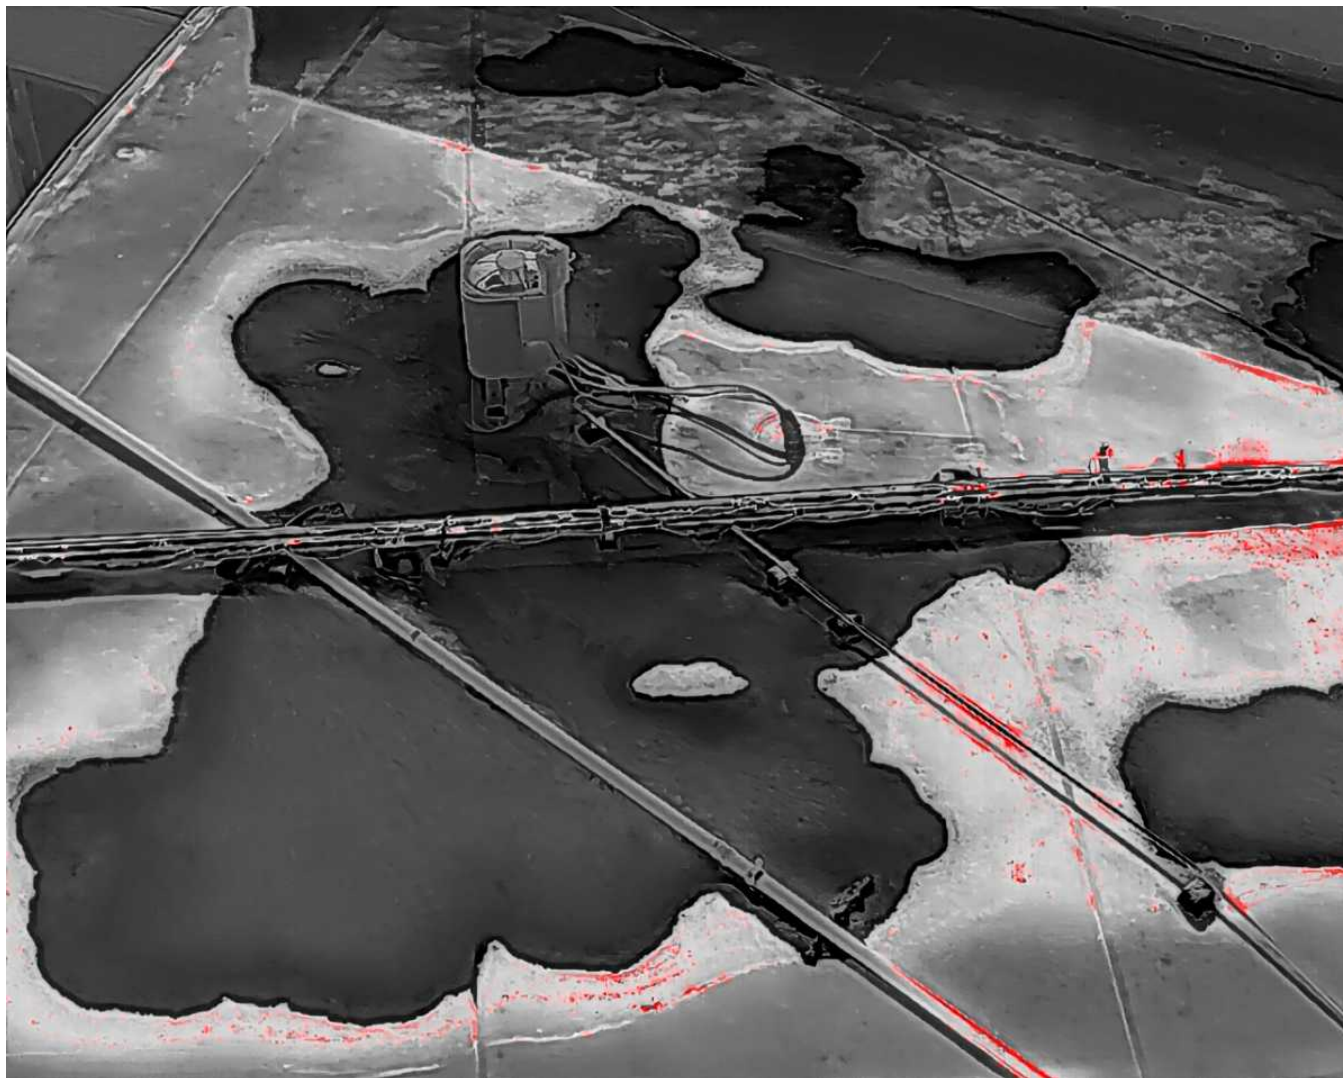
34 34-Boiling Temperatures Date Taken: 4/21/2025 Taken By: Angela Night

Ponding water creates dark areas on the roof surface. These dark areas absorb more sunlight than a white roof, leading to a significant temperature increase.

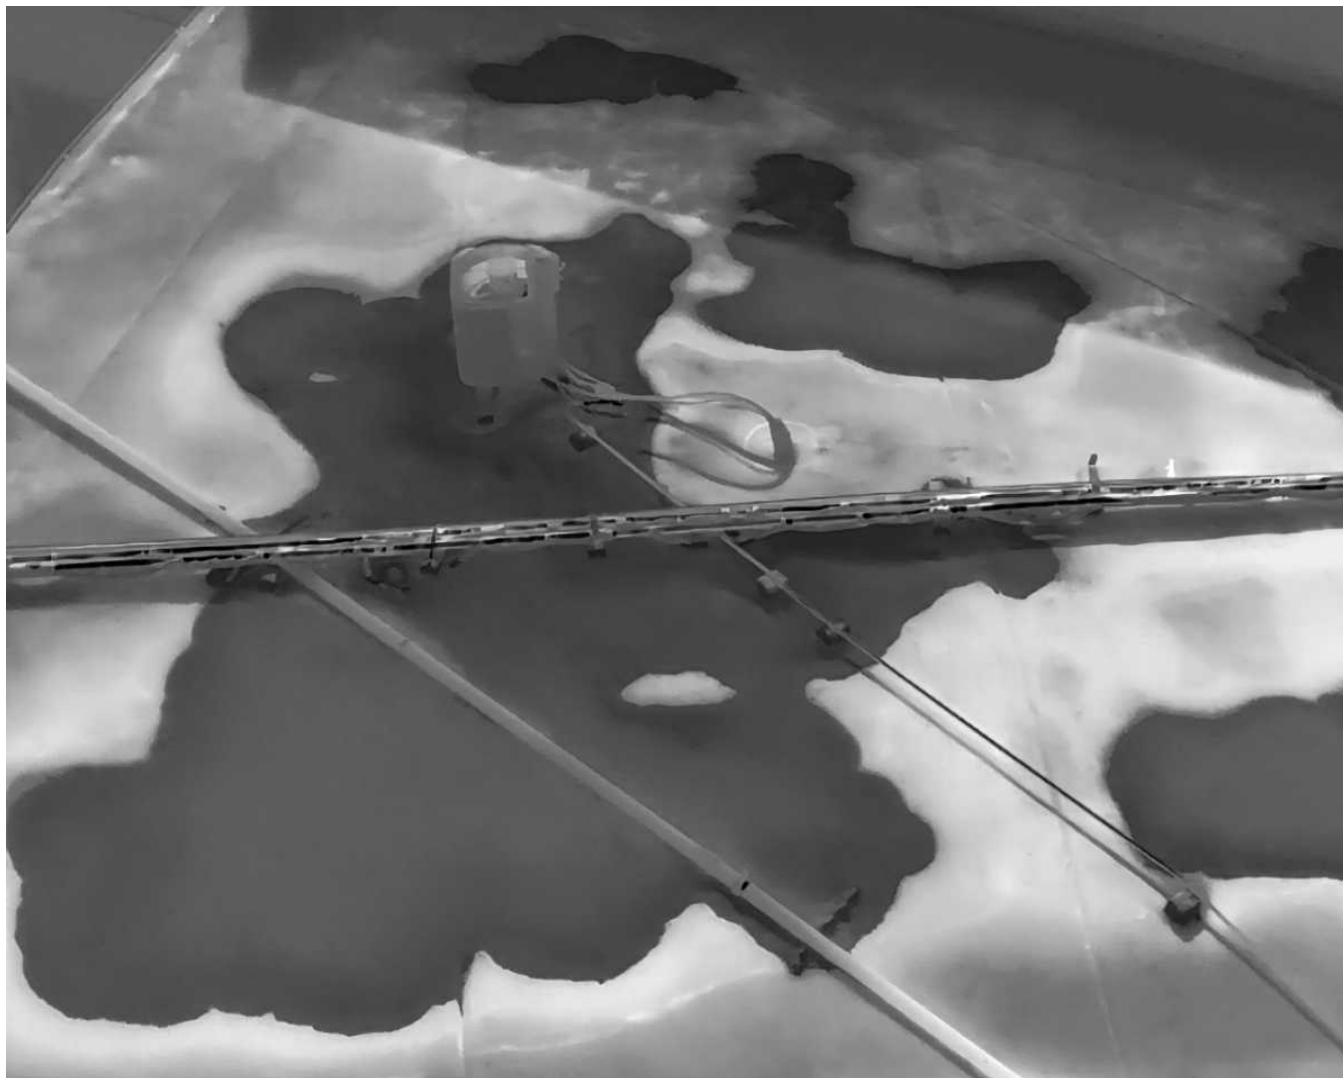
35 35-UV Degredation Date Taken: 4/21/2025 Taken By: Angela Night

While white TPO membranes are designed to reflect UV radiation, ponding water can concentrate the sun's rays, increasing UV damage to the membrane

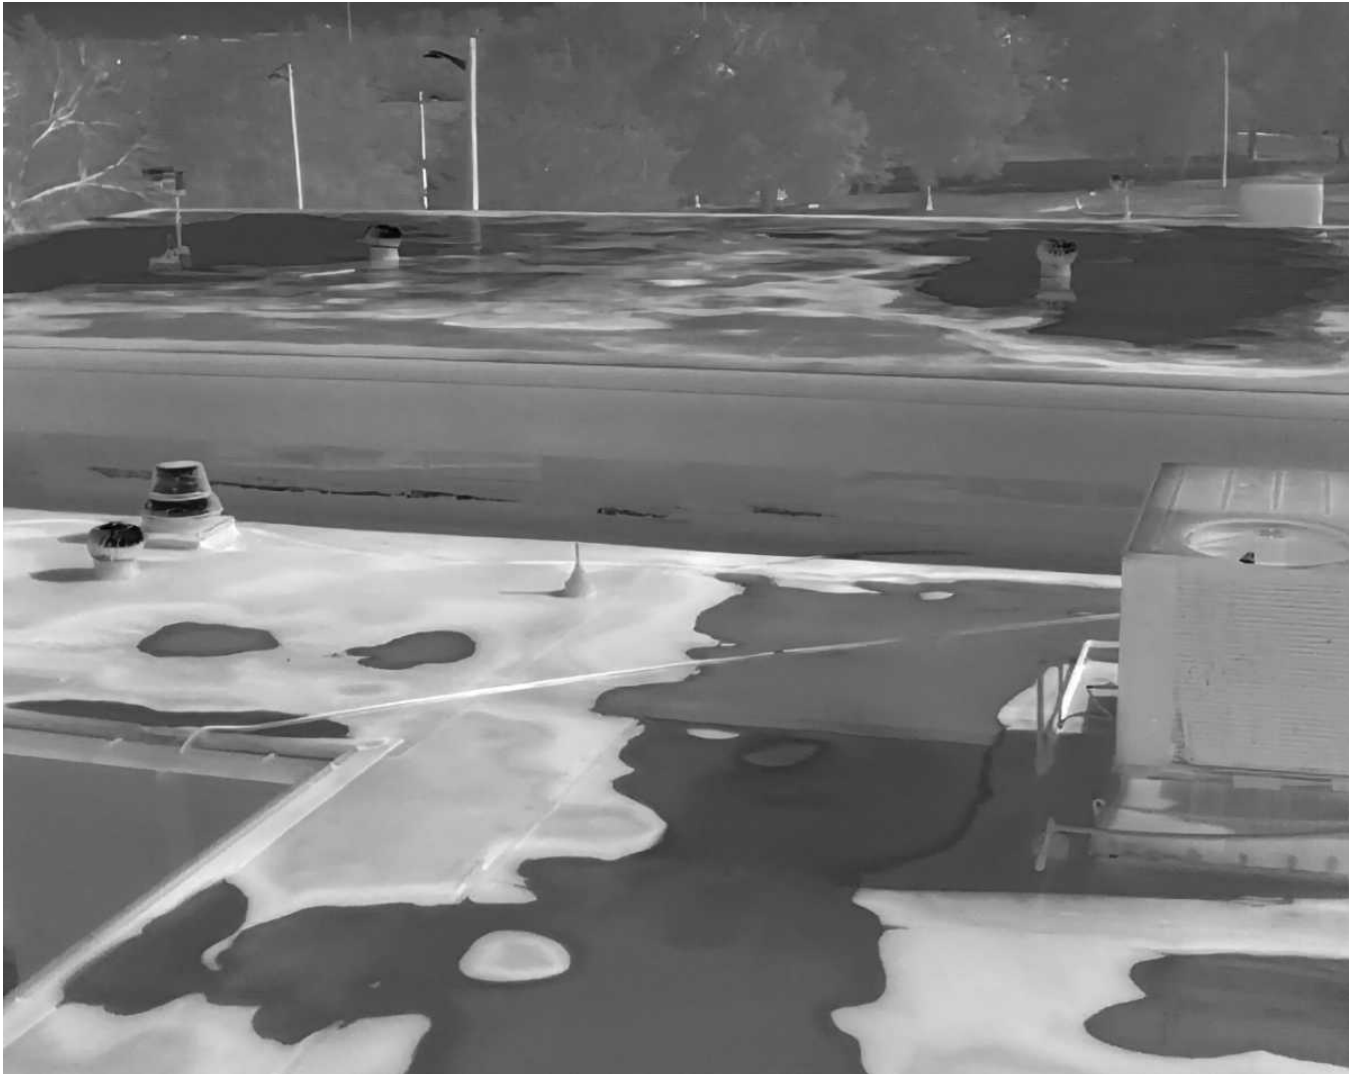
- 36 36-UV Degredation Date Taken: 4/21/2025 Taken By: Angela Night
- While white TPO membranes are designed to reflect UV radiation, ponding water can concentrate the sun's rays, increasing UV damage to the membrane

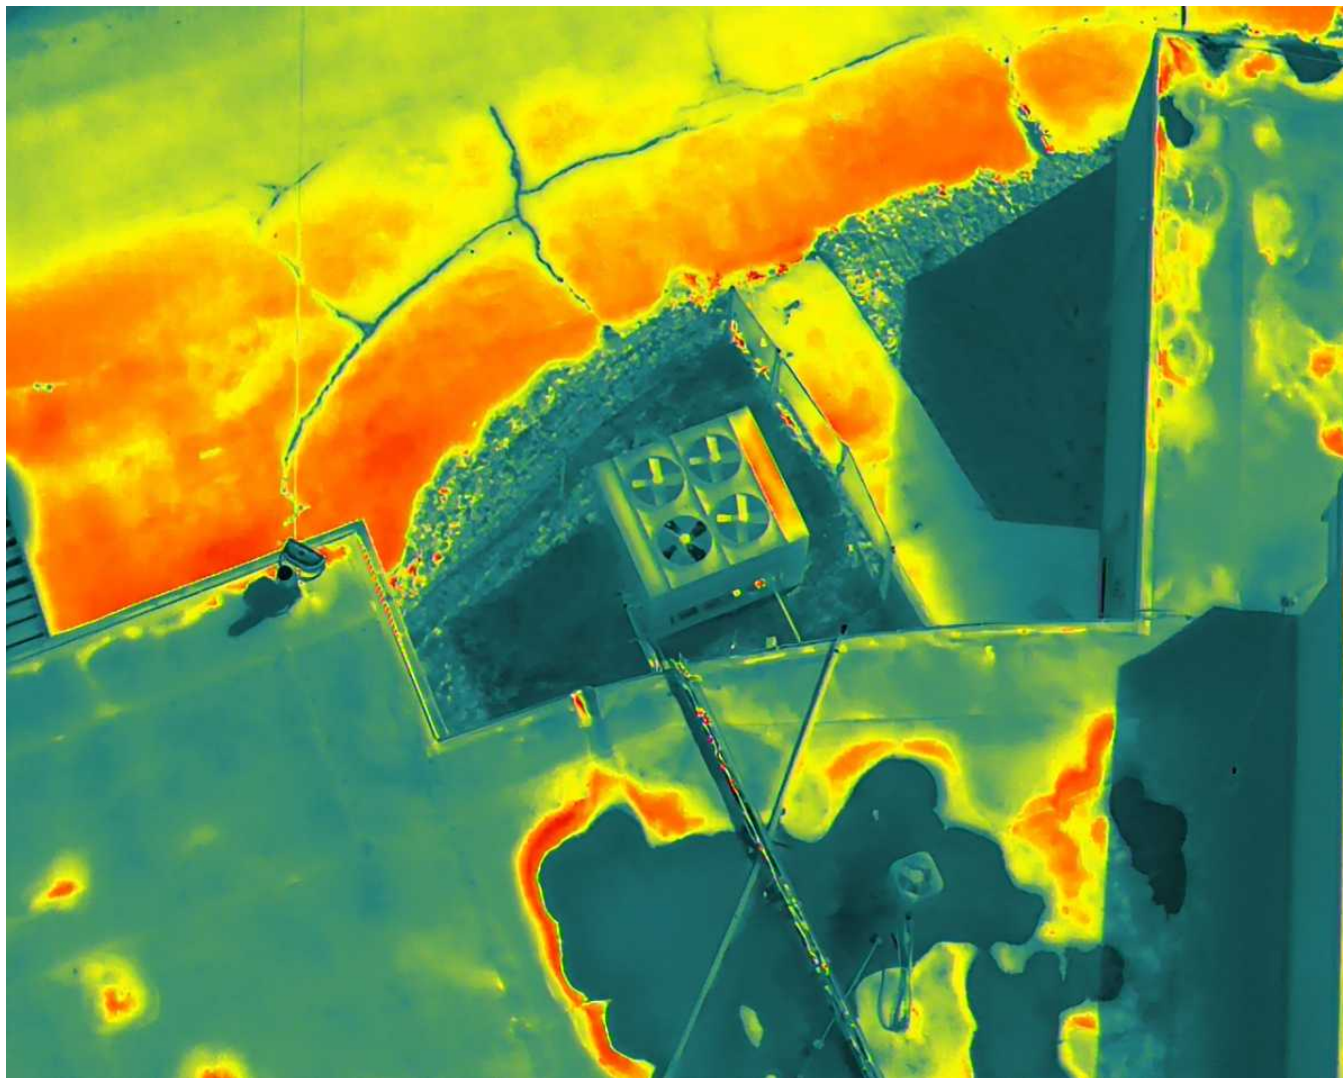
39 39-Boiling Temperatures Date Taken: 4/21/2025 Taken By: Angela Night

Ponding water creates dark areas on the roof surface. These dark areas absorb more sunlight than a white roof, leading to a significant temperature increase.

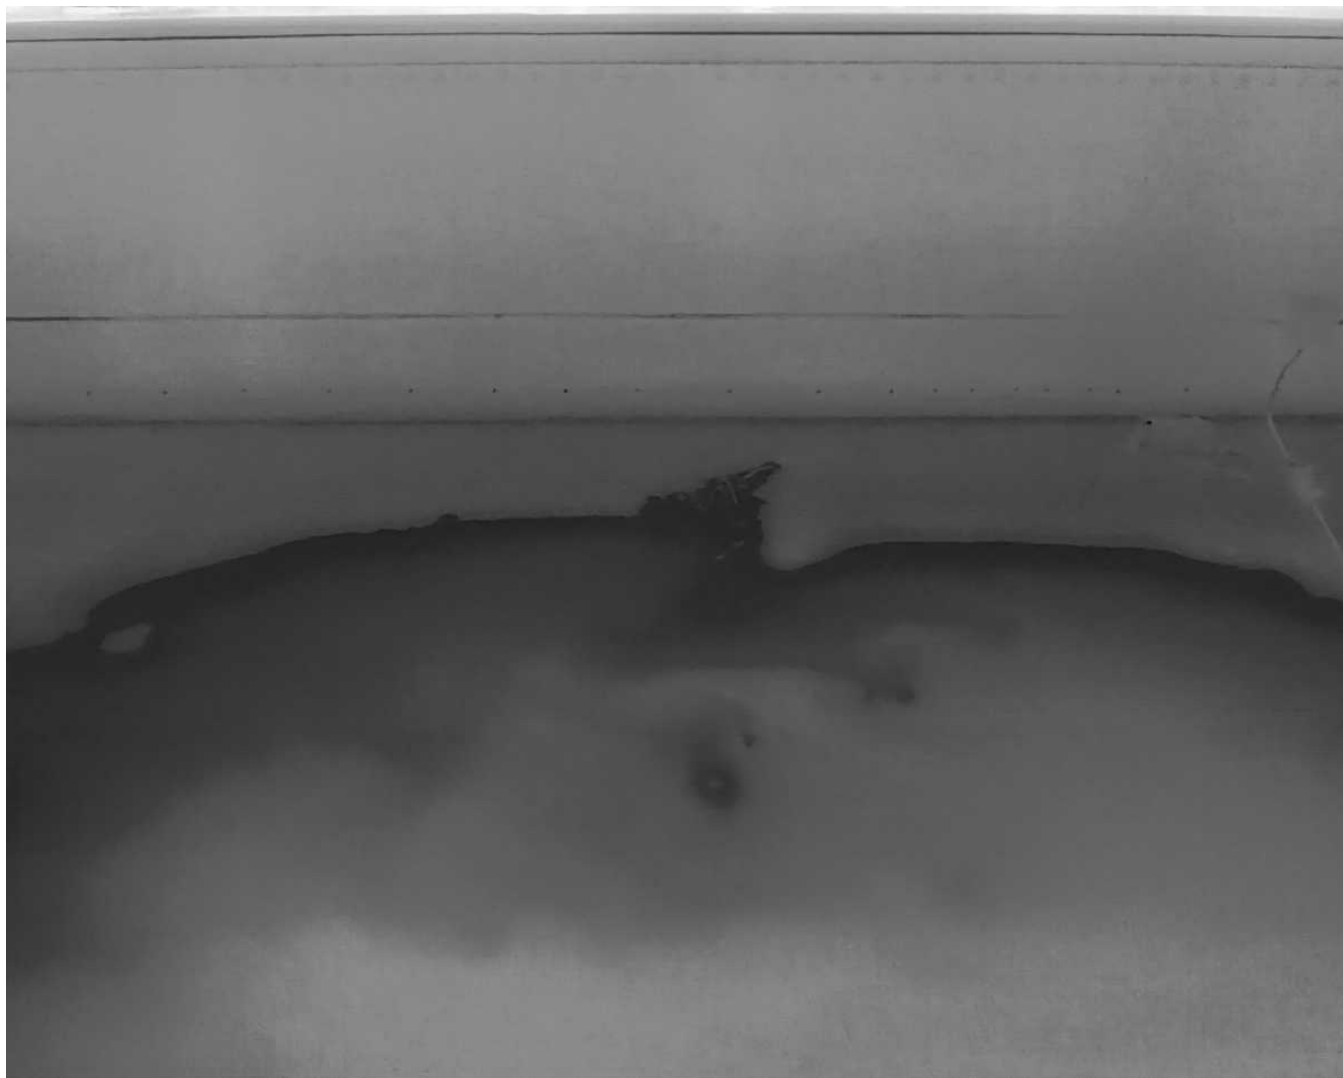
40

40-UV Degredation

While white TPO membranes are designed to reflect UV radiation, ponding water can concentrate the sun's rays, increasing UV damage to the membrane

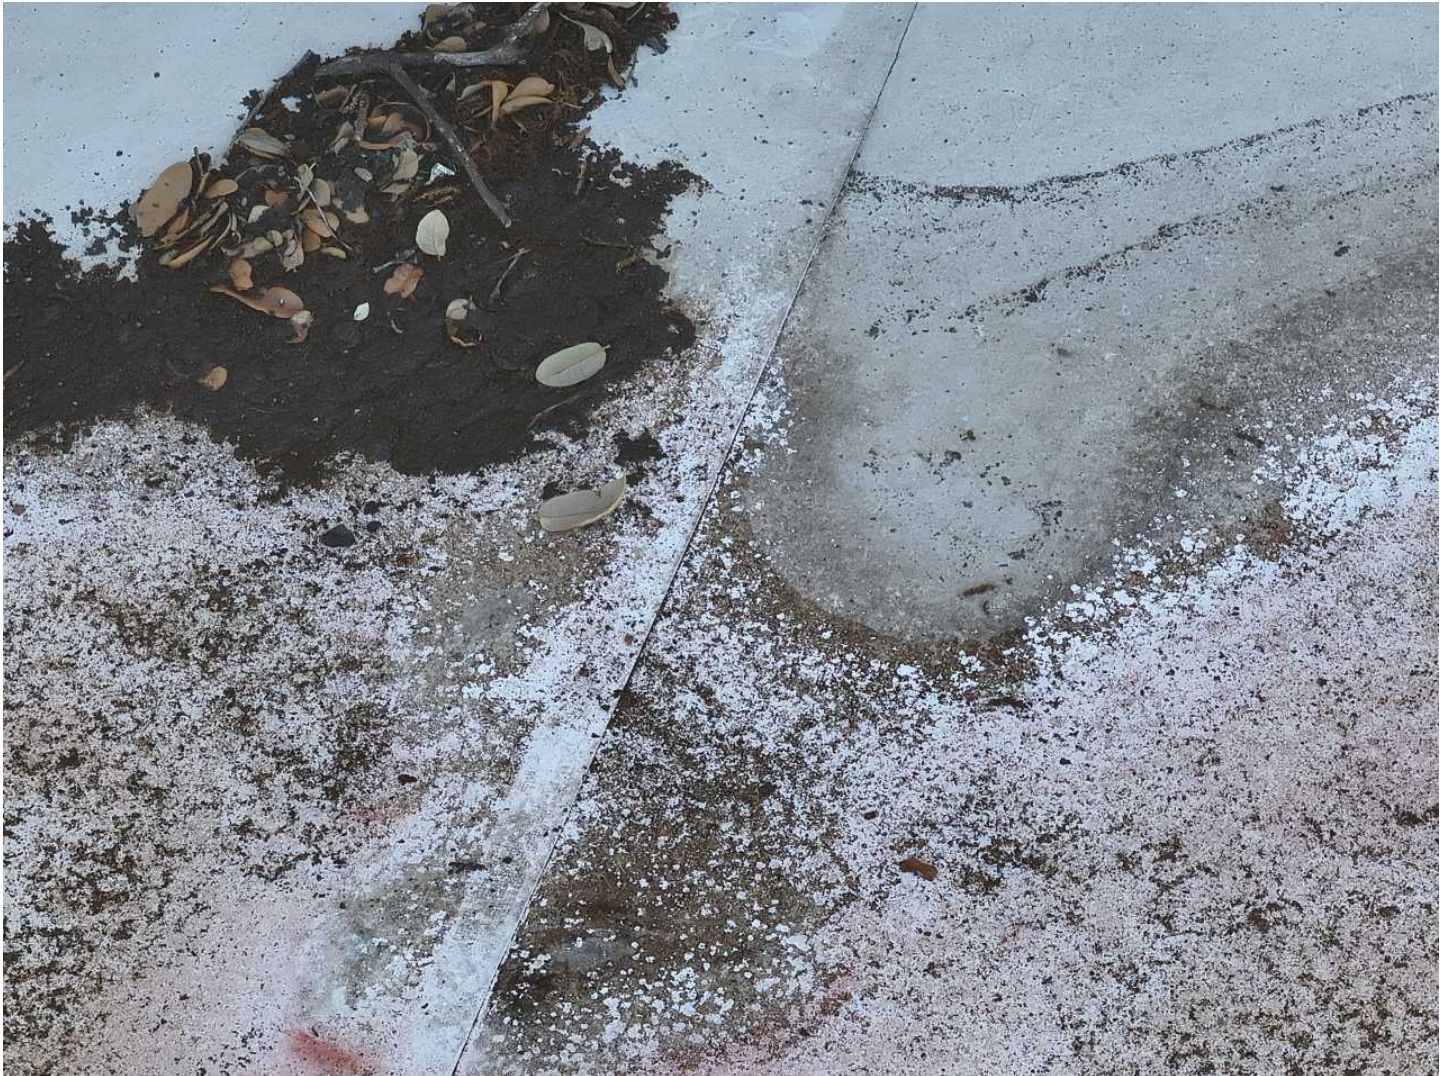
41 41-UV Degredation Date Taken: 4/21/2025 Taken By: Angela Night

While white TPO membranes are designed to reflect UV radiation, ponding water can concentrate the sun's rays, increasing UV damage to the membrane

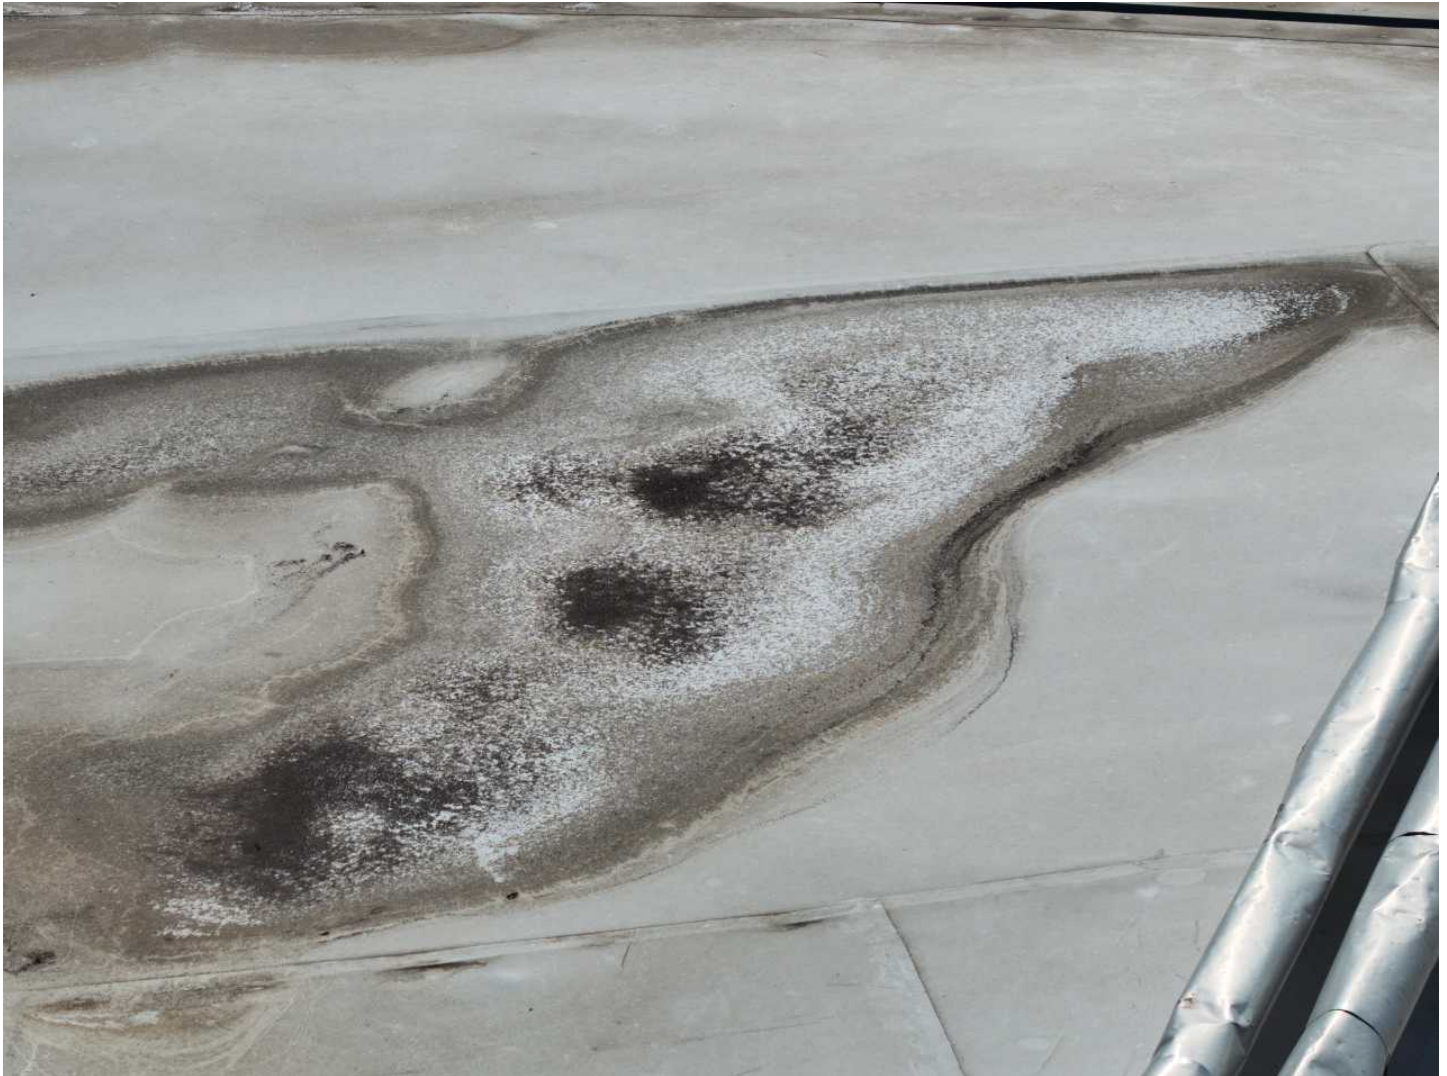
42 42-Boiling Temperatures Date Taken: 4/21/2025 Taken By: Angela Night

Ponding water creates dark areas on the roof surface. These dark areas absorb more sunlight than a white roof, leading to a significant temperature increase.
