DIV7|ROOF Company

Estimate: FOSTER_COLLEGE

The current roofing system is a TPO (Thermoplastic Polyolefin) that is mechanically attached (there are various areas across the mapping area that were found to be improperly installed). **A fully adhered system is highly recommended in comparison to a mechanically attached system to be applied a gravel ballast built-up roof. Fully adhered systems can reduce the number of seams needed, decreasing potential leak points.**

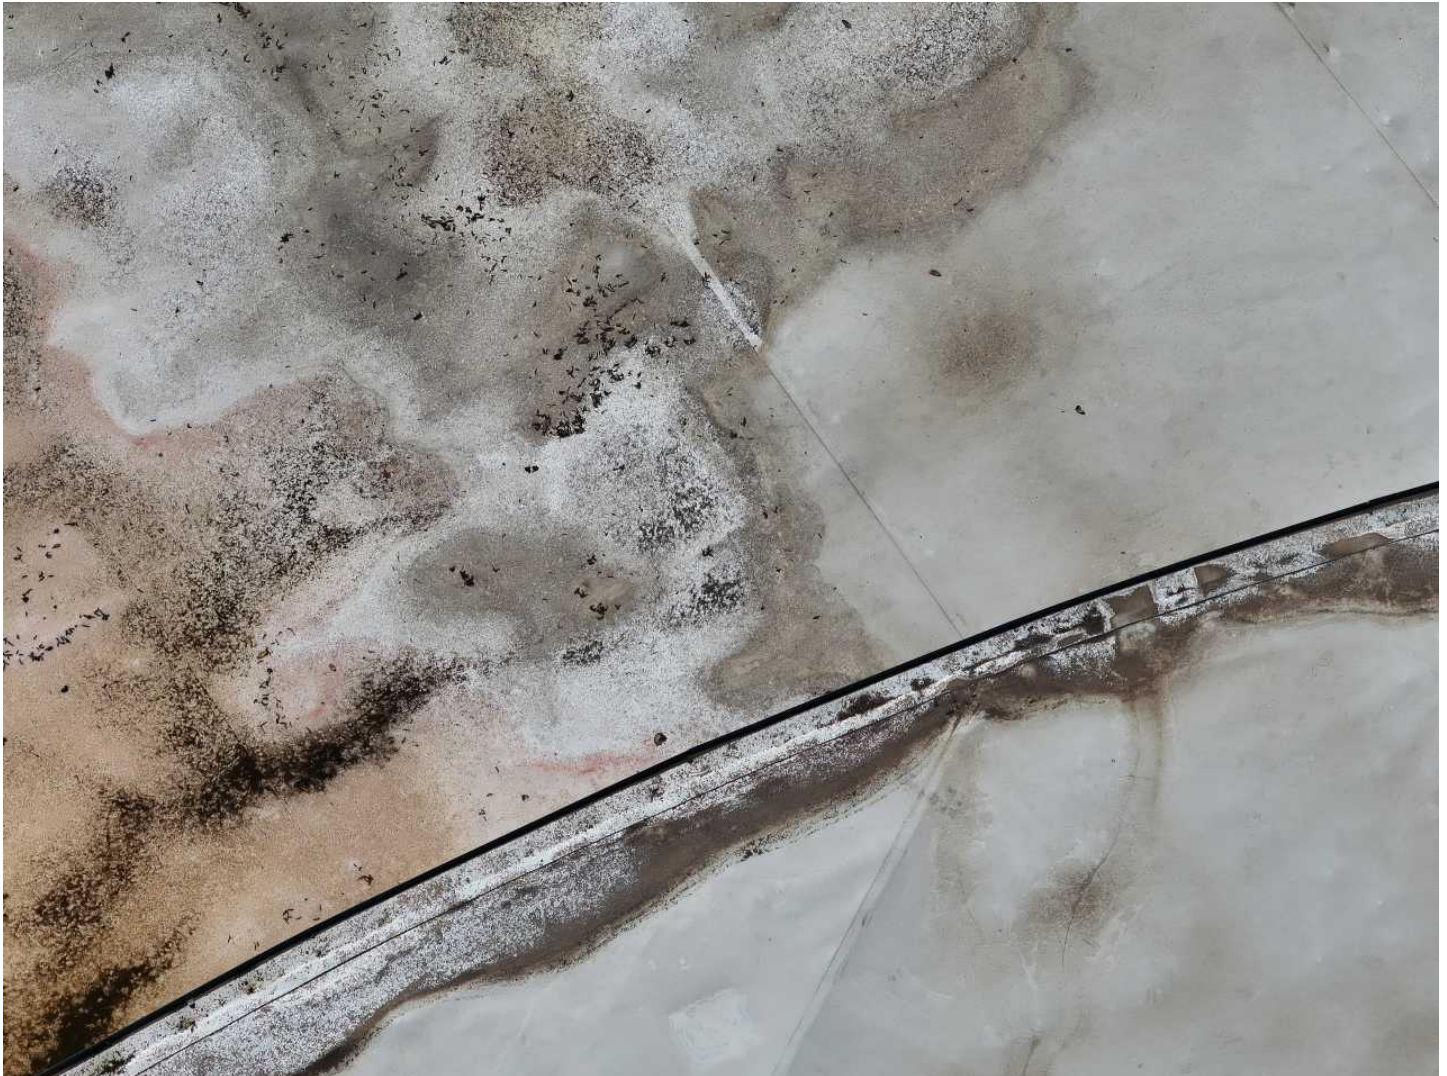
43 43-Boiling Temperatures Date Taken: 4/21/2025 Taken By: Angela Night

Ponding water creates dark areas on the roof surface. These dark areas absorb more sunlight than a white roof, leading to a significant temperature increase.

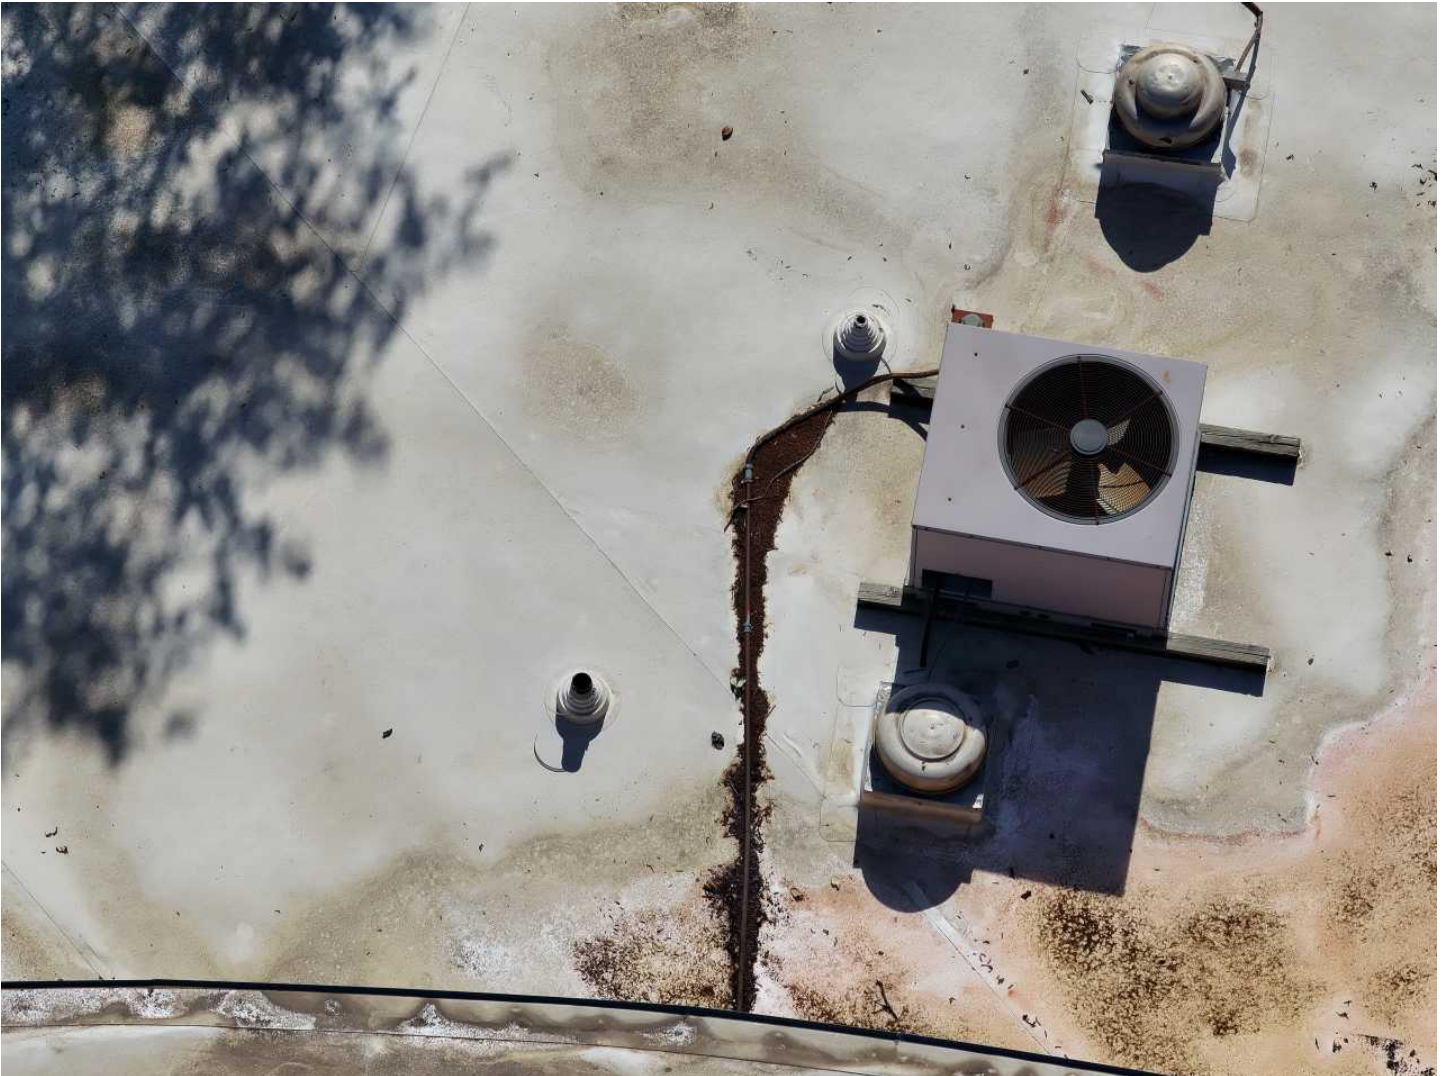
44 44-Boiling Temperatures Date Taken: 4/21/2025 Taken By: Angela Night

Ponding water creates dark areas on the roof surface. These dark areas absorb more sunlight than a white roof, leading to a significant temperature increase.

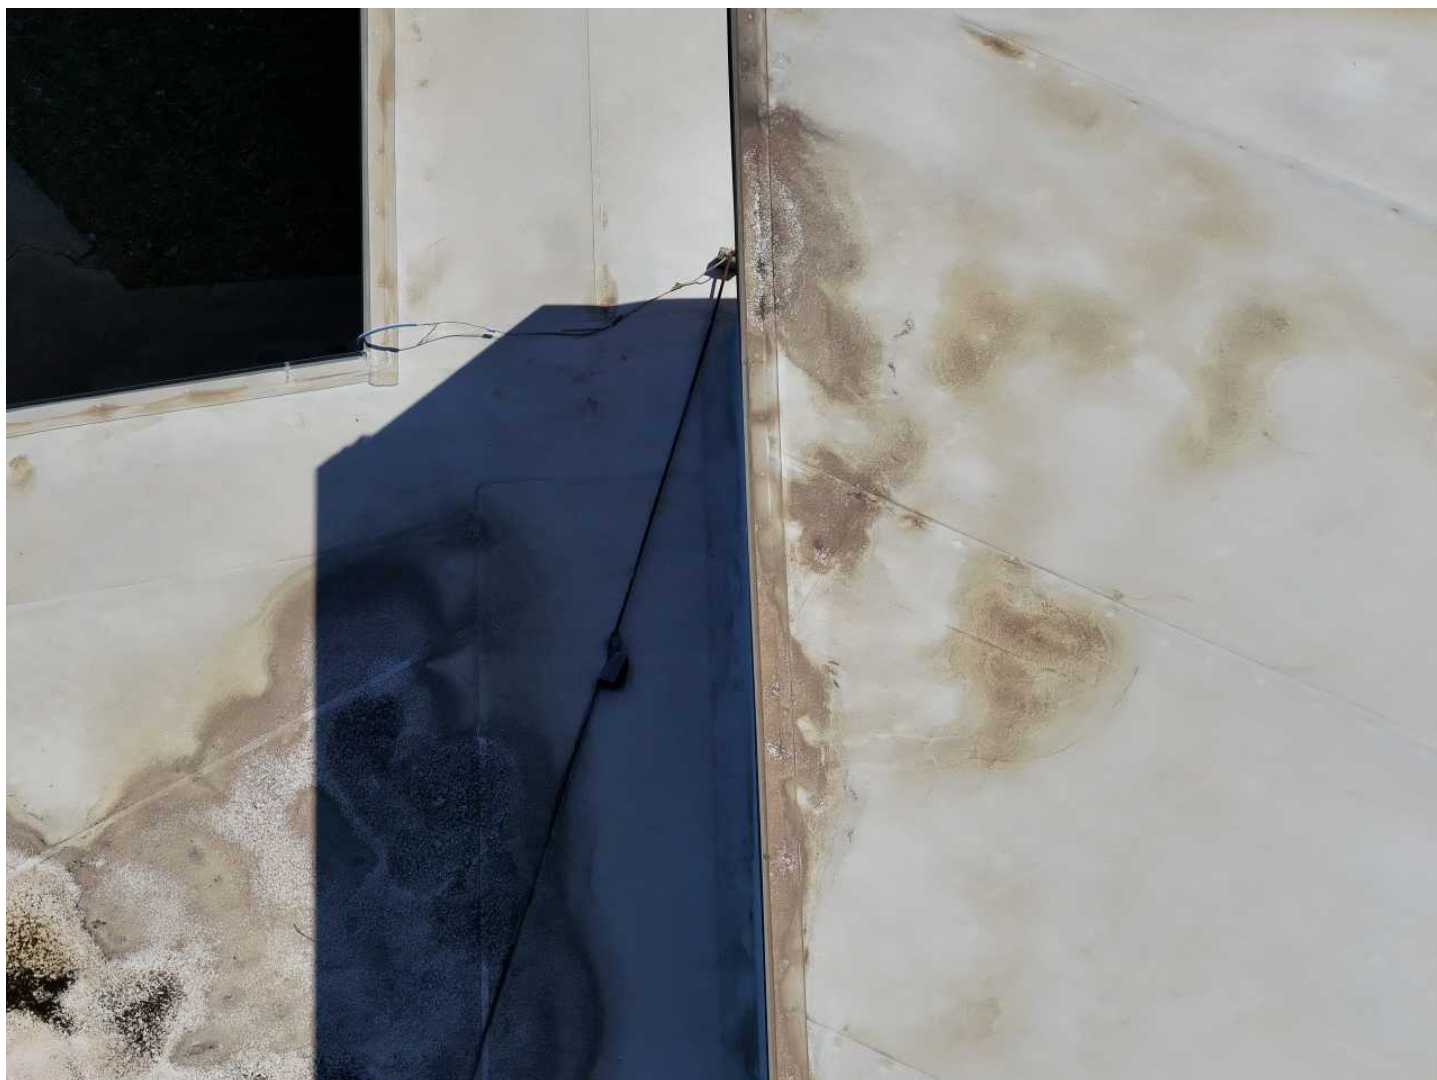
45 45-Boiling Temperatures Date Taken: 4/21/2025 Taken By: Angela Night

Ponding water creates dark areas on the roof surface. These dark areas absorb more sunlight than a white roof, leading to a significant temperature increase.

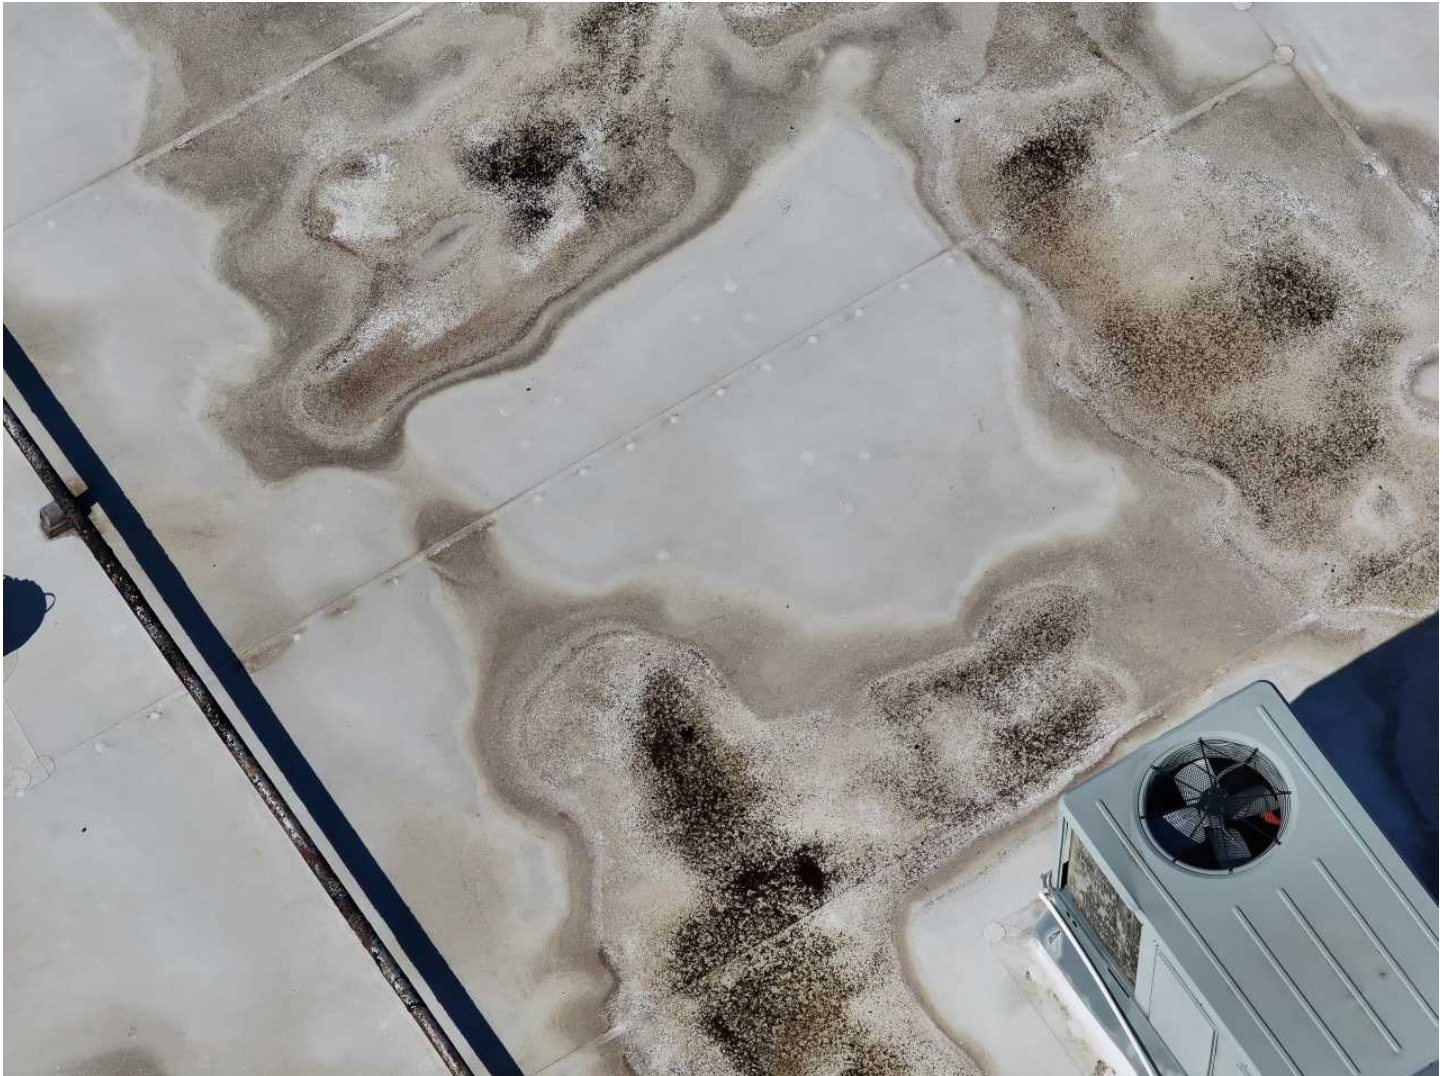
46 46-Boiling Temperatures Date Taken: 4/21/2025 Taken By: Angela Night

Ponding water creates dark areas on the roof surface. These dark areas absorb more sunlight than a white roof, leading to a significant temperature increase.

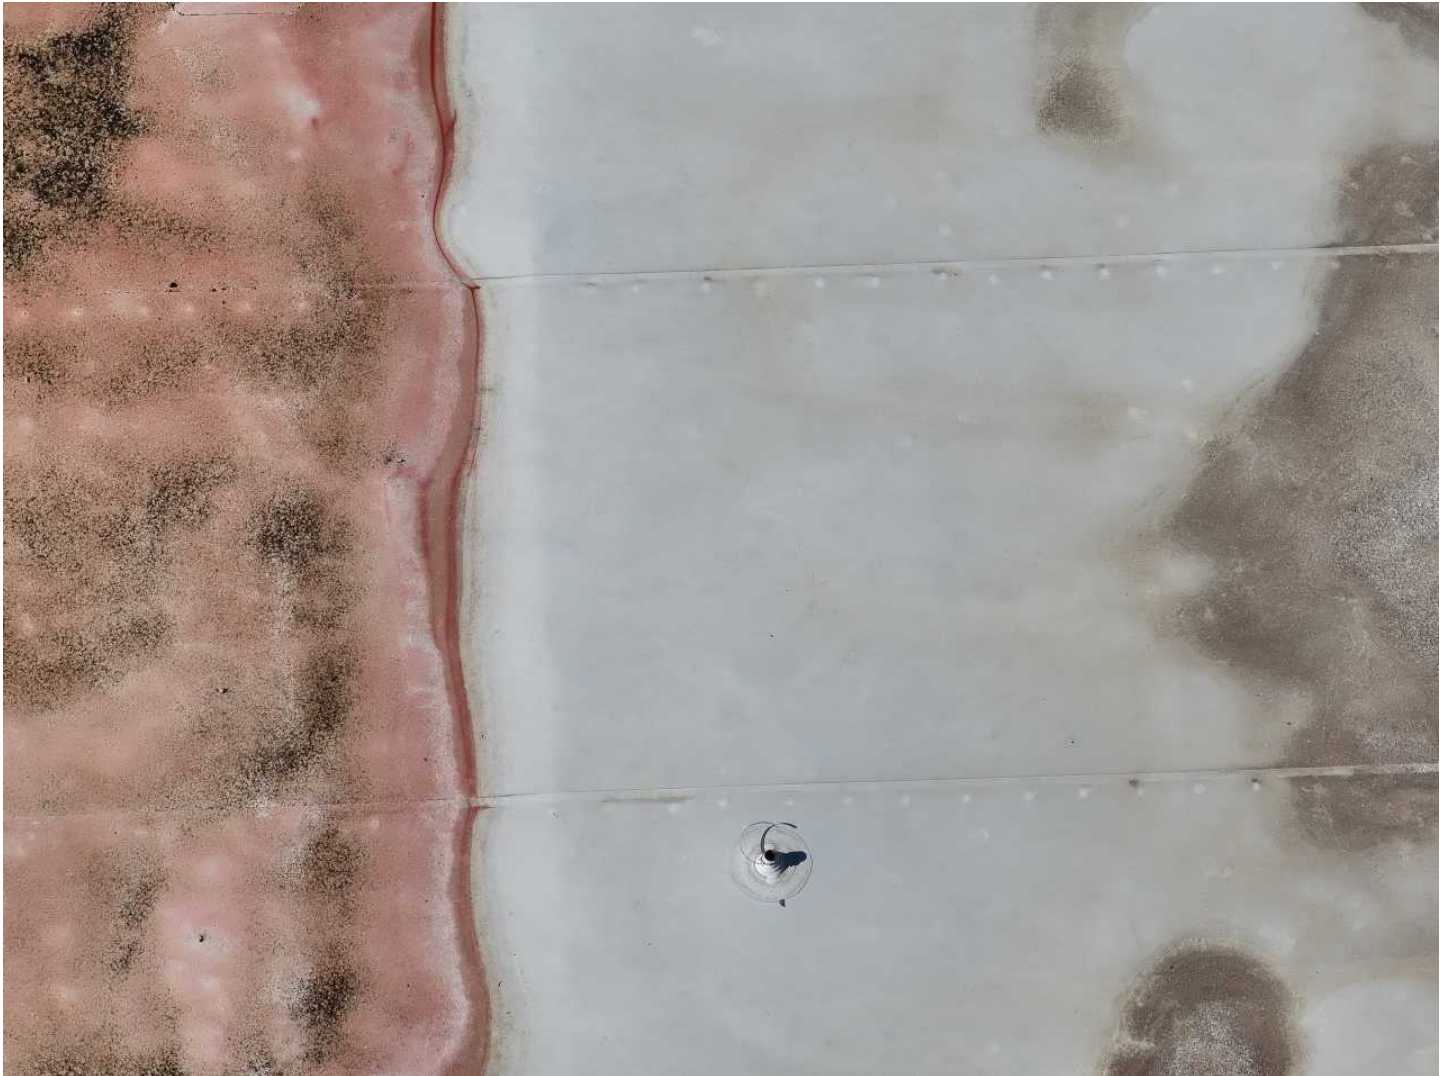
47 47-Boiling Temperatures Date Taken: 4/21/2025 Taken By: Angela Night

Ponding water creates dark areas on the roof surface. These dark areas absorb more sunlight than a white roof, leading to a significant temperature increase.

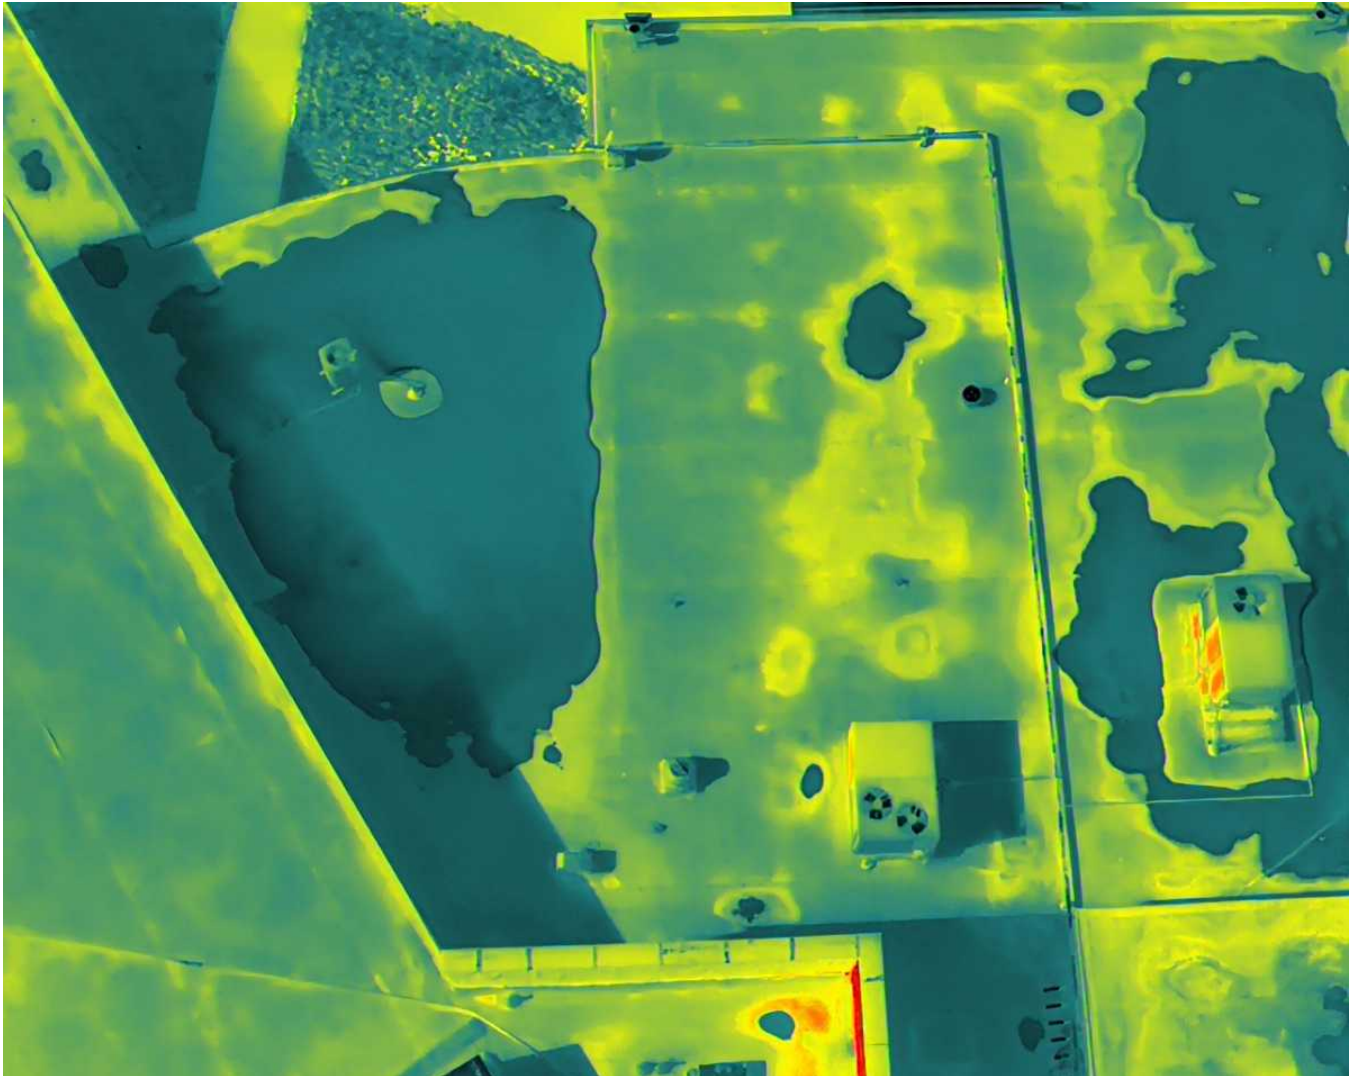
48

48-Boiling Temperatures

Ponding water creates dark areas on the roof surface. These dark areas absorb more sunlight than a white roof, leading to a significant temperature increase.

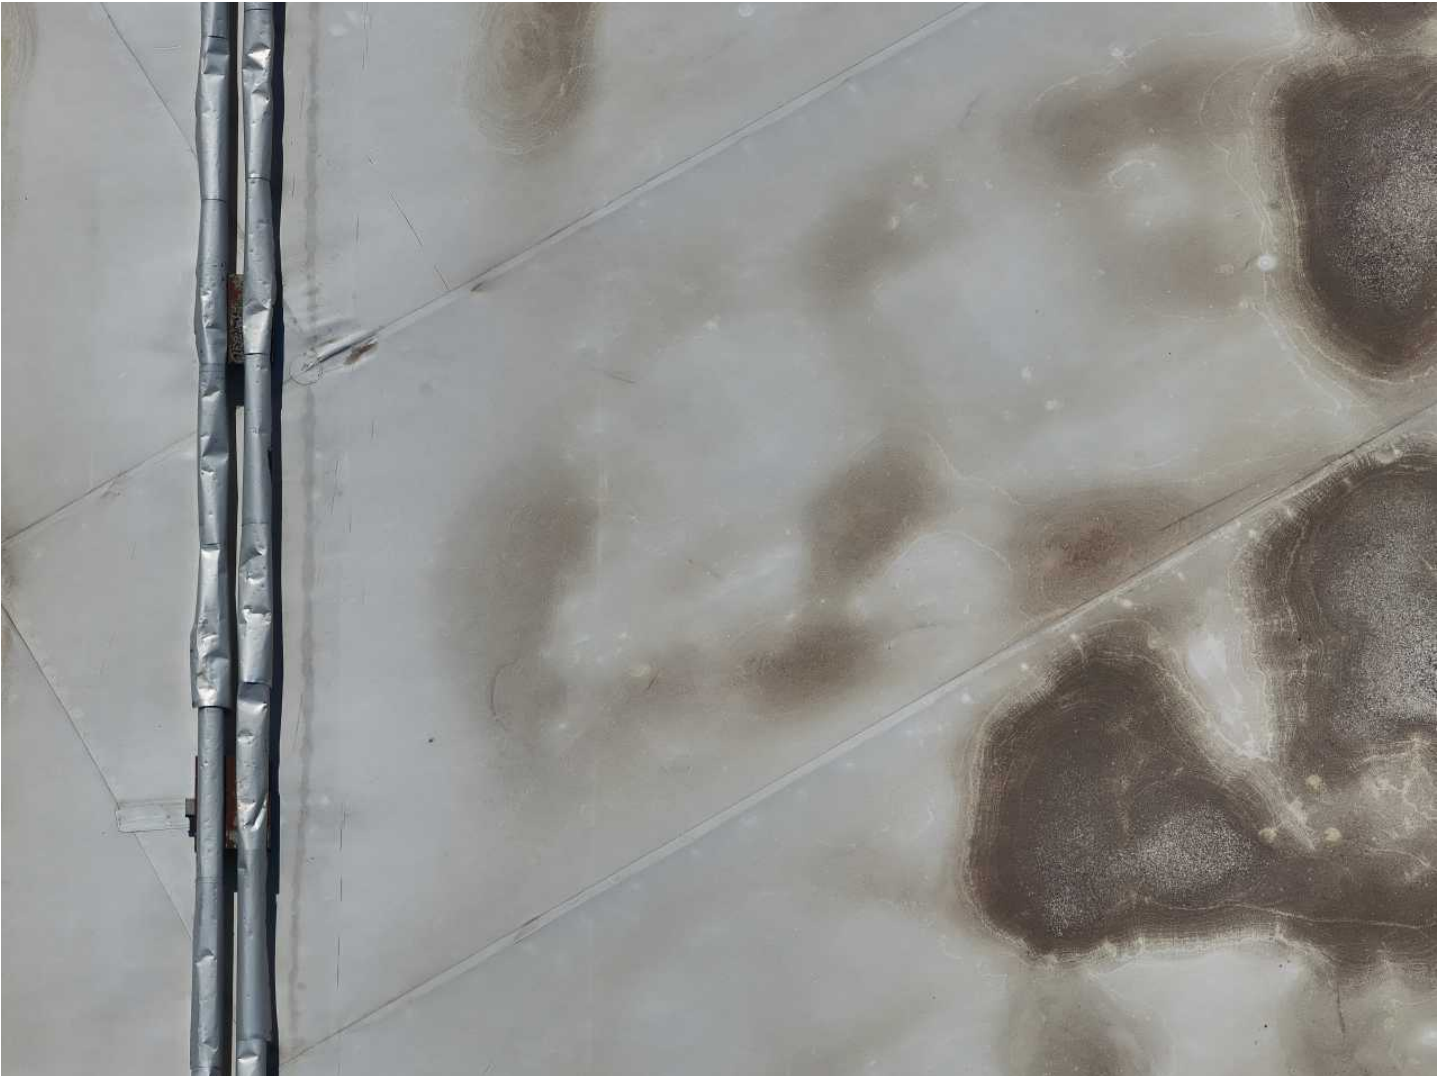
49

49-UV Degredation

While white TPO membranes are designed to reflect UV radiation, ponding water can concentrate the sun's rays, increasing UV damage to the membrane

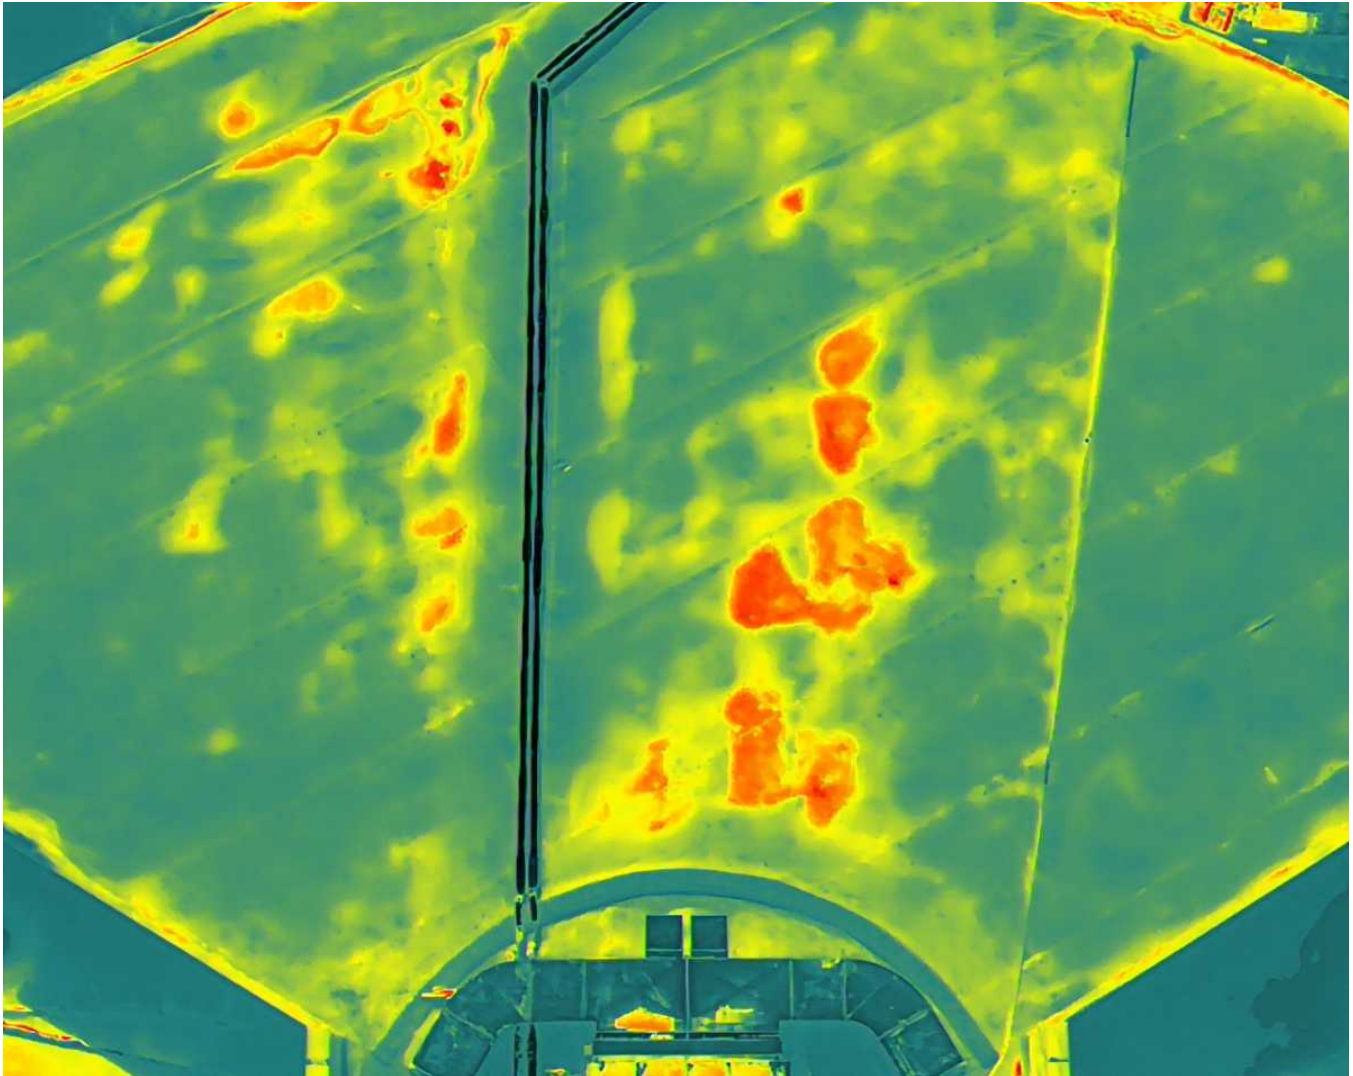
50

50-Boiling Temperatures

Ponding water creates dark areas on the roof surface. These dark areas absorb more sunlight than a white roof, leading to a significant temperature increase.

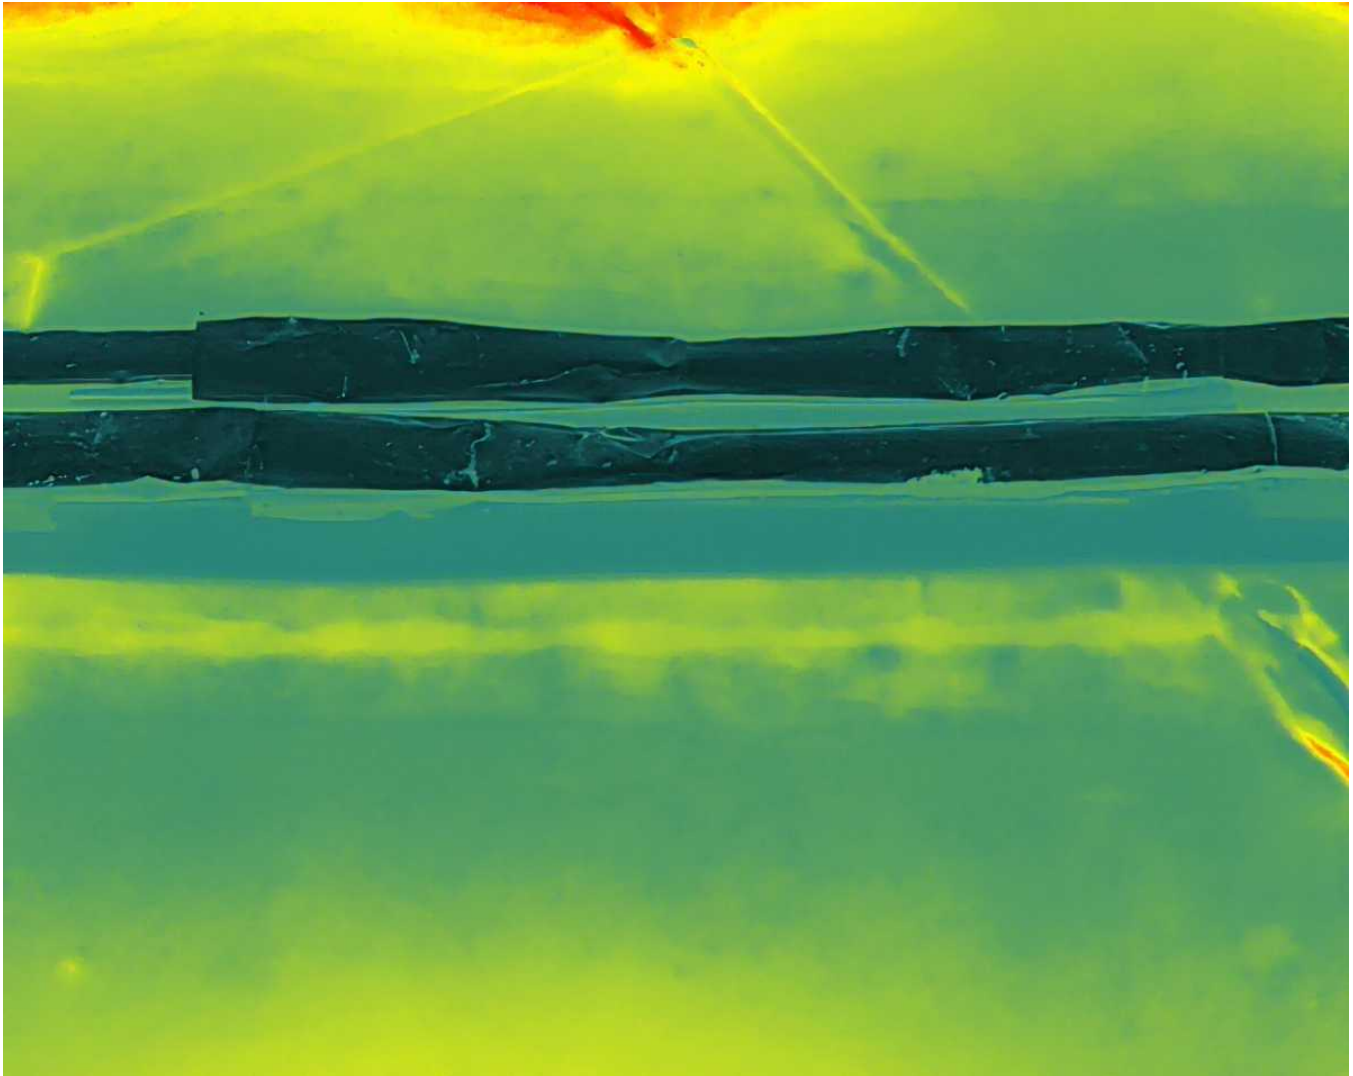
51 51-UV Degredation Date Taken: 4/21/2025 Taken By: Angela Night

While white TPO membranes are designed to reflect UV radiation, ponding water can concentrate the sun's rays, increasing UV damage to the membrane

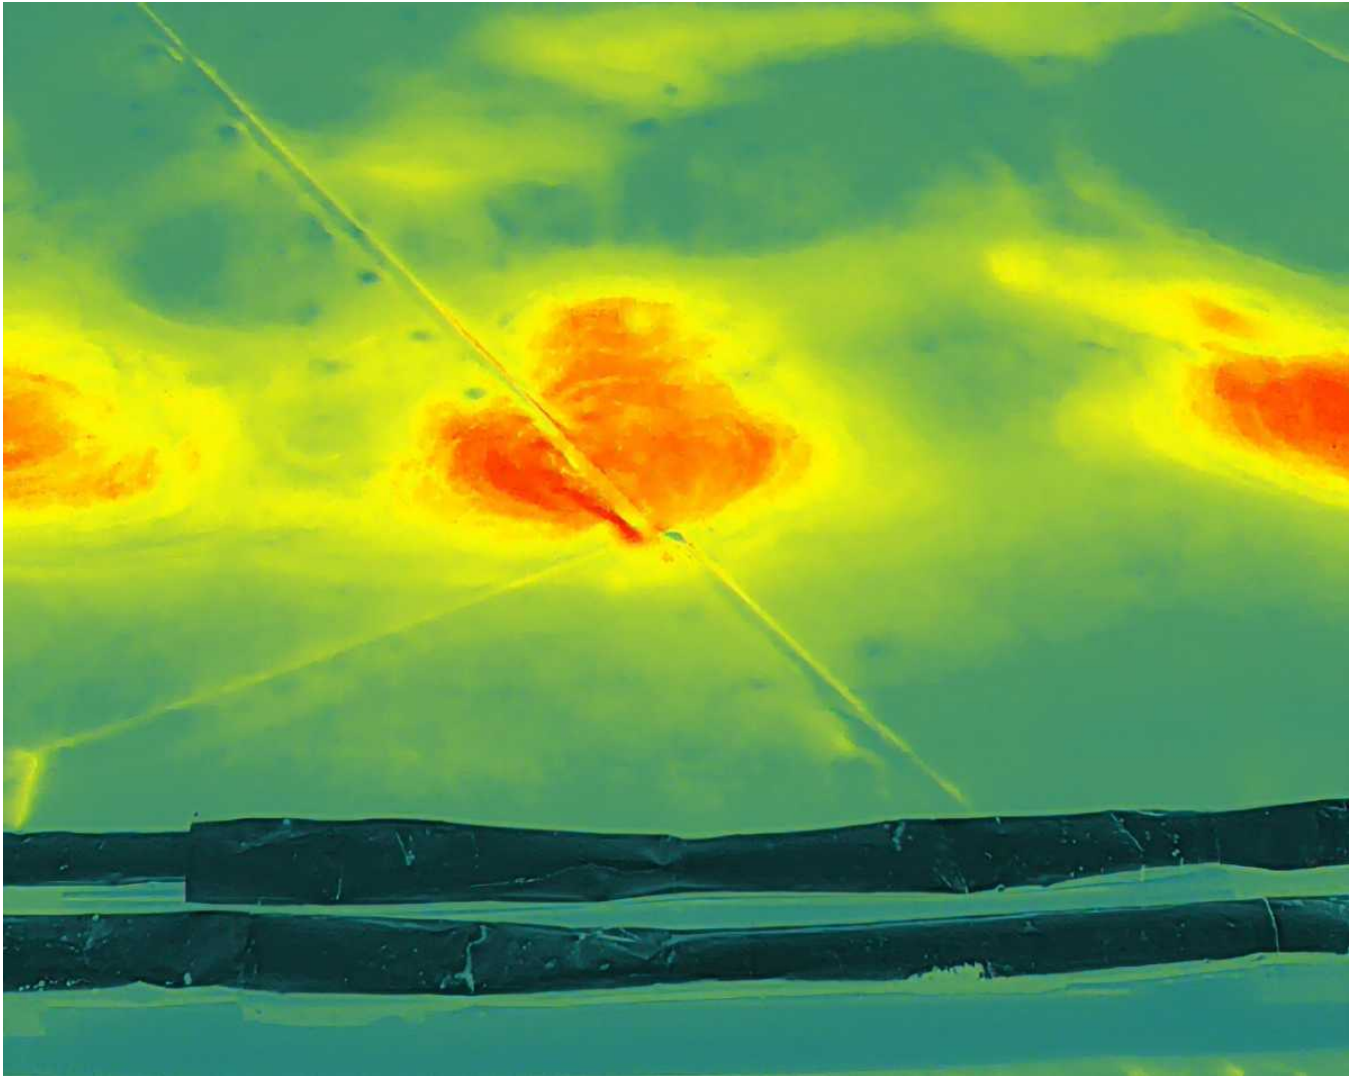
While white TPO membranes are designed to reflect UV radiation, ponding water can concentrate the sun's rays, increasing UV damage to the membrane

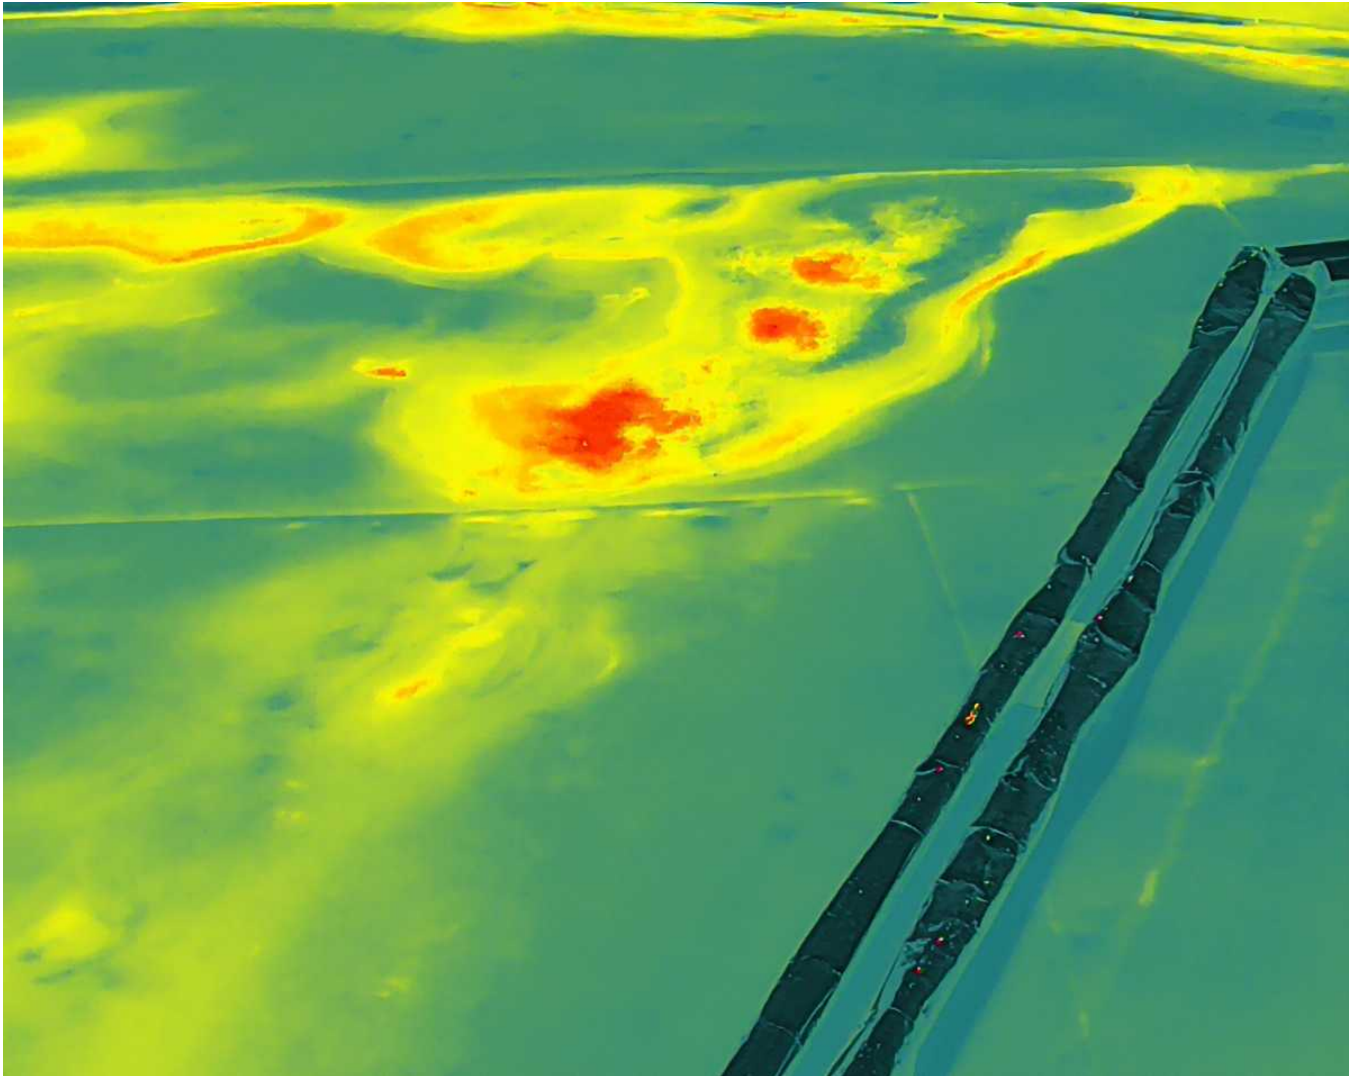
53-UV Degredation

While white TPO membranes are designed to reflect UV radiation, ponding water can concentrate the sun's rays, increasing UV damage to the membrane

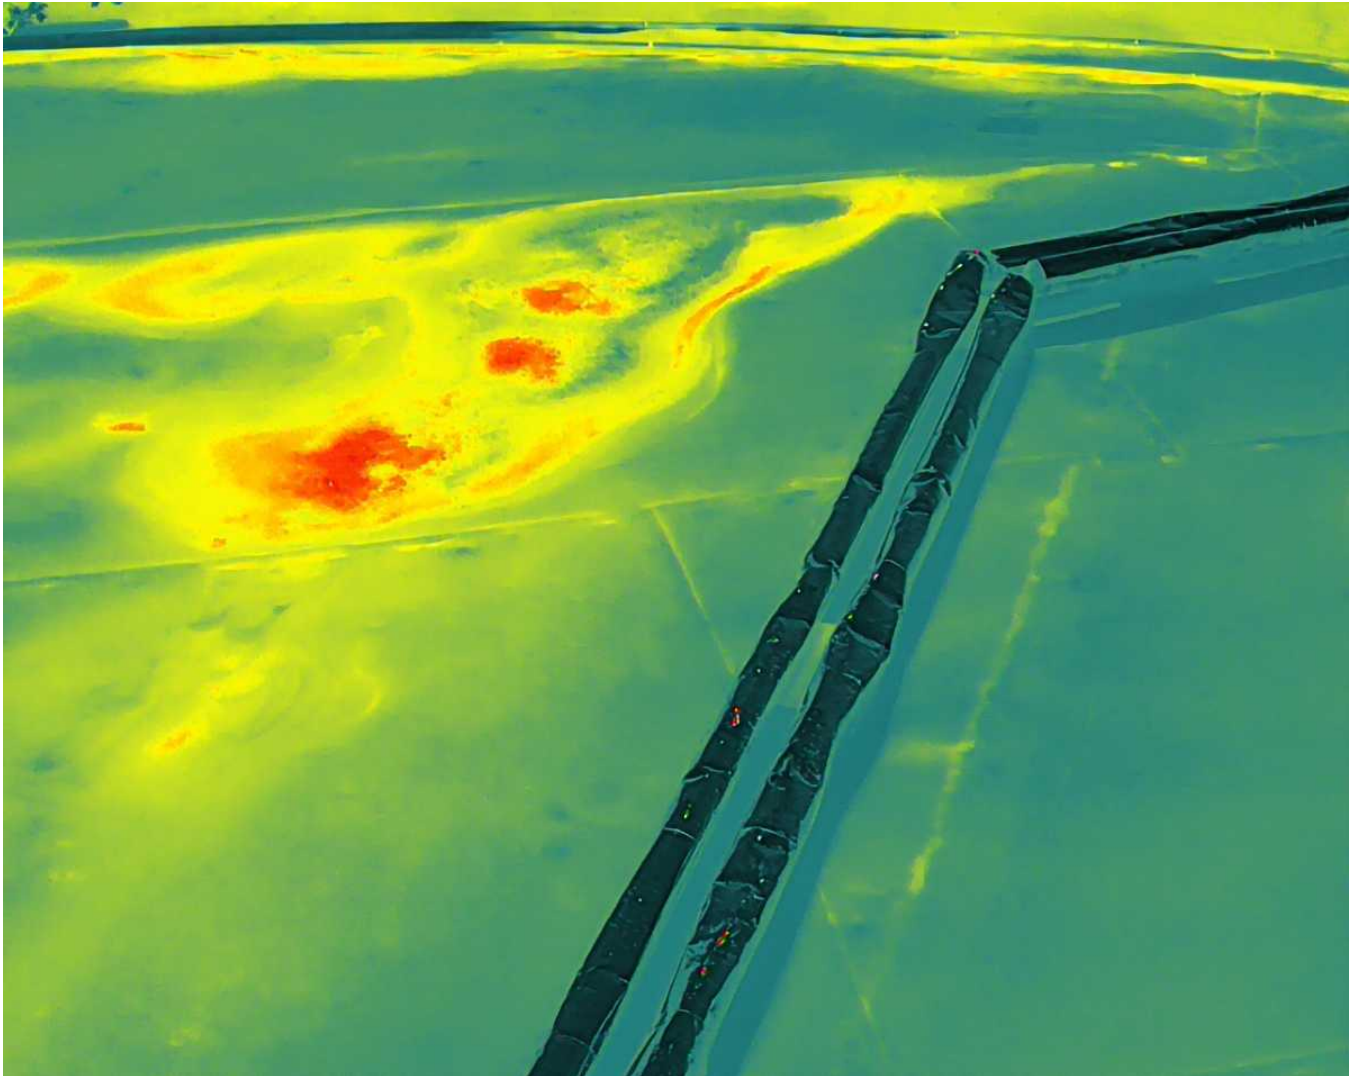
54-UV Degredation

While white TPO membranes are designed to reflect UV radiation, ponding water can concentrate the sun's rays, increasing UV damage to the membrane

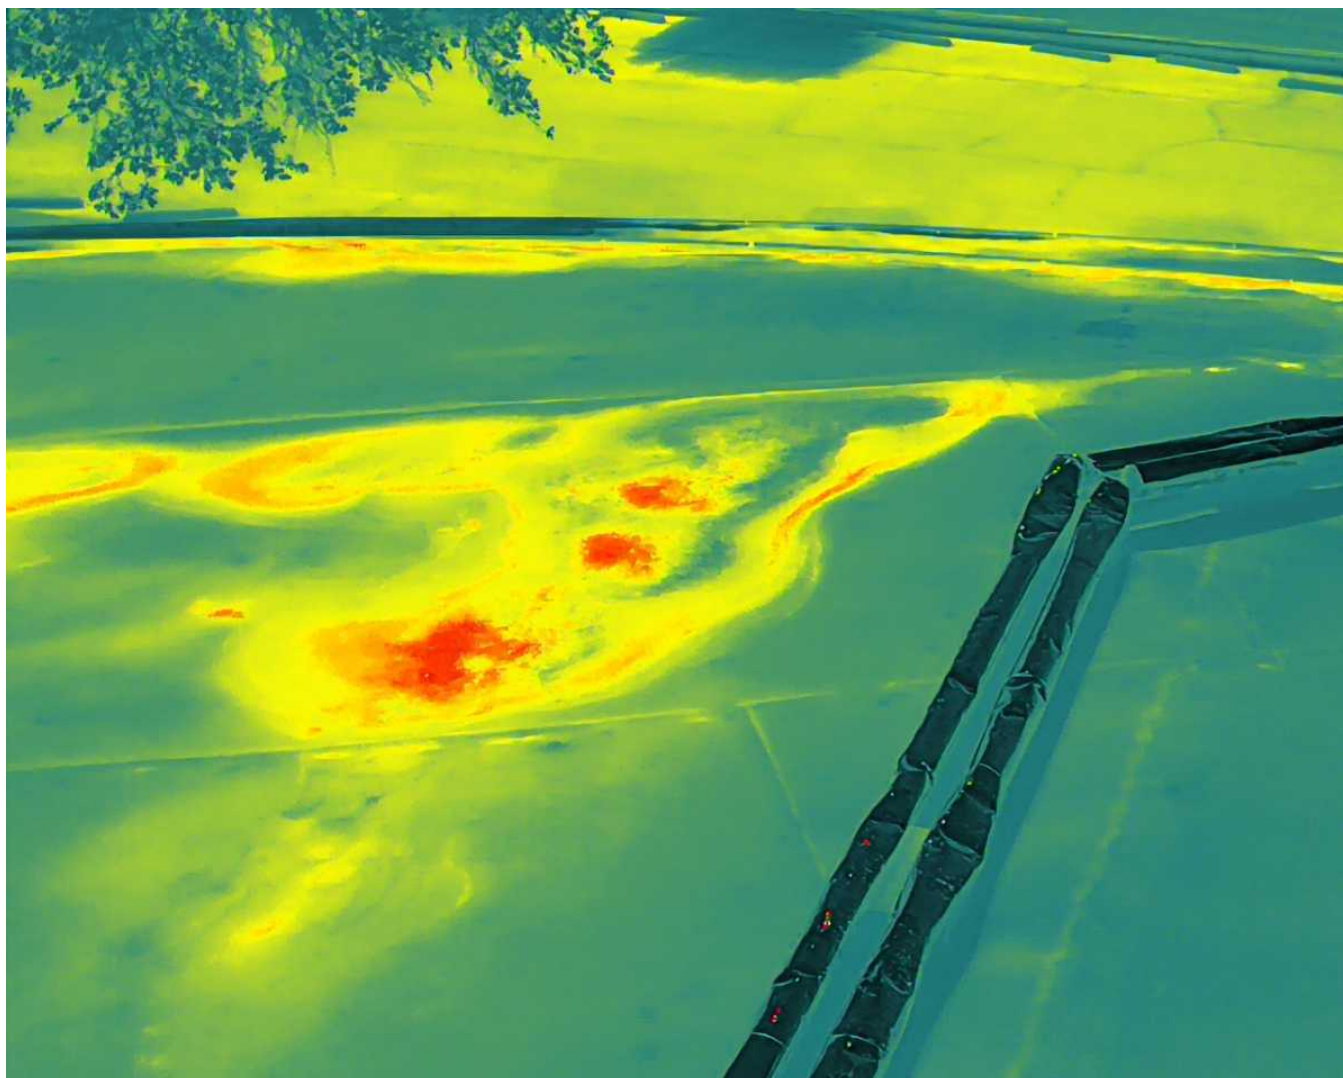
55-UV Degredation

While white TPO membranes are designed to reflect UV radiation, ponding water can concentrate the sun's rays, increasing UV damage to the membrane

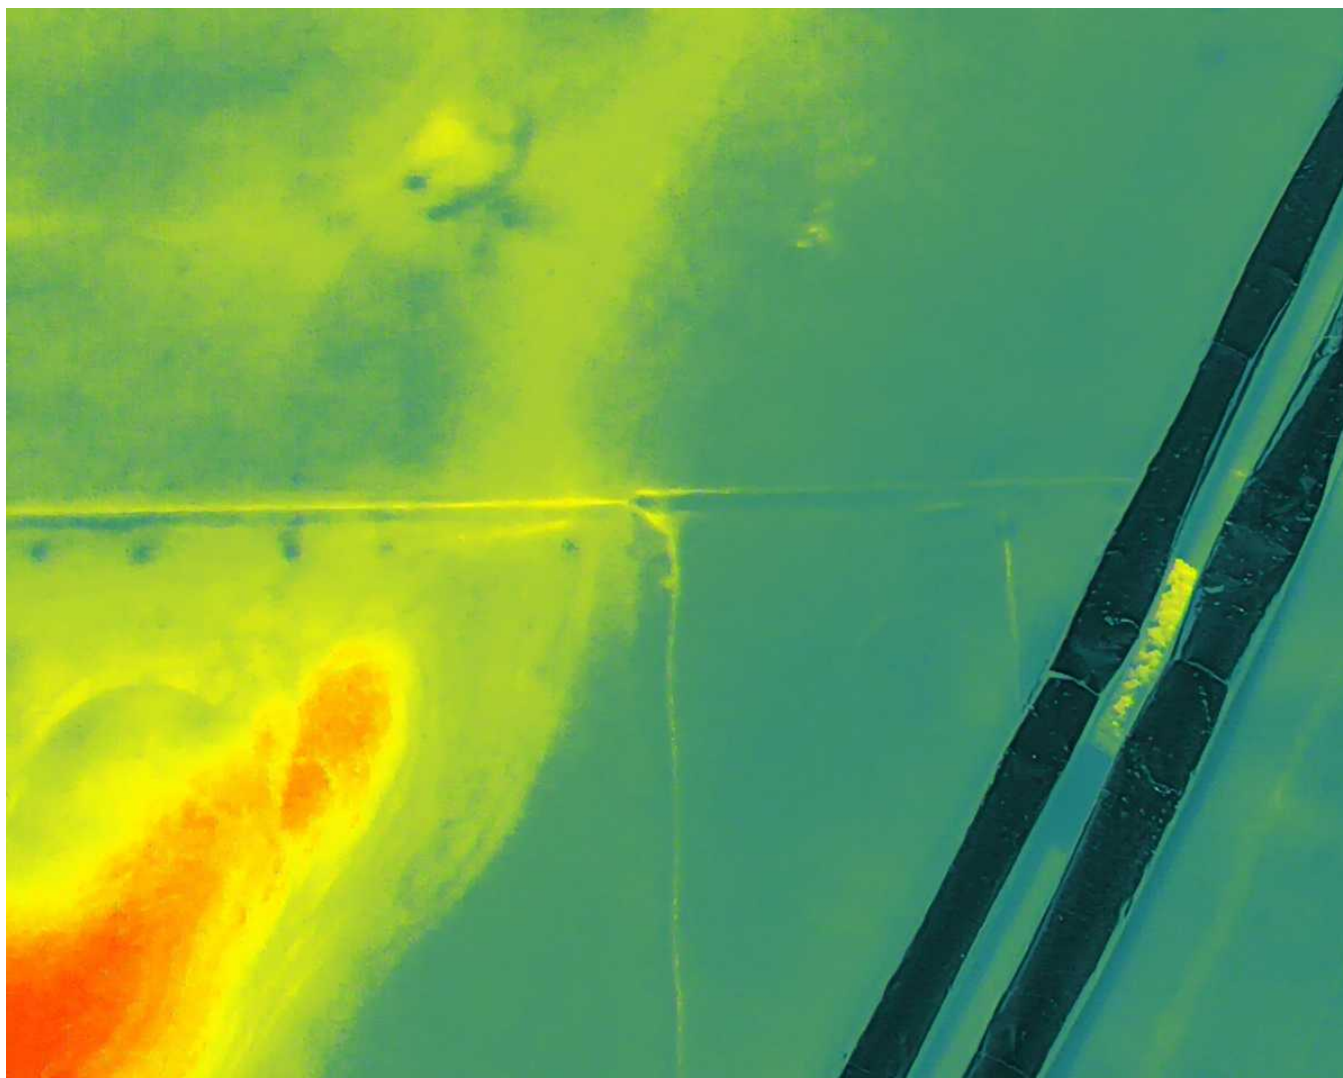
56 56-UV Degredation Date Taken: 4/21/2025 Taken By: Angela Night

While white TPO membranes are designed to reflect UV radiation, ponding water can concentrate the sun's rays, increasing UV damage to the membrane
