DIV7|ROOF Company

Estimate: FOSTER_COLLEGE

The current roofing system is a TPO (Thermoplastic Polyolefin) that is mechanically attached (there are various areas across the mapping area that were found to be improperly installed). **A fully adhered system is highly recommended in comparison to a mechanically attached system to be applied a gravel ballast built-up roof. Fully adhered systems can reduce the number of seams needed, decreasing potential leak points.**

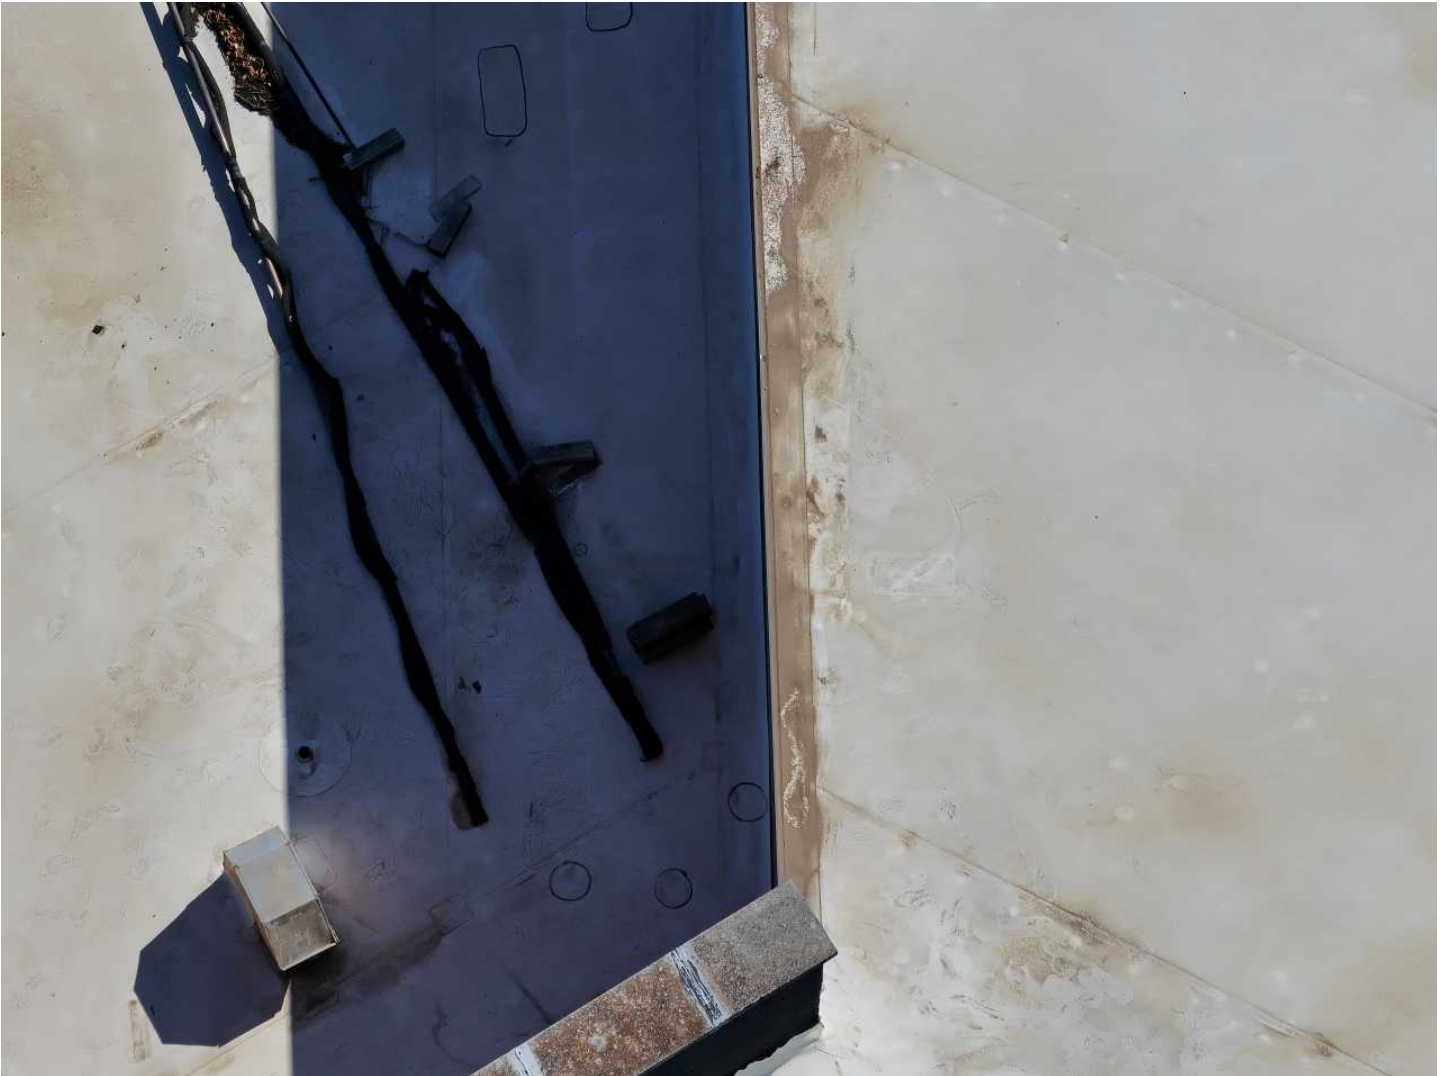
57 57-UV Degredation Date Taken: 4/21/2025 Taken By: Angela Night

While white TPO membranes are designed to reflect UV radiation, ponding water can concentrate the sun's rays, increasing UV damage to the membrane

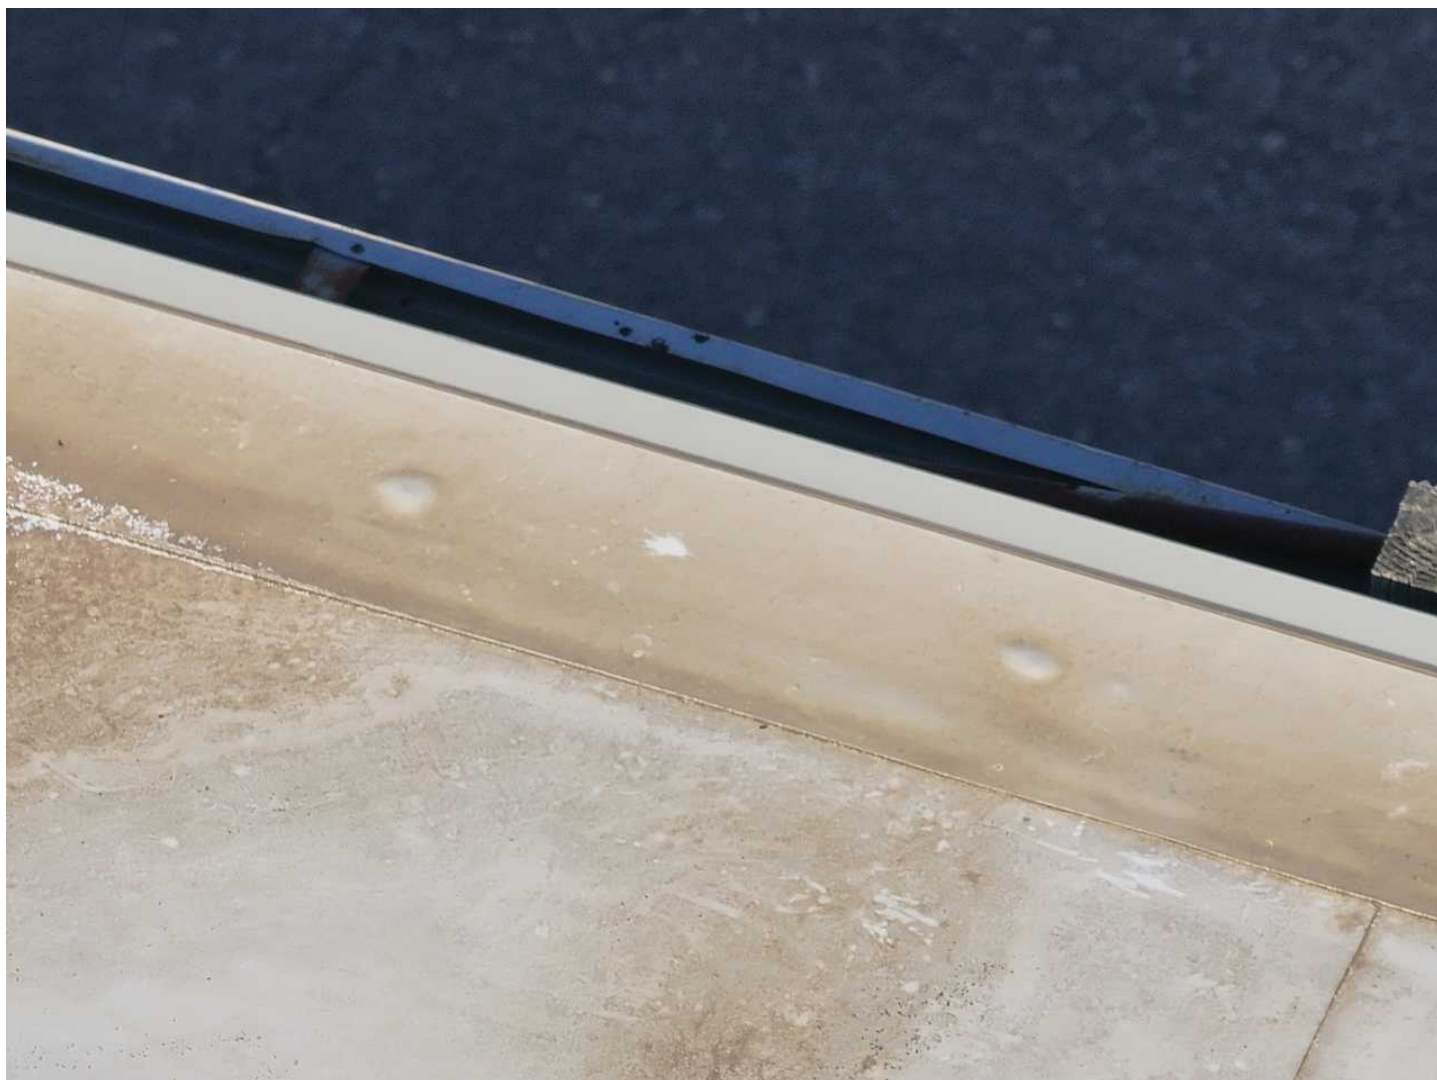
58-Indicative Hail

Natural power wash markings from hail that was present (non damaging).

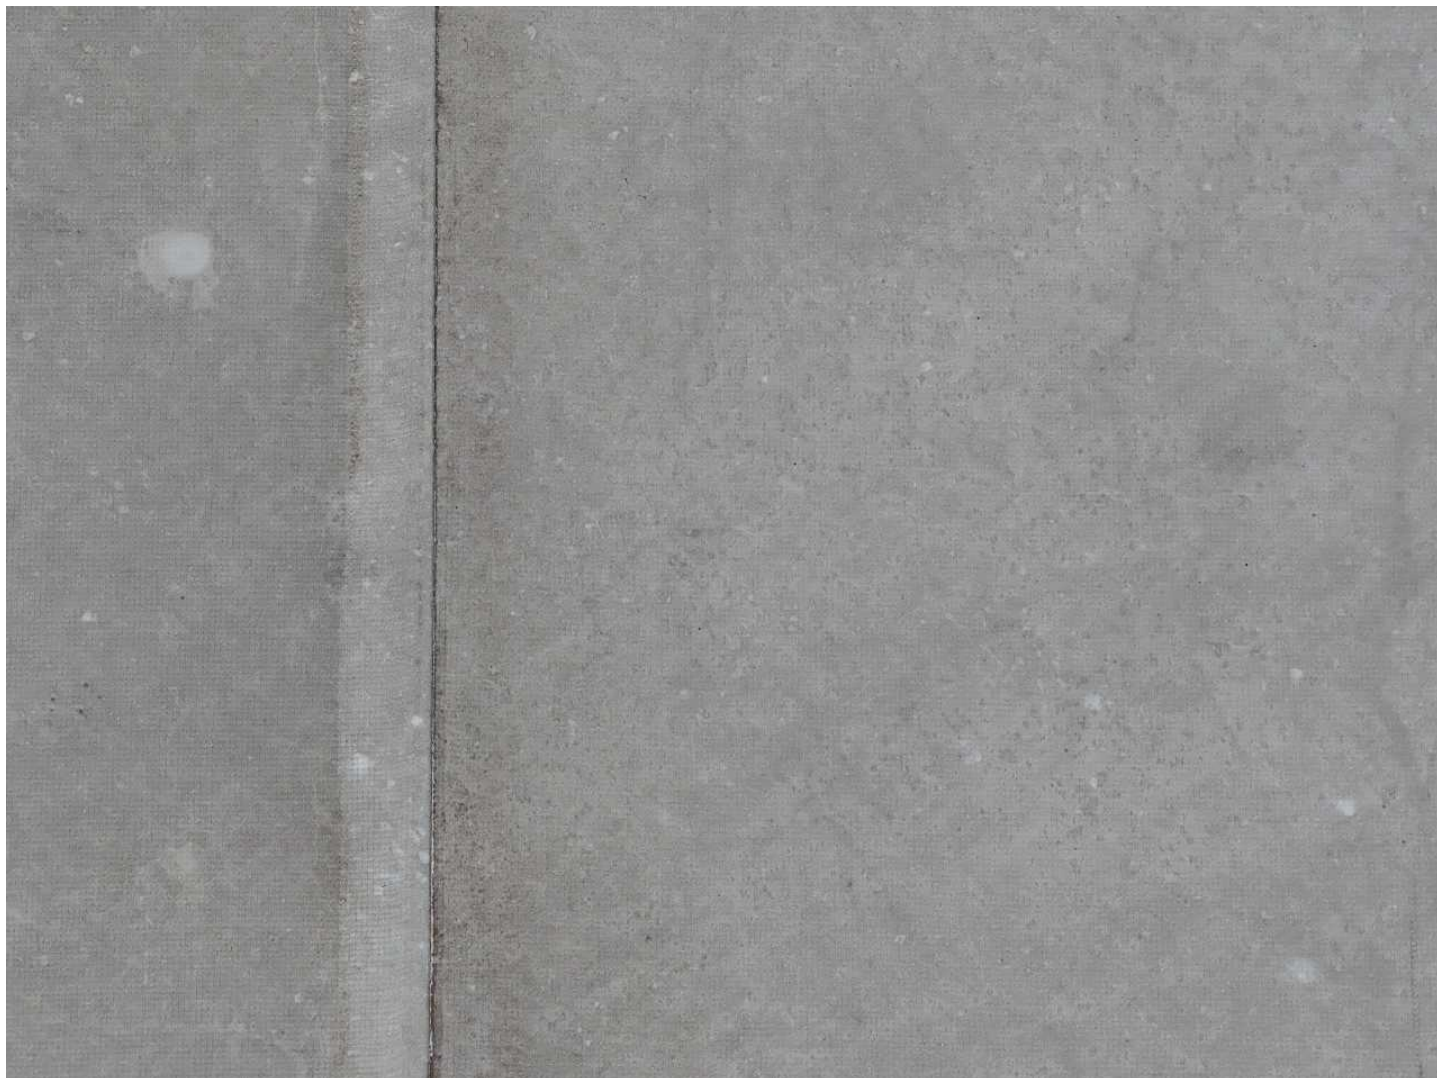
59 59-Indicative Hail Date Taken: 4/21/2025 Taken By: Angela Night
Natural power wash markings from hail that was present (non damaging).

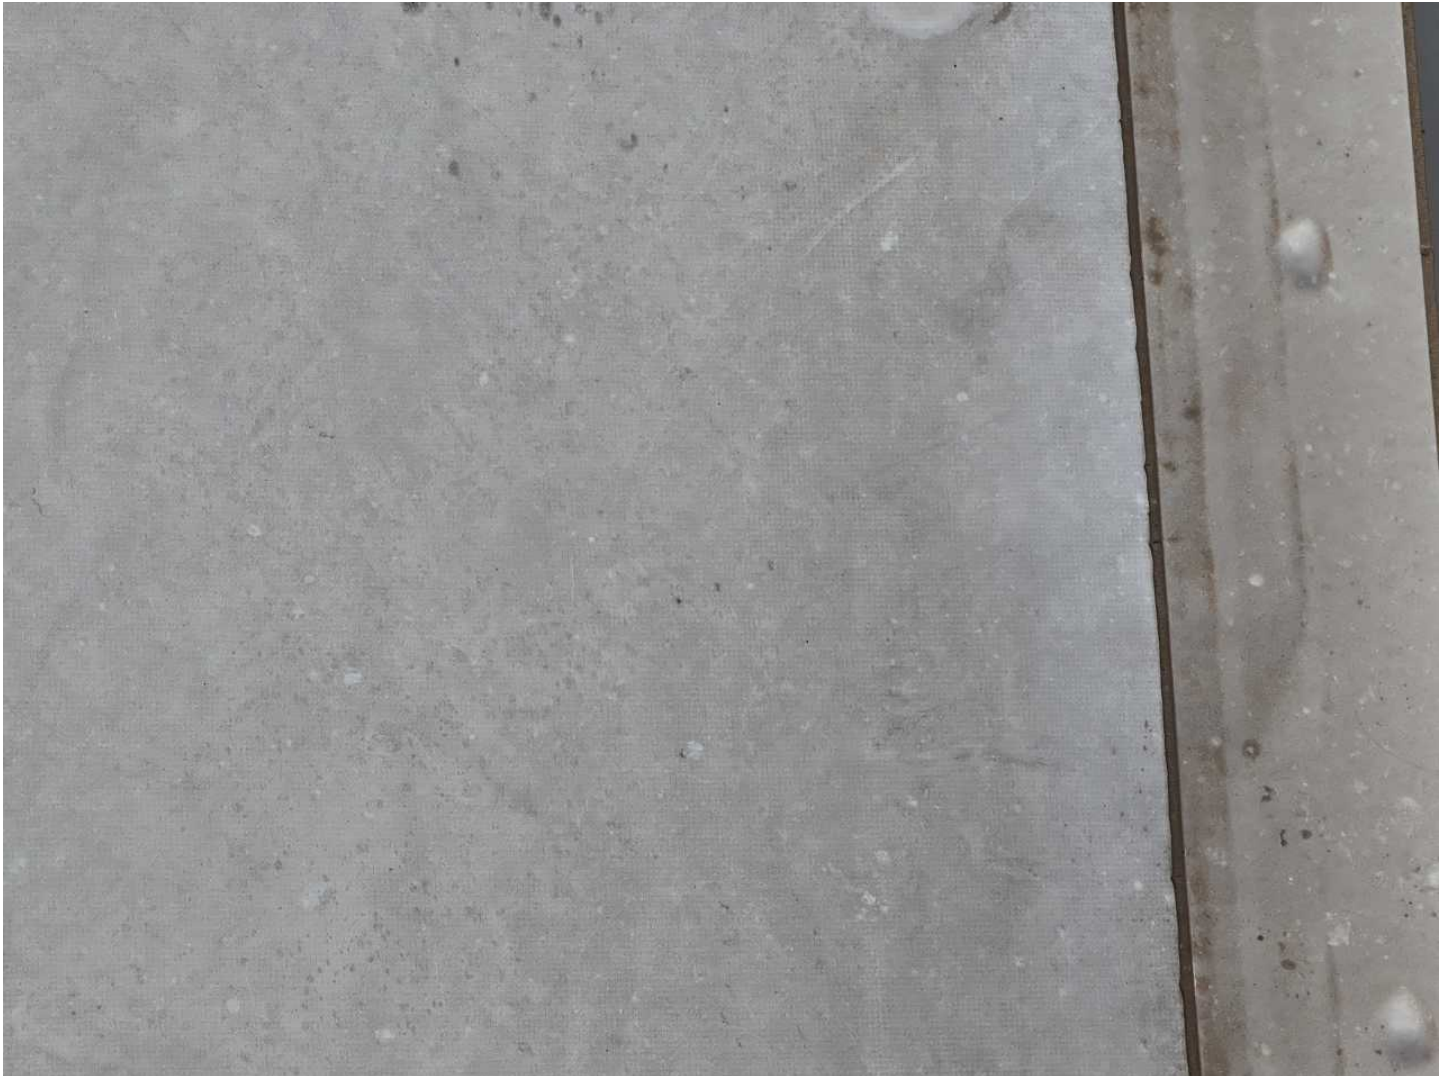
60 60-Indicative Hail Date Taken: 4/21/2025 Taken By: Angela Night
Natural power wash markings from hail that was present (non damaging).

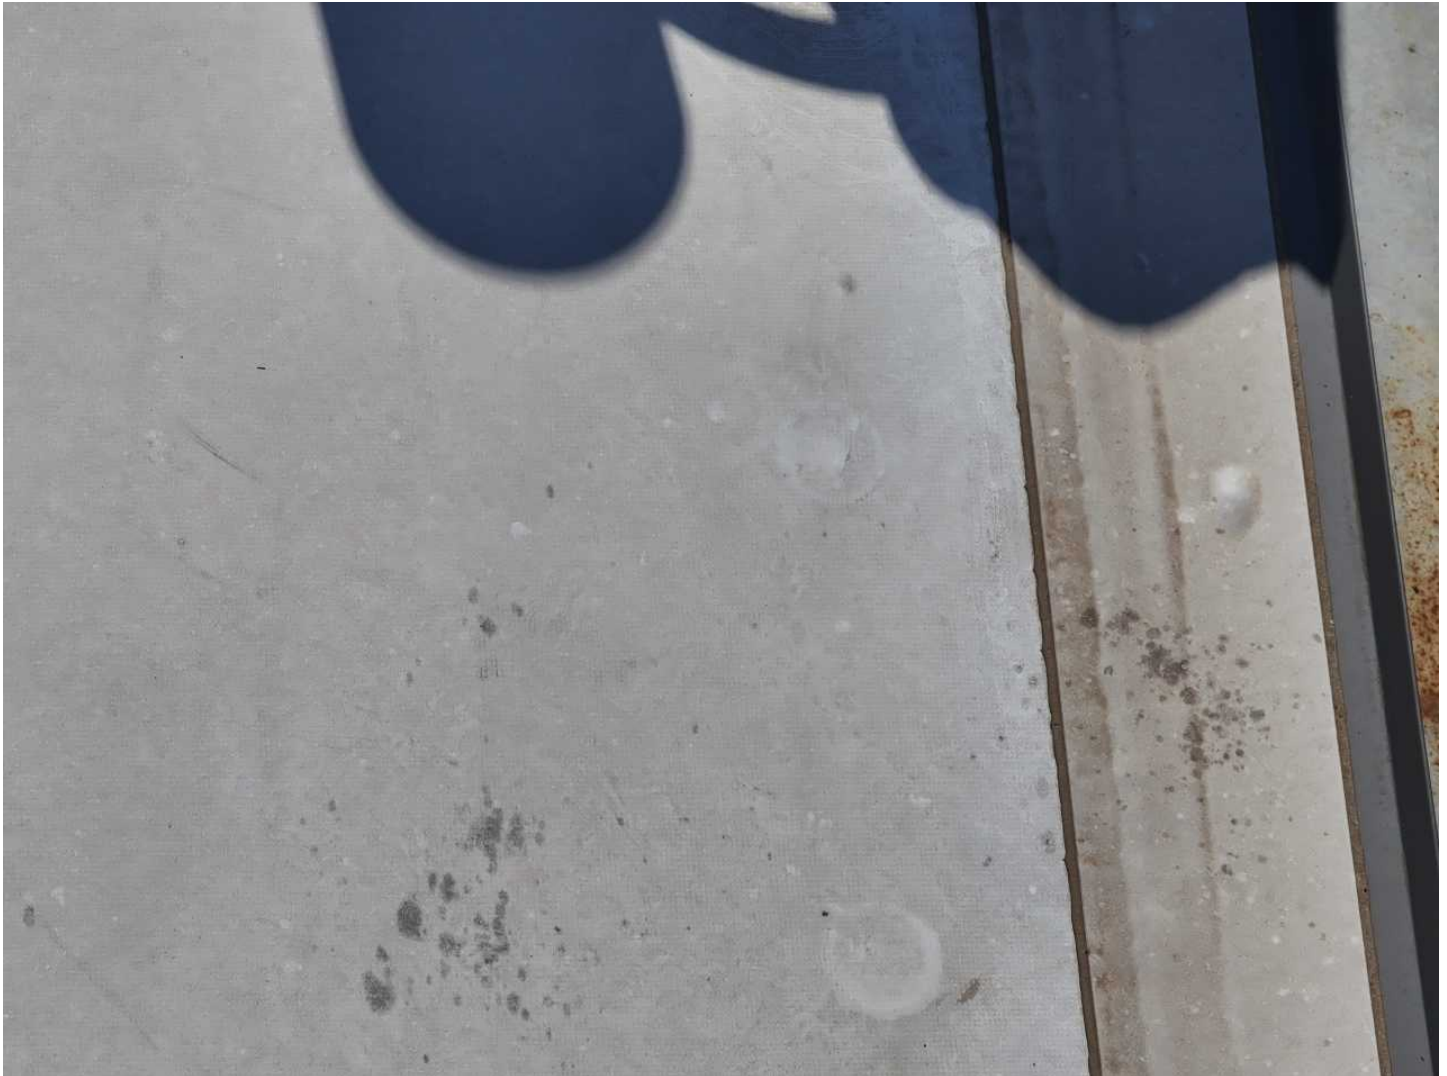
61 61-Indicative Hail Date Taken: 4/21/2025 Taken By: Angela Night
Natural power wash markings from hail that was present (non damaging).

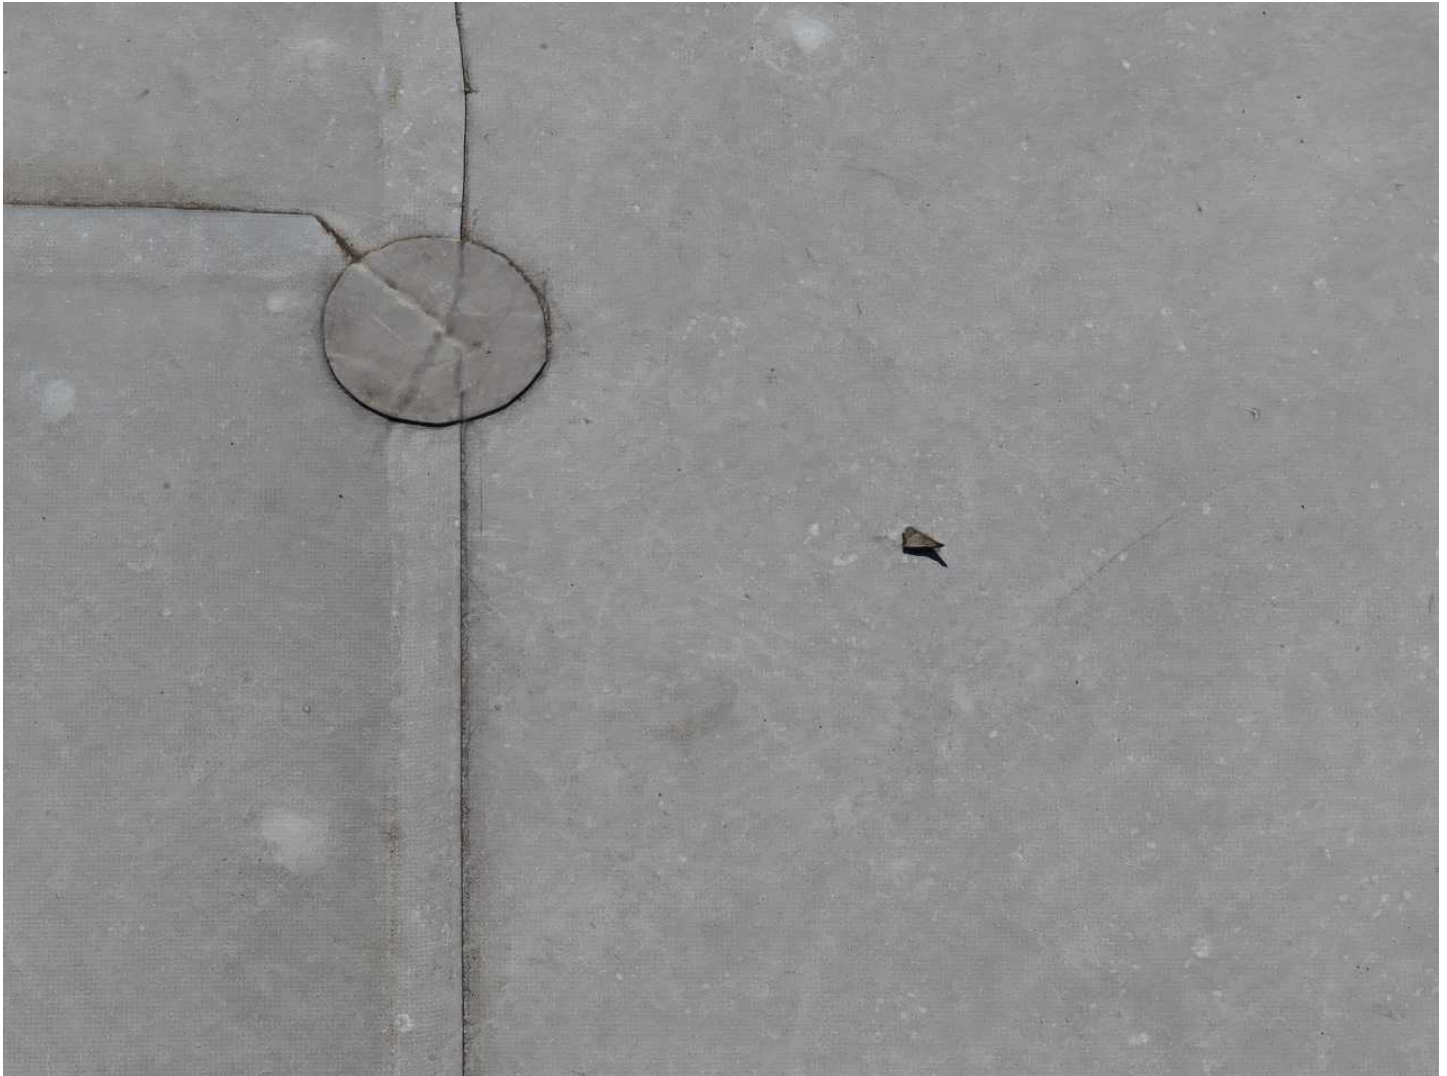
62-Indicative Hail

Natural power wash markings from hail that was present (non damaging).

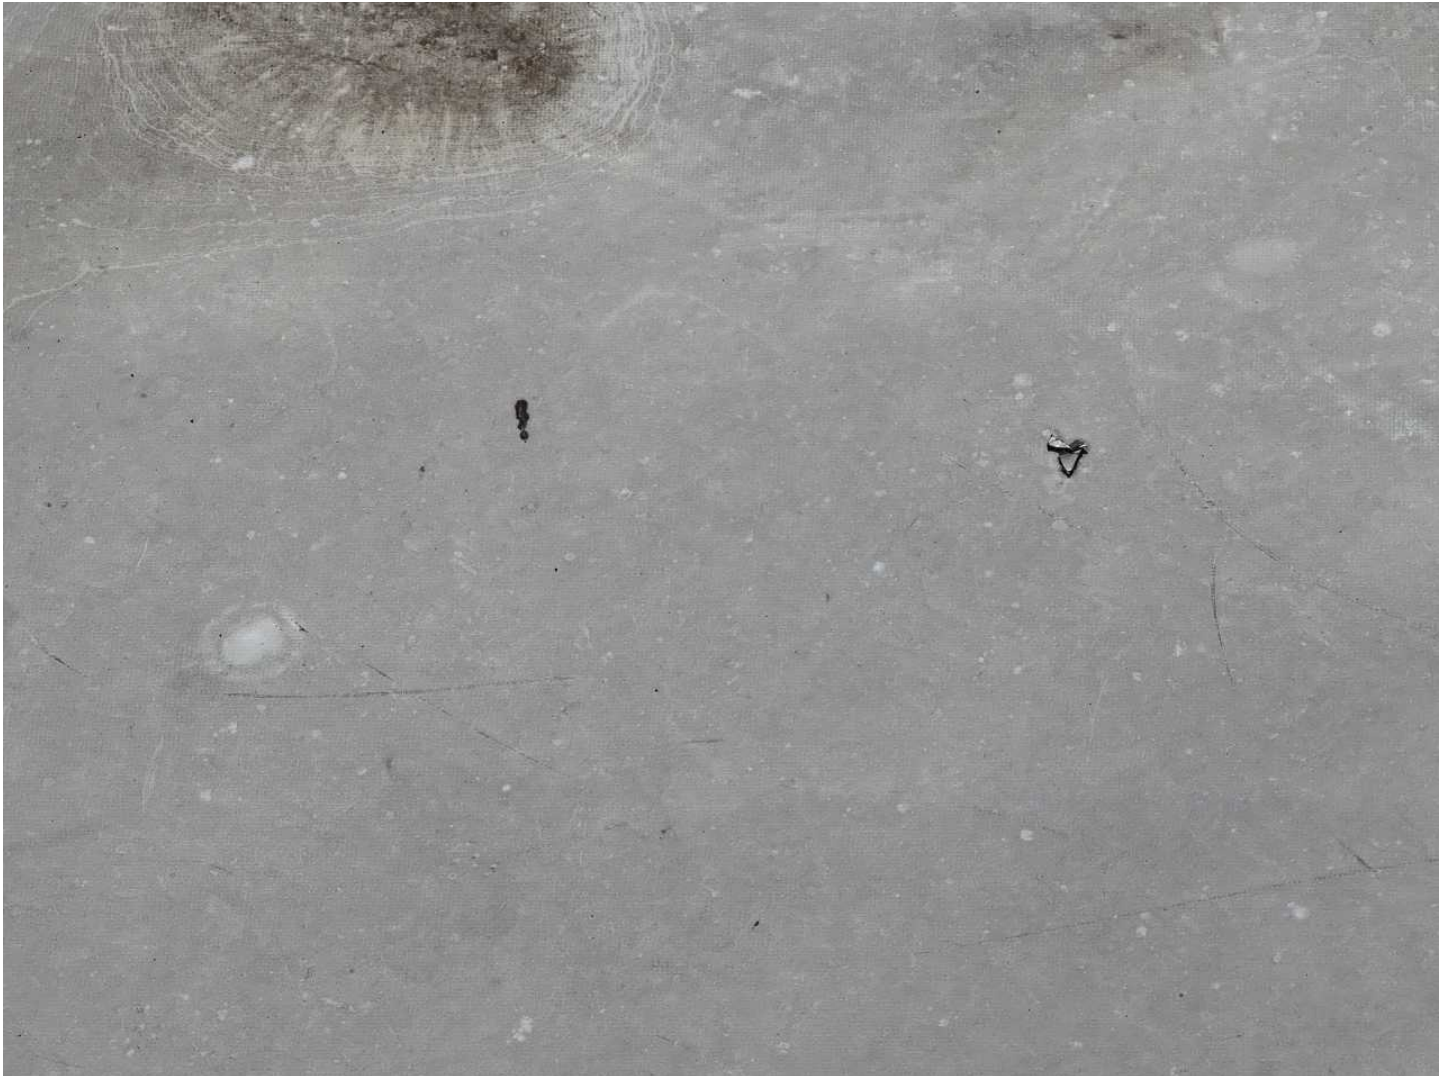
63-Indicative Hail

Natural power wash markings from hail that was present (non damaging).

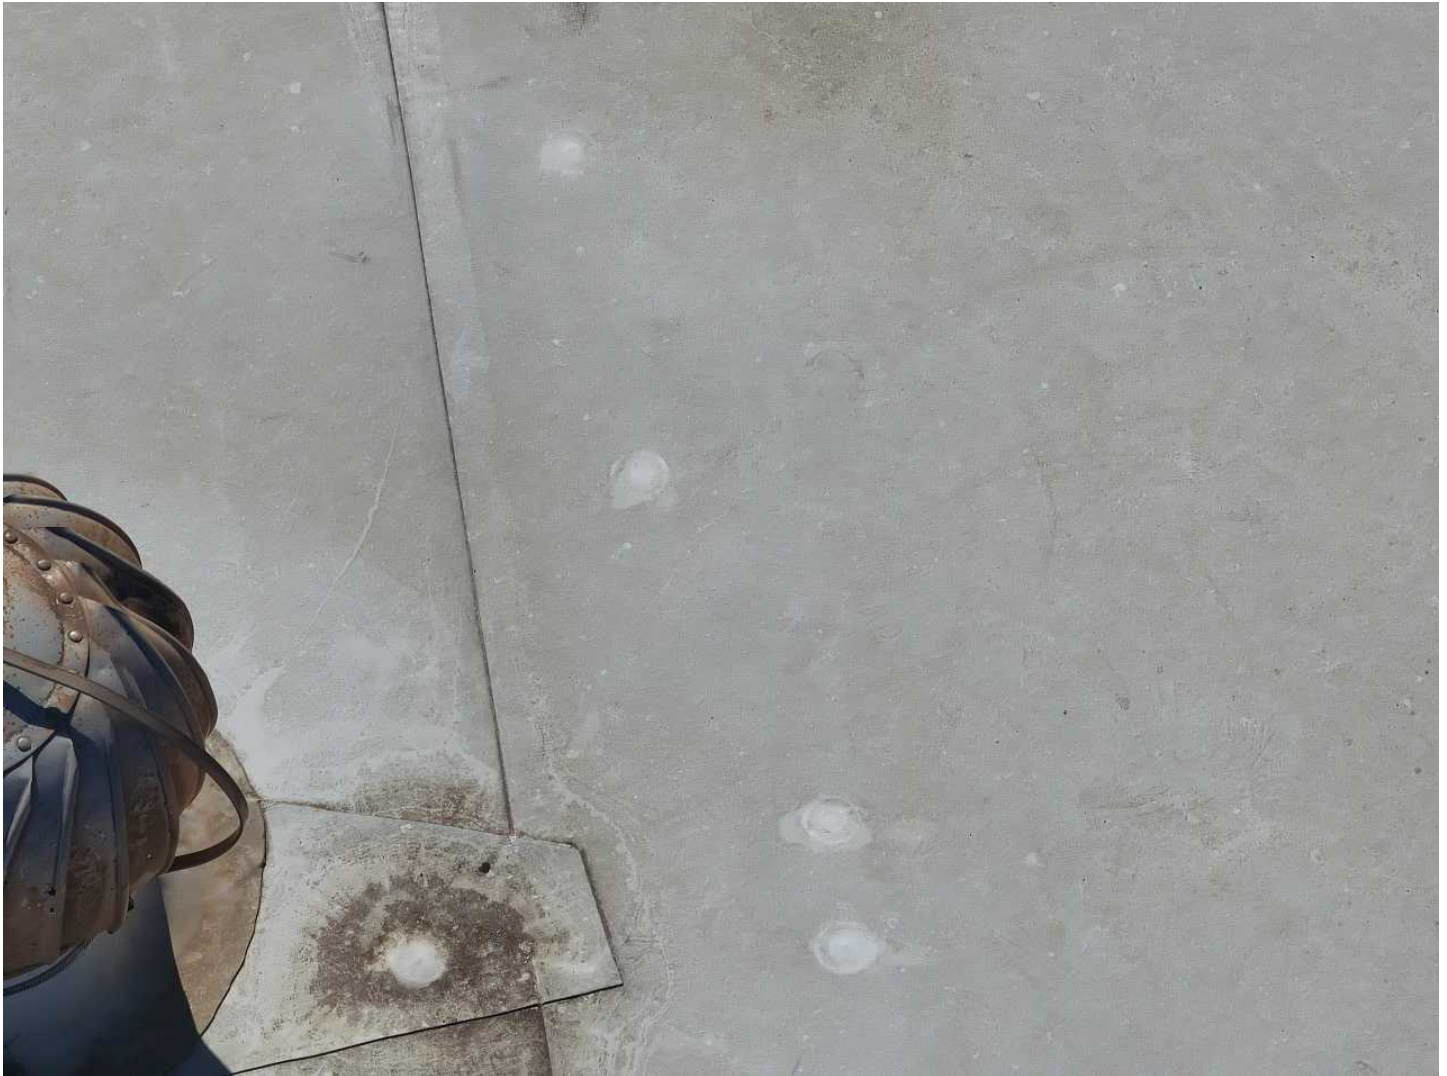
64-Indicative Hail

Natural power wash markings from hail that was present (non damaging).

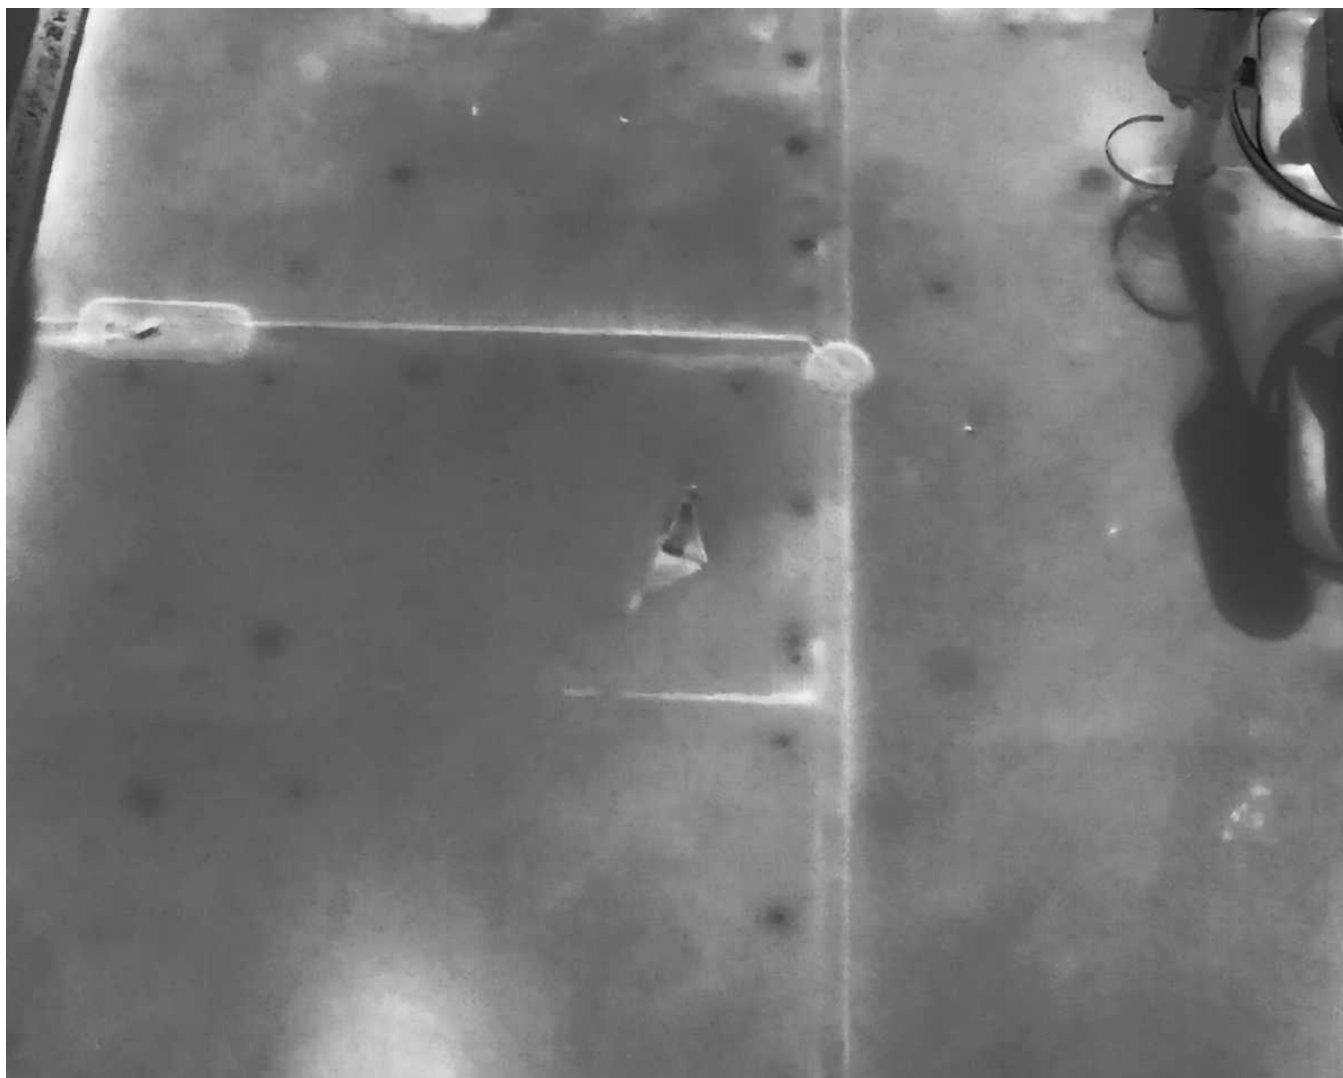
74 74-Mechanical Damage Date Taken: 4/21/2025 Taken By: Angela Night
Splits are present on the roof that potentially were caused by irregular handling by roof repair companies.

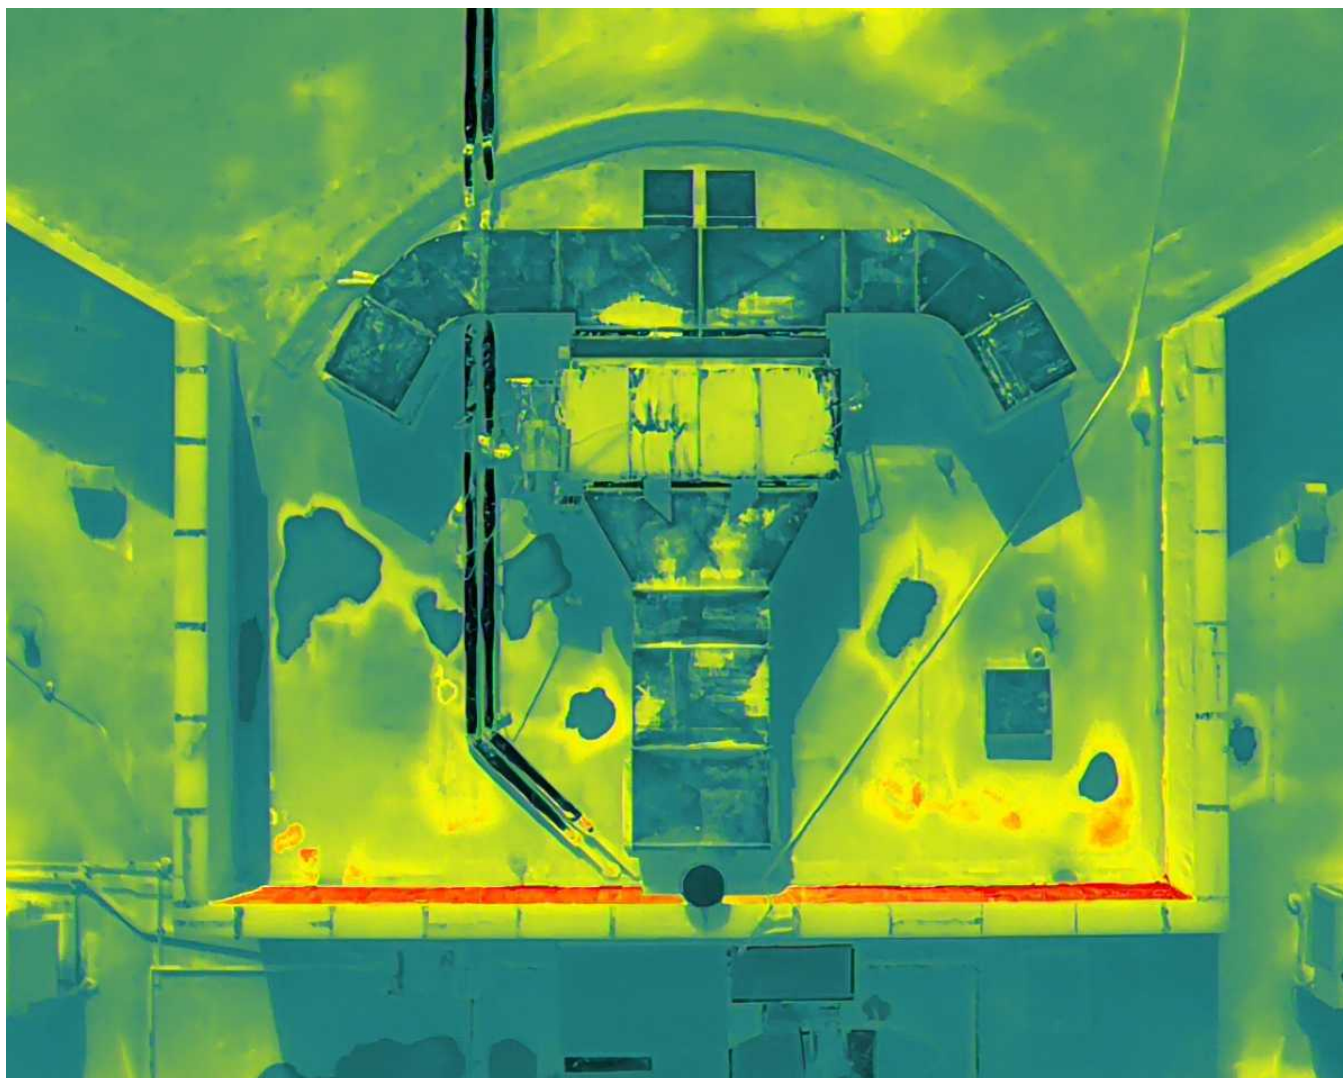
The wall has reached full temps and will begin to loose its structural integrity.

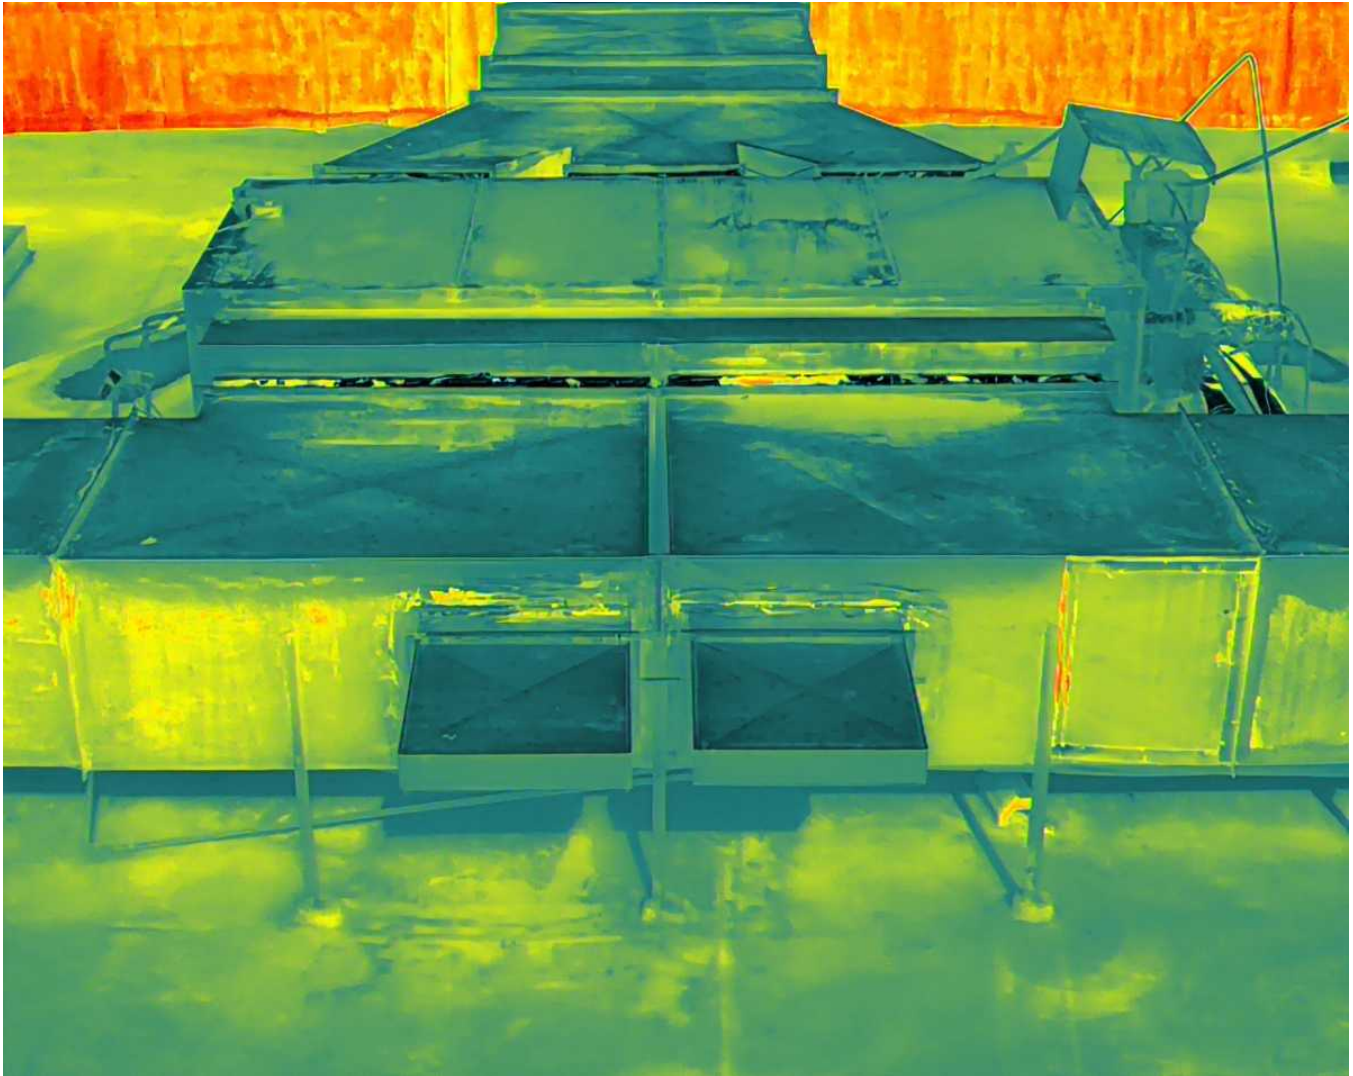
88 82-Parapet Date Taken: 4/21/2025 Taken By: Angela Night
IR was used in this instance to depict the concentration of high temperatures.

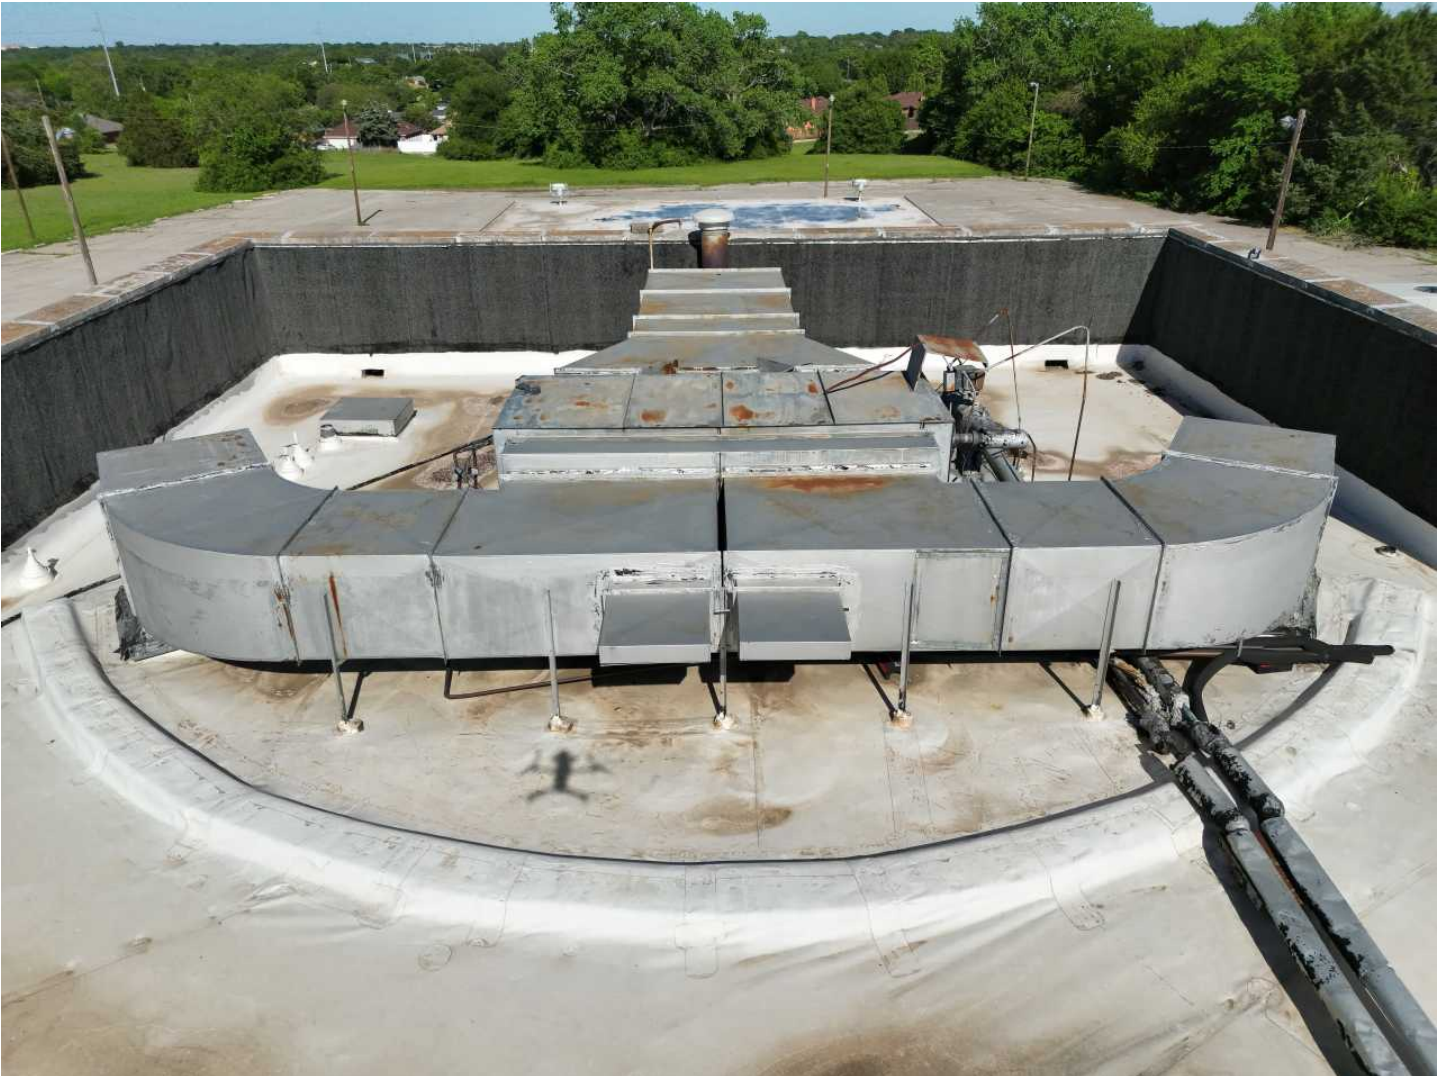
84-Parapet

IR was used in this instance to depict the concentration of high temperatures.

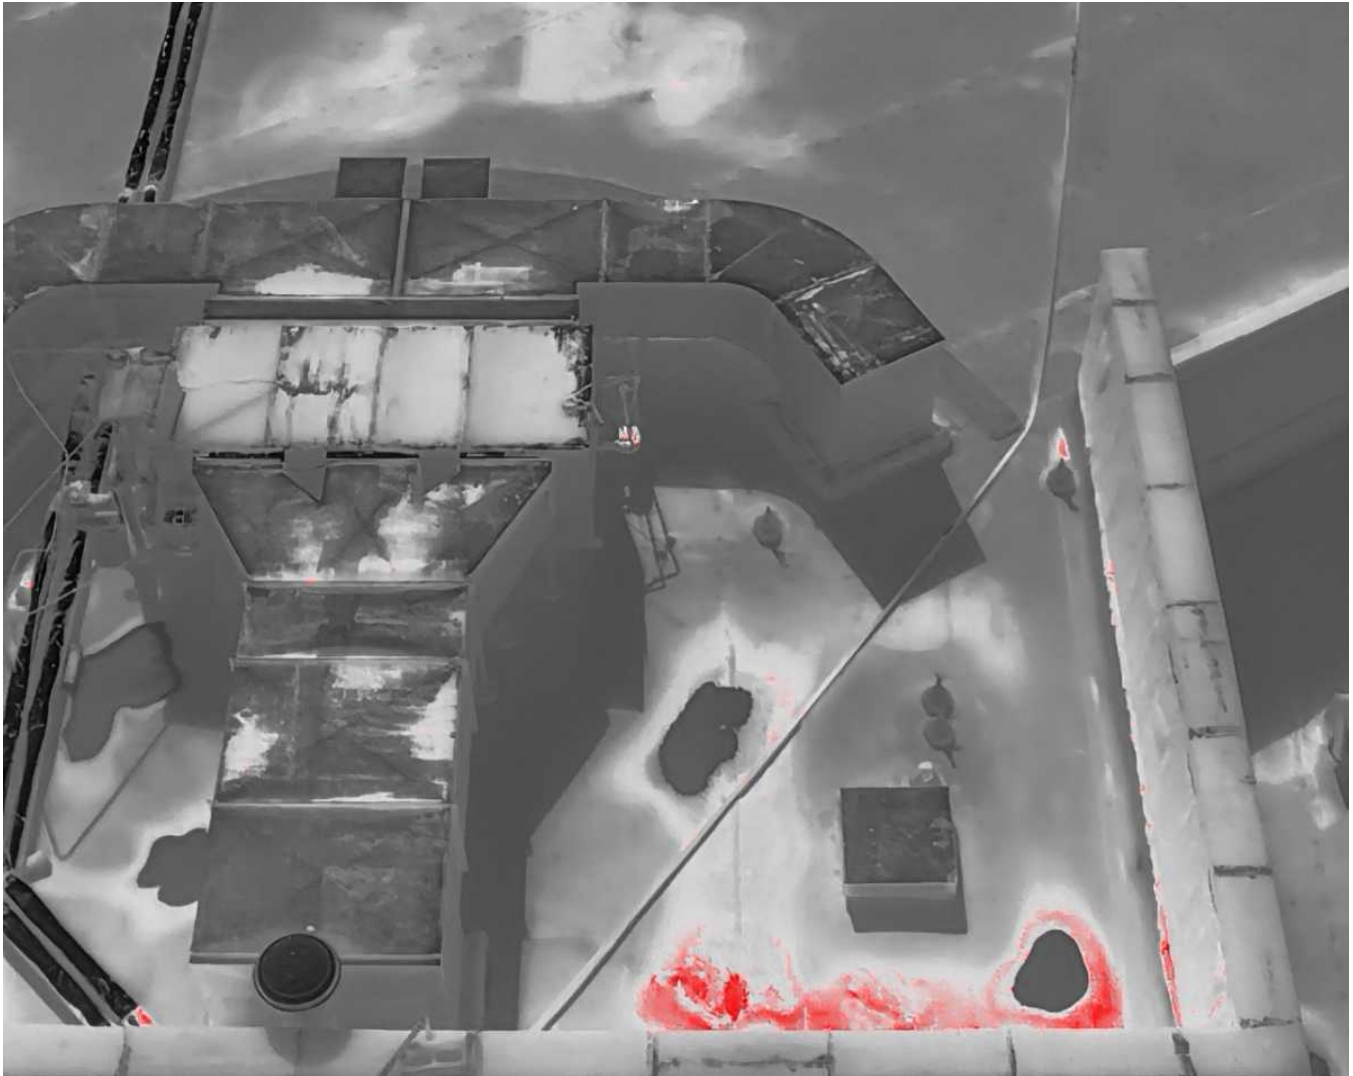
85-Parapet

The wall has reached full temps and will begin to loose its structural integrity.

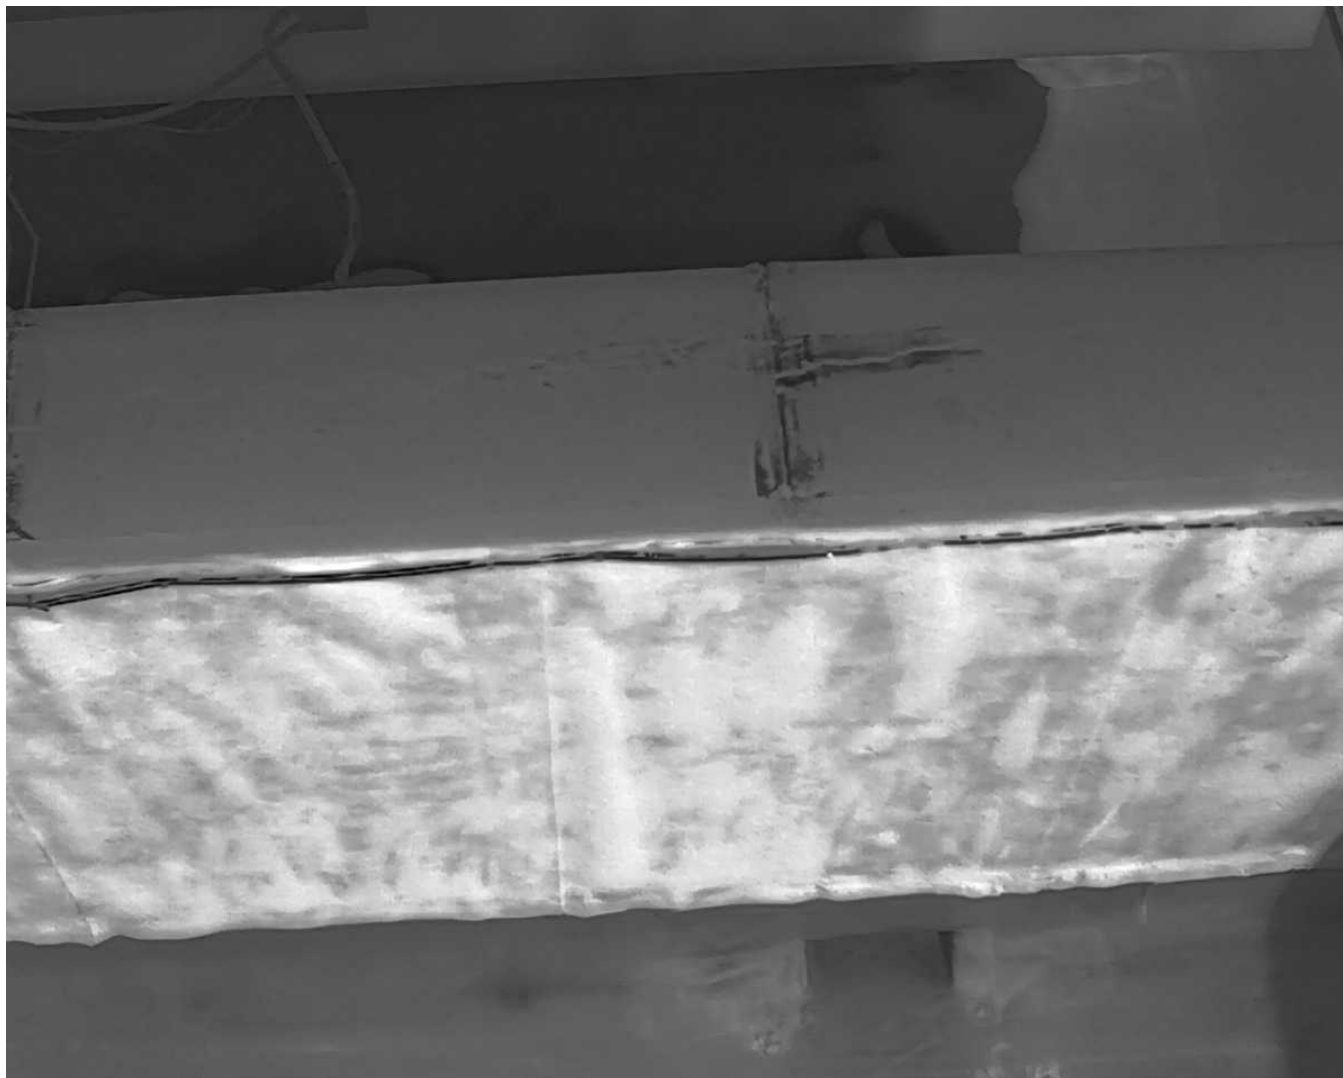
93 88-Loose Seams Date Taken: 4/21/2025 Taken By: Angela Night
Edges around the roof membrane are separating from their seams due to poor installation and gap movement.

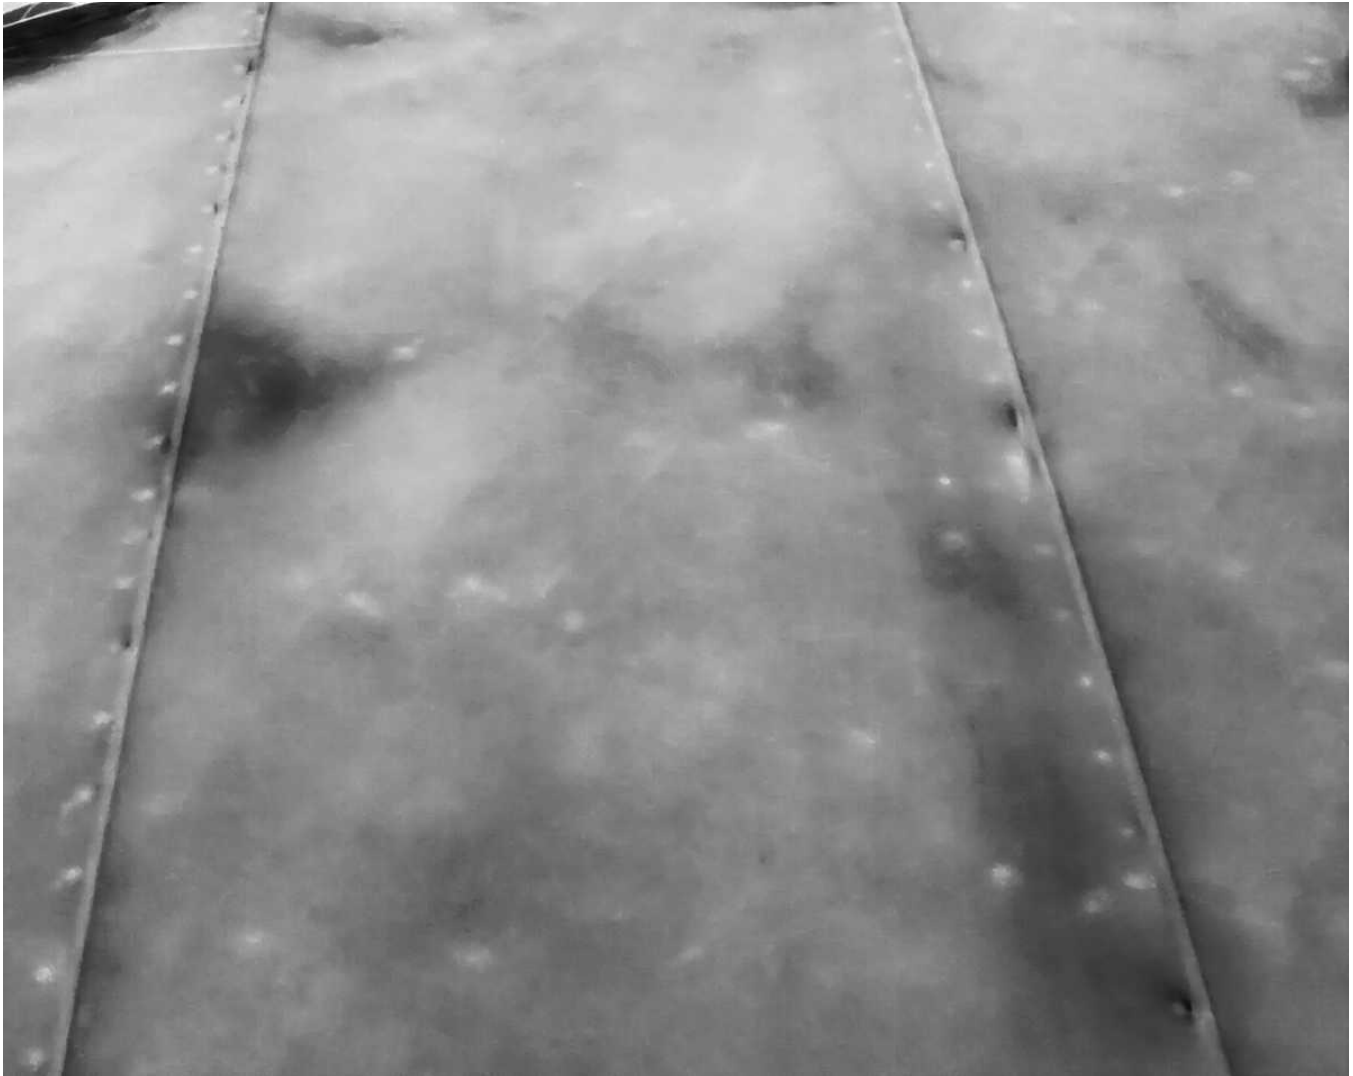
100 95-Loose Seams Date Taken: 4/21/2025 Taken By: Angela Night
Edges around the roof membrane are separating from their seams due to poor installation and gap movement.
