DIV7|ROOF Company

Estimate: FOSTER_COLLEGE

The current roofing system is a TPO (Thermoplastic Polyolefin) that is mechanically attached (there are various areas across the mapping area that were found to be improperly installed). **A fully adhered system is highly recommended in comparison to a mechanically attached system to be applied a gravel ballast built-up roof. Fully adhered systems can reduce the number of seams needed, decreasing potential leak points.**

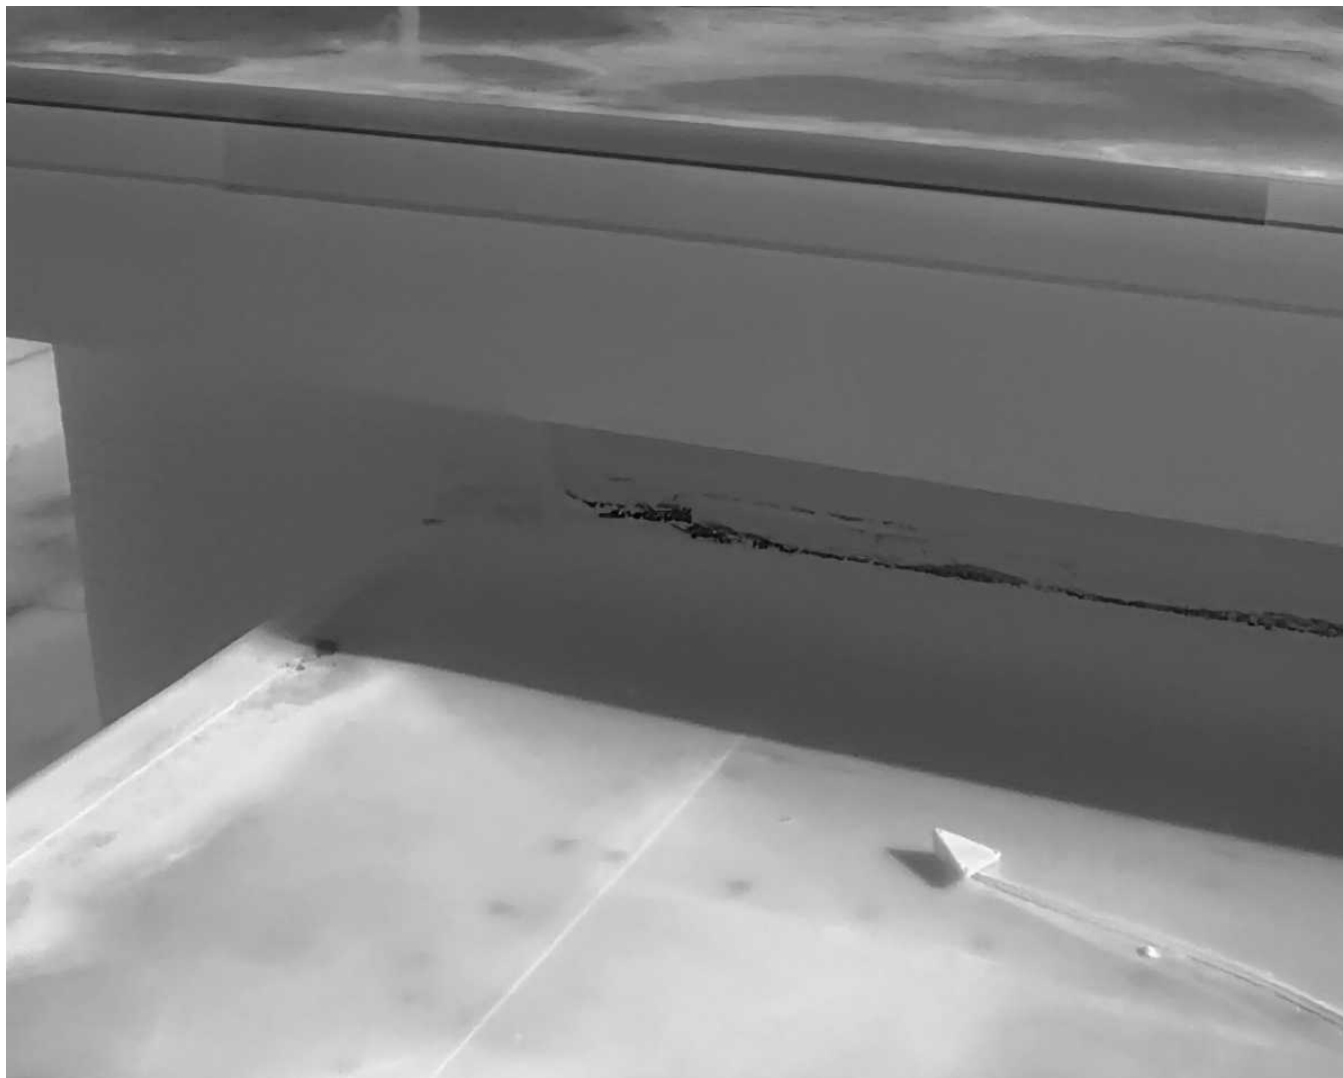
116 116-Failed Flashing Date Taken: 4/21/2025 Taken By: Angela Night
Inadequate craftsmanship and unorganized placement indicative of a poor repair job or uncertified contractor.

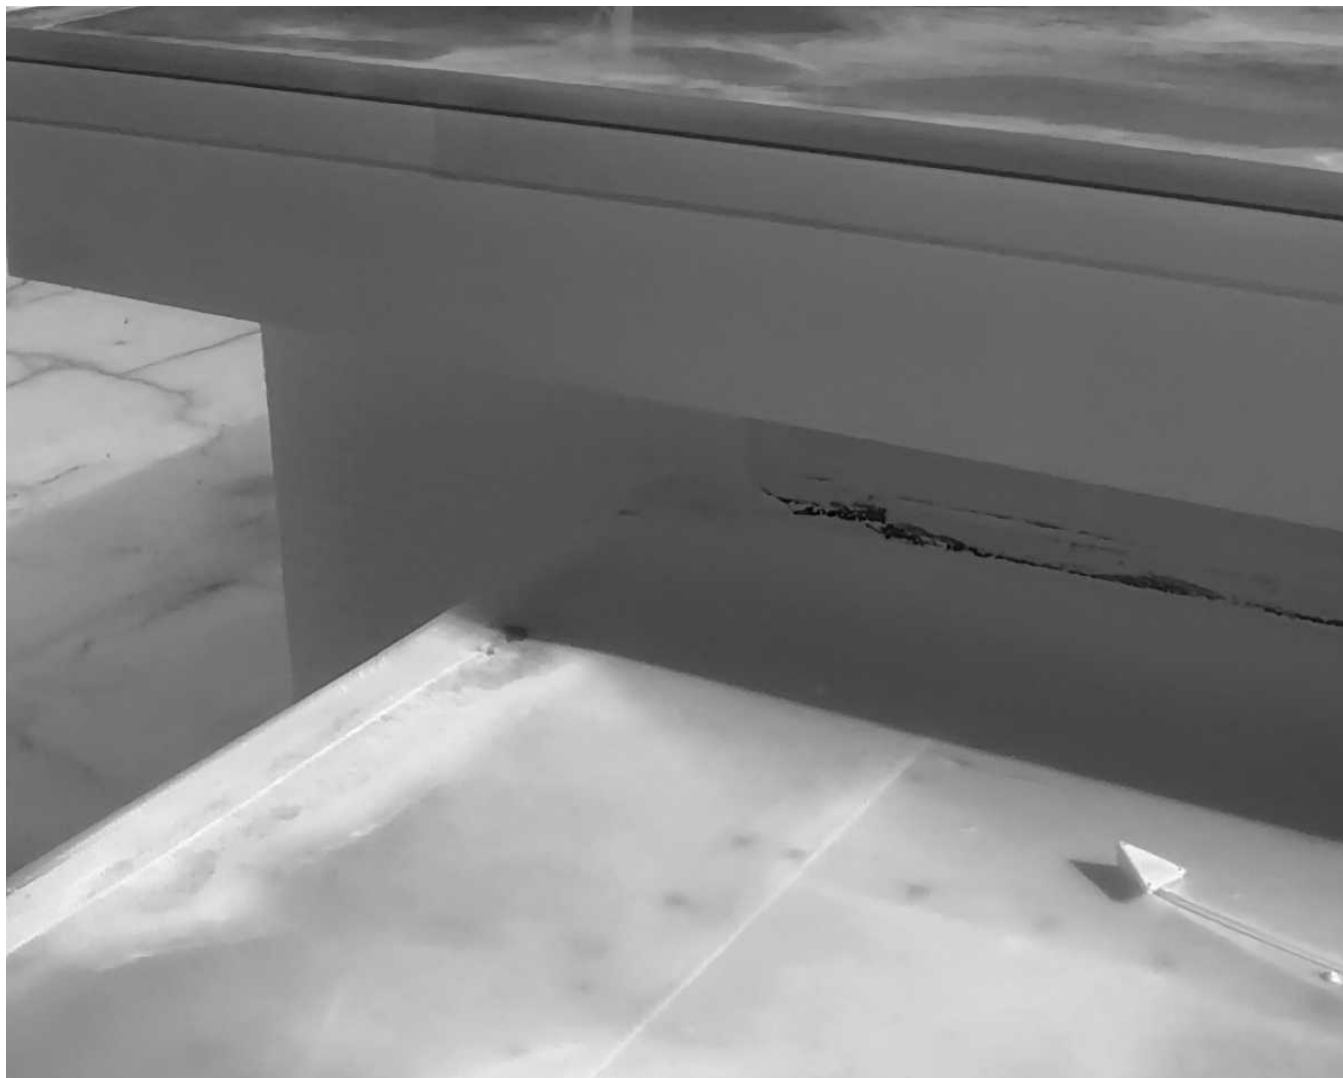
117 117-Failed Flashing Date Taken: 4/21/2025 Taken By: Angela Night
Inadequate craftsmanship and unorganized placement indicative of a poor repair job or uncertified contractor.

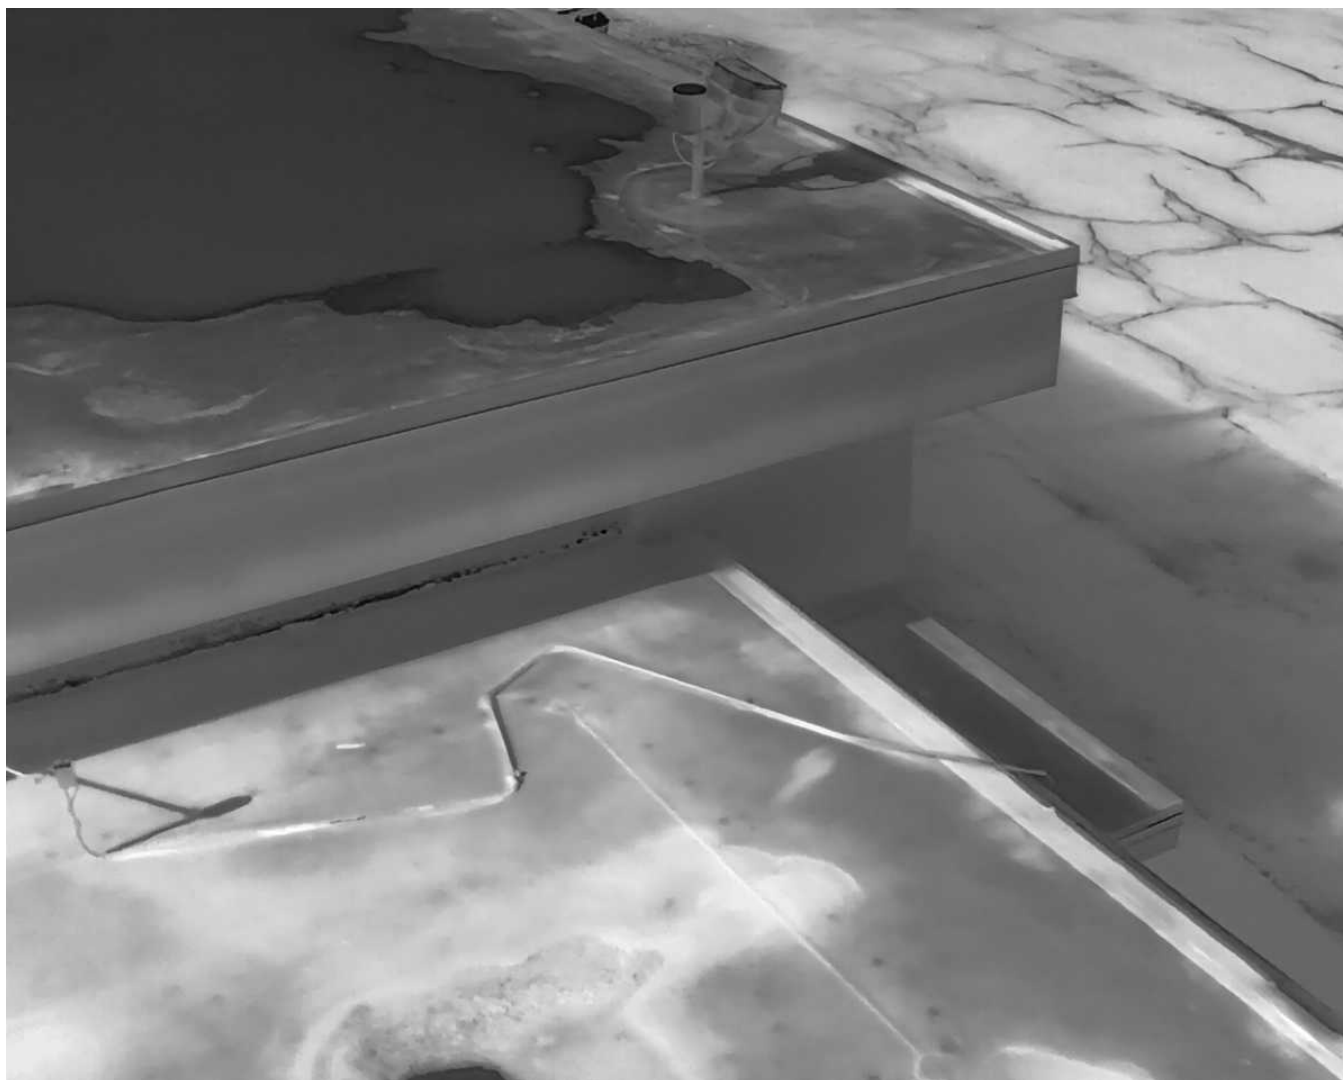
118 118-Failed Flashing Date Taken: 4/21/2025 Taken By: Angela Night
Inadequate craftsmanship and unorganized placement indicative of a poor repair job or uncertified contractor.

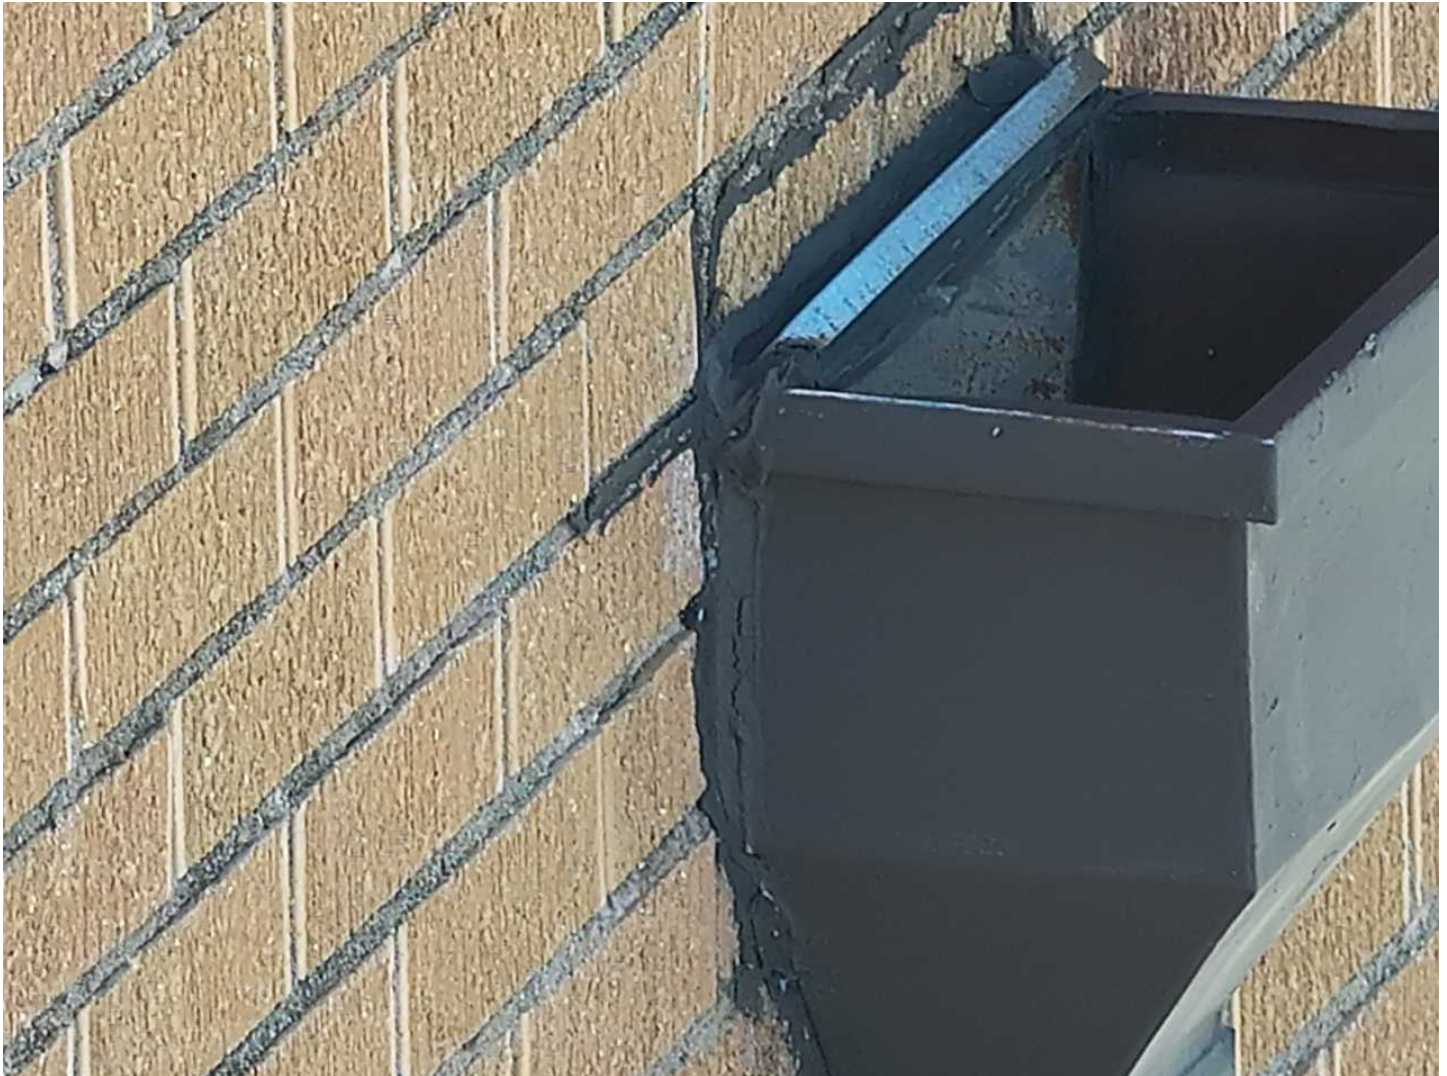
123 123-Conductor Head
Need scrapped around and resealed

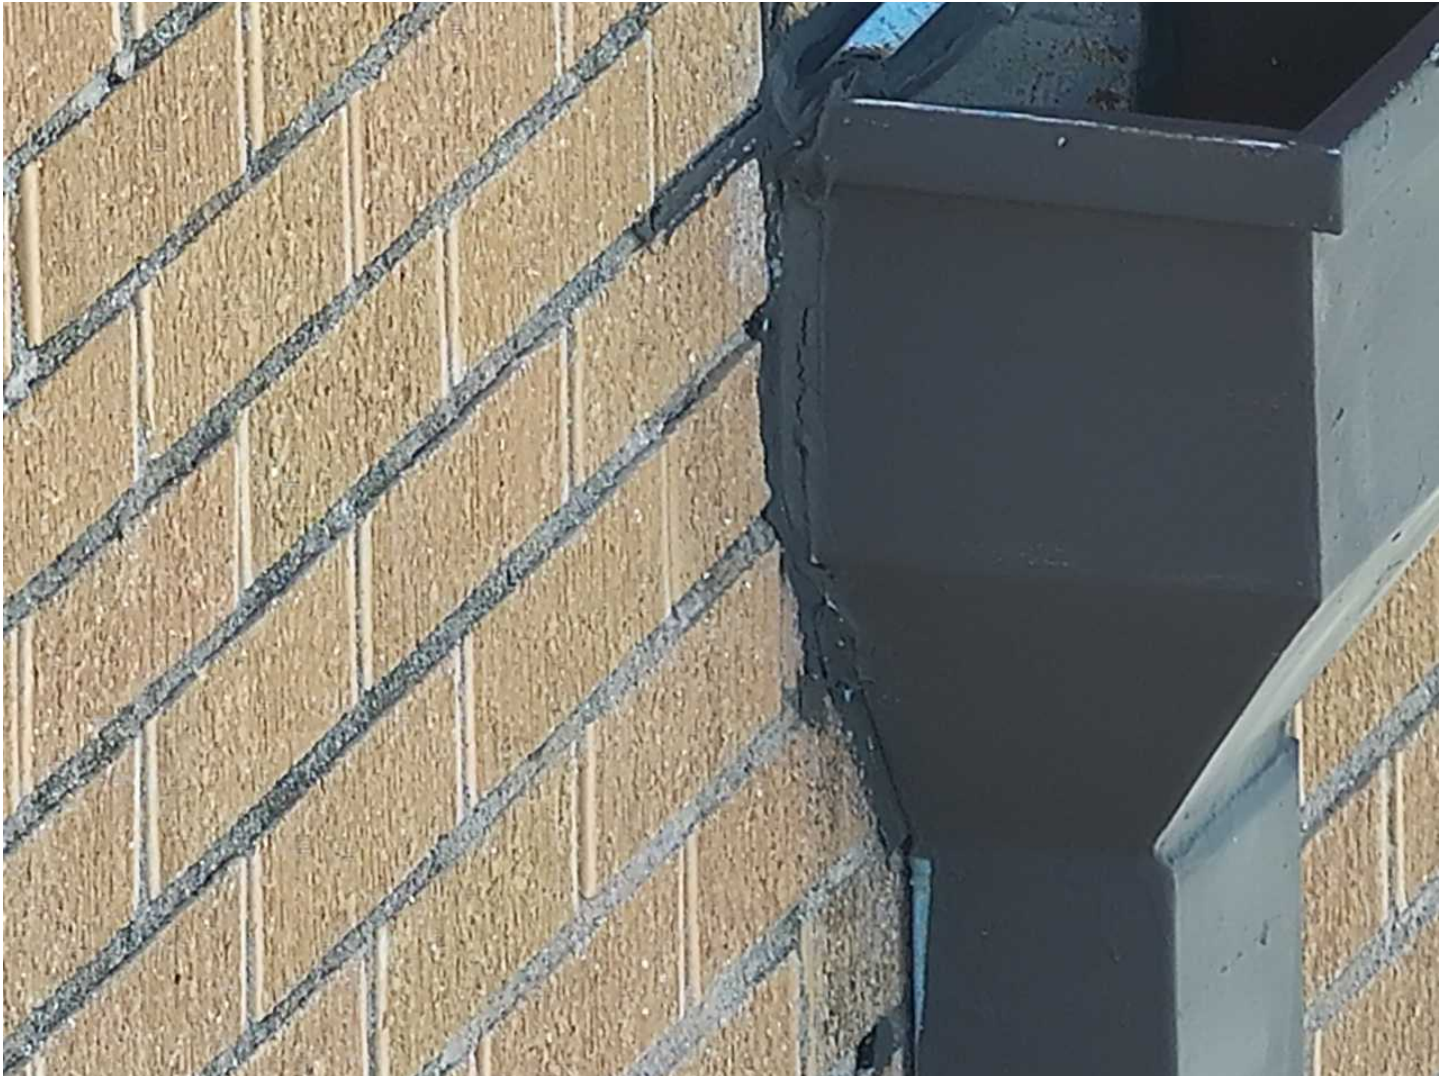
124 124-Conductor Head
Need scrapped around and resealed

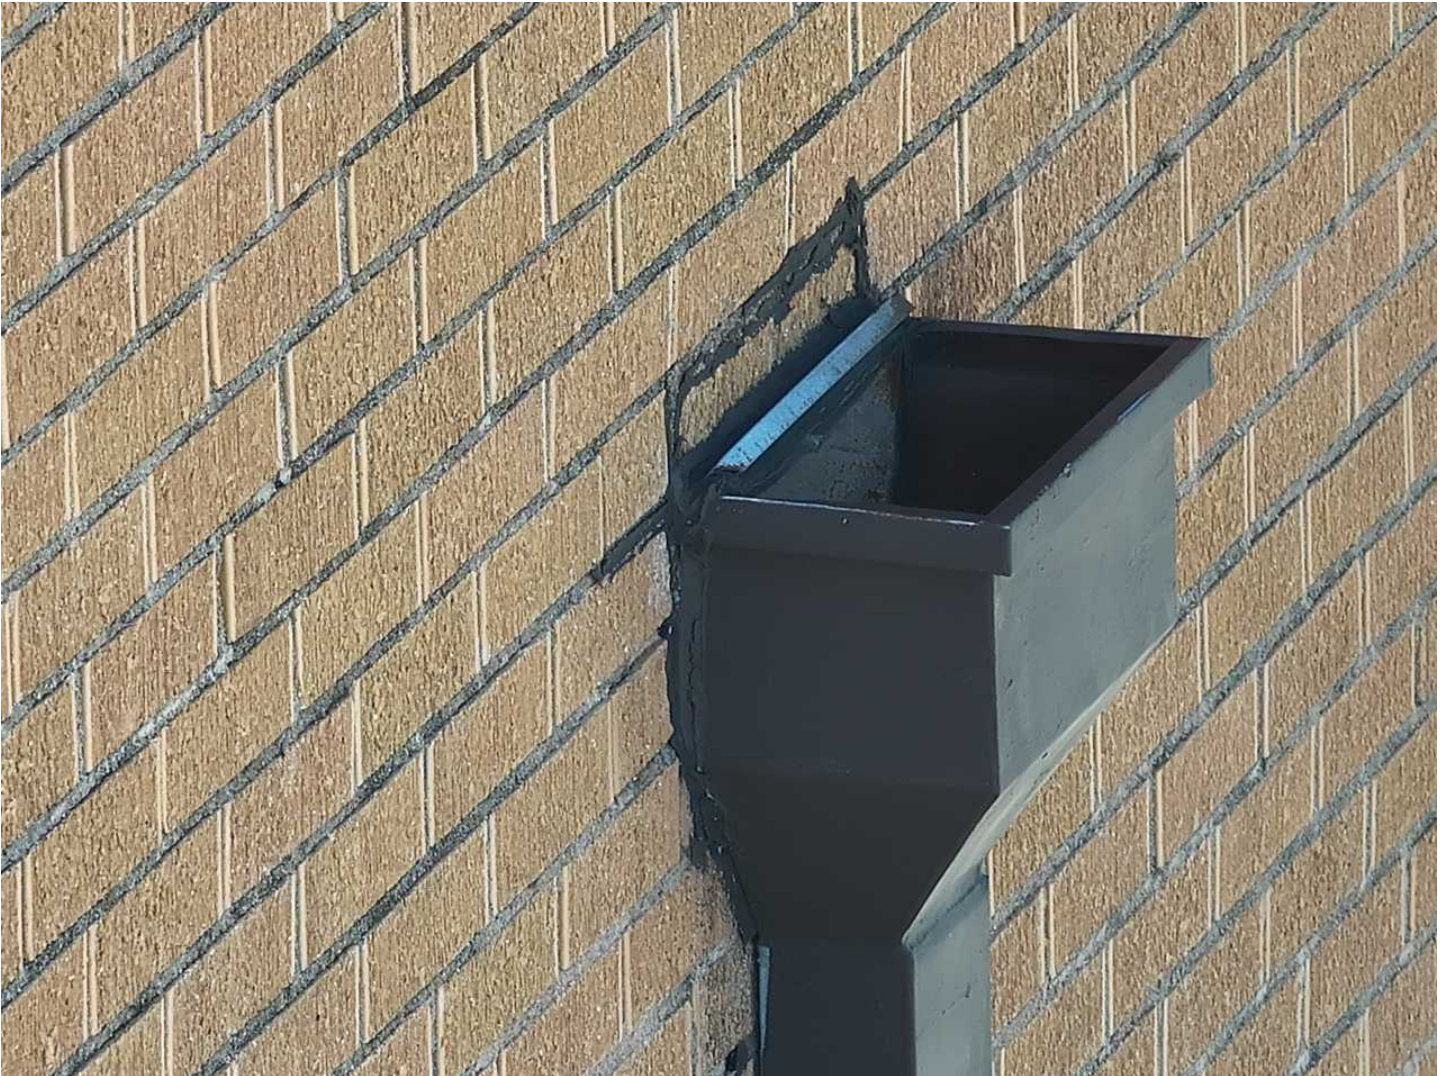
125 125-Conductor Head
Need scrapped around and resealed
